Arborist Report

Inventory and Assessment of Trees Associated to Construction at
103 Ioco Road, Port Moody

February 2, 2021

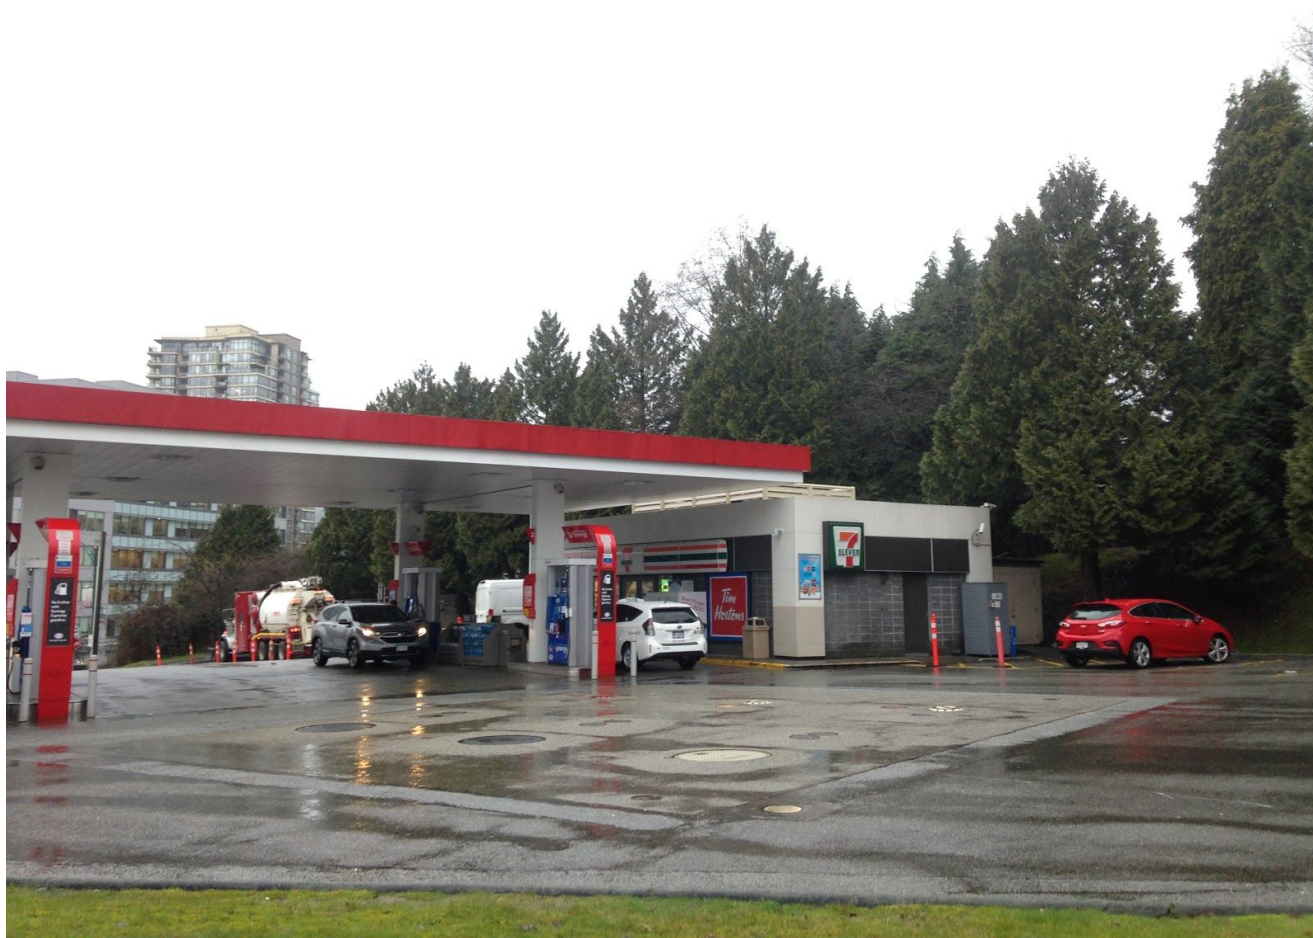
image of property from street at time of field data collection

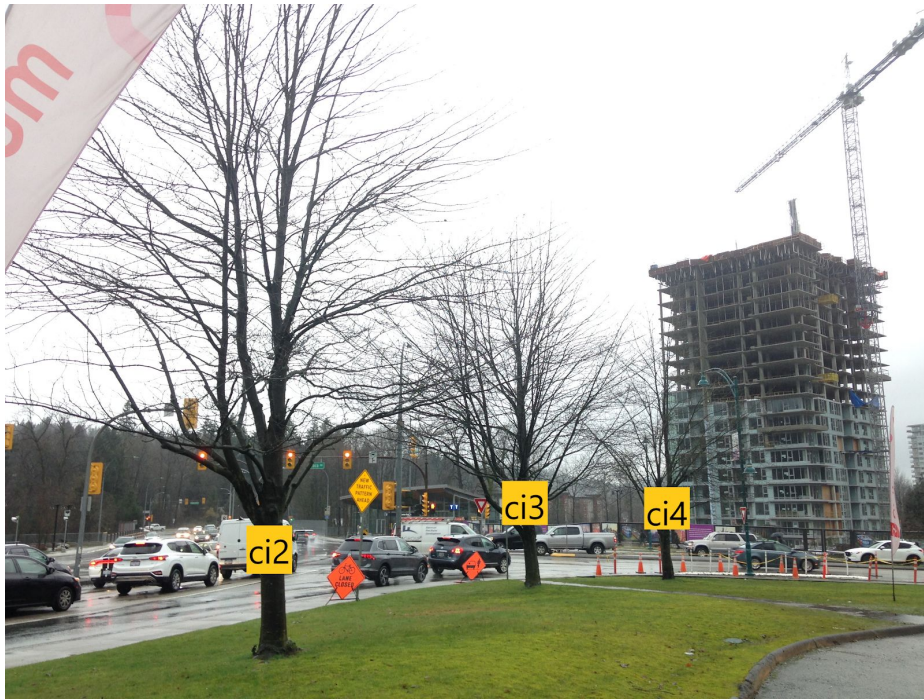
IMAGE 1- Trees ci2, ci43 and ci4

ID#	Surv eyed	Common Name	Botanical Name	DBH (cm)	Condition & Comments	Retention Suitability	Action	TPZ (m)
ci1	y	Black Cottonwood	<i>Populus trichocarpa</i>	52	Single, stem with slight lean to the Northwest. Located on top of a slope.	Moderate	Retain Install barrier 3.12m from tree	3.12
ci2	y	Maple	<i>Acer spp</i>	27	Straight, single stem. Natural form. Mechanical damage to exposed roots.	Good	Retain Install barrier 1.62m from tree	1.62
ci3	y	Maple	<i>Acer spp</i>	38	Straight, single stem. Natural form. Girdled root at base of tree.	Good	Retain Install barrier 2.28m from tree	2.28
ci4	y	Maple	<i>Acer spp</i>	37	Straight, single stem. Natural form. Large mechanical wound to base of tree as well as mechanical damage to exposed roots. Bark is sloughing off base of tree at site of wound.	Moderate	Retain Install barrier 2.22m from tree	2.22
ci5	y	Cherry	<i>Prunus spp</i>	25	Single stem, slight lean West. Natural form. Mechanical damage to exposed roots. Twine left on the root ball is showing. Decay observed at sites of previous limb removals.	Moderate	Retain Install barrier 1.50m from tree	1.50

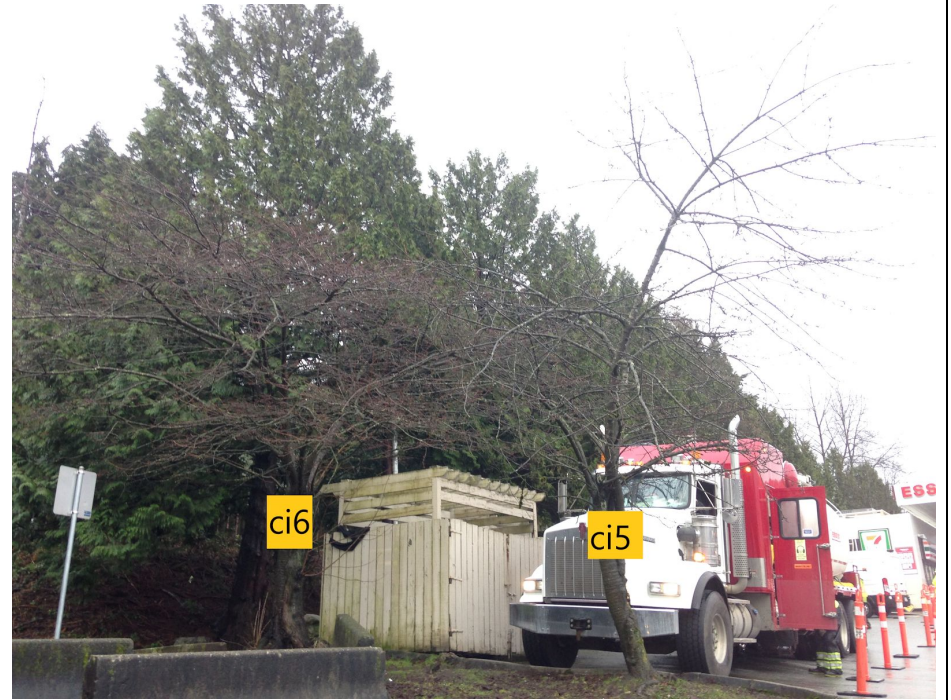
IMAGE 2- Trees ci5 and ci6

ID#	Surveyed	Common Name	Botanical Name	DBH (cm)	Condition & Comments	Retention Suitability	Action	TPZ (m)
ci6	y	Cherry	<i>Prunus spp</i>	43	Natural form. Exposed root flare. Mechanical damage to exposed roots and root flare. Decay observed at sites of previous limb removals.	Moderate	Retain Install barrier 2.58m from tree	2.58
654	y	Western Red Cedar	<i>Thuja plicata</i>	50	Single, straight stem. Natural form. Full crown. Located on a slope.	Good	Retain Install barrier 3.00m from tree	3.00
655	y	Western Red Cedar	<i>Thuja plicata</i>	46	Single, straight stem. Natural form. Full crown. Located on a slope.	Good	Retain Install barrier 2.76m from tree	2.76
656	y	Western Red Cedar	<i>Thuja plicata</i>	48	Single, straight stem. Natural form. Full crown. Located on a slope.	Good	Retain Install barrier 2.88m from tree	2.88
657	y	Paper Birch	<i>Betula papyrifera</i>	38	Single, straight stem. Natural form. Located in conflict with proposed construction	Good	Remove	2.28

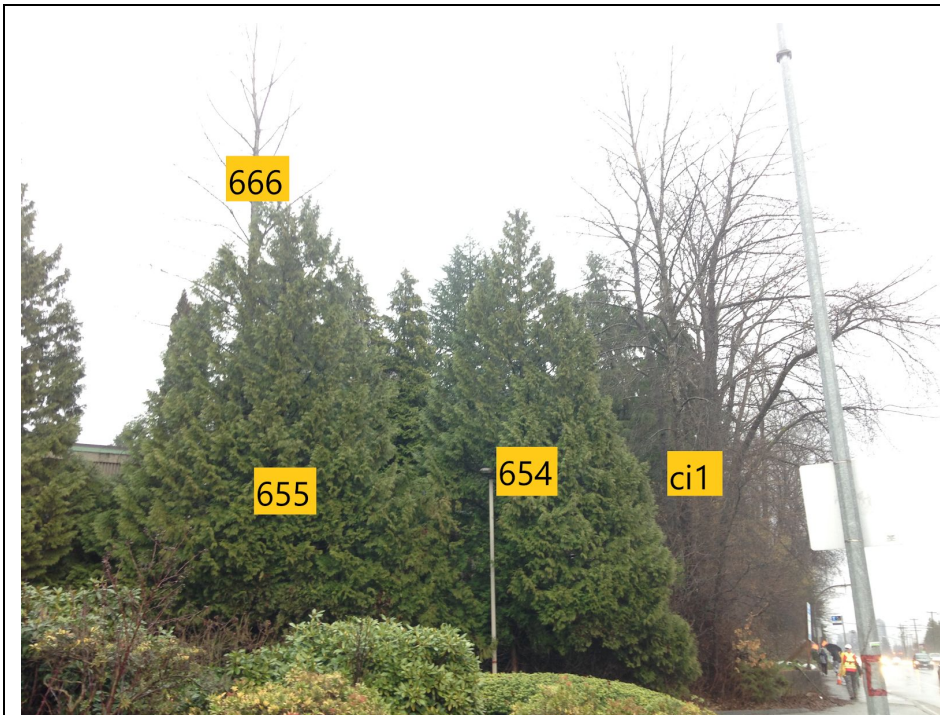
IMAGE 3- Trees ci1, 654, 655 and 666

666	n	Black Cottonwood	<i>Populus trichocarpa</i>	48	Single stem. Natural form. Located on a slope.	Moderate	Retain Install barrier 2.88m from tree	2.88
667	y	Cherry	<i>Prunus spp</i>	16+16 =32	Dual stem. Sweeps Southwest. Located in conflict with proposed construction	Moderate	Remove	1.92
668	y	Red Alder	<i>Alnus Rubra</i>	34	Straight, single stem. Located in conflict with proposed construction	Moderate	Remove	2.04

- Tree barriers shown on the “Tree Plan for Construction” are to be installed and kept in place during the entire duration of construction.
- Arborist to supervise construction works inside the TPZ of trees 654, 655 and 656

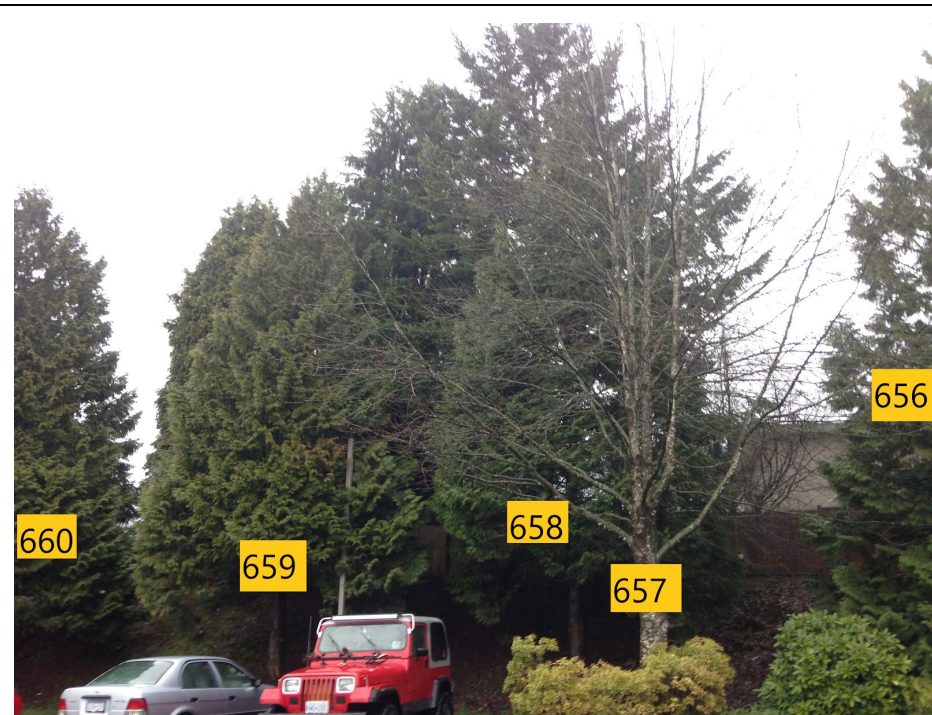
IMAGE 4- Trees 656, 657, 658, 659 and 660

658	y	Western Red Cedar	<i>Thuja plicata</i>	34	Single, straight stem. Natural form. Full crown. Located on a slope. Located in conflict with proposed construction	Good	Remove	2.04
659	y	Western Red Cedar	<i>Thuja plicata</i>	39	Single, straight stem. Natural form. Full crown. Located on a slope. Mechanical damage at the base of the tree. Located in conflict with proposed construction	Good	Remove	2.34
660	y	Western Red Cedar	<i>Thuja plicata</i>	47	Single, straight stem. Natural form. Full crown. Located on a slope. Located in conflict with proposed construction	Good	Remove	2.82

- Trees #657, 658, 659, 660, 661, 662, 663, 664, 665, 667 and 668 are recommended for removal because they are located in conflict with the proposed construction.
- Tree #669 is a mostly dead Alder in poor condition. It is recommended for removal.

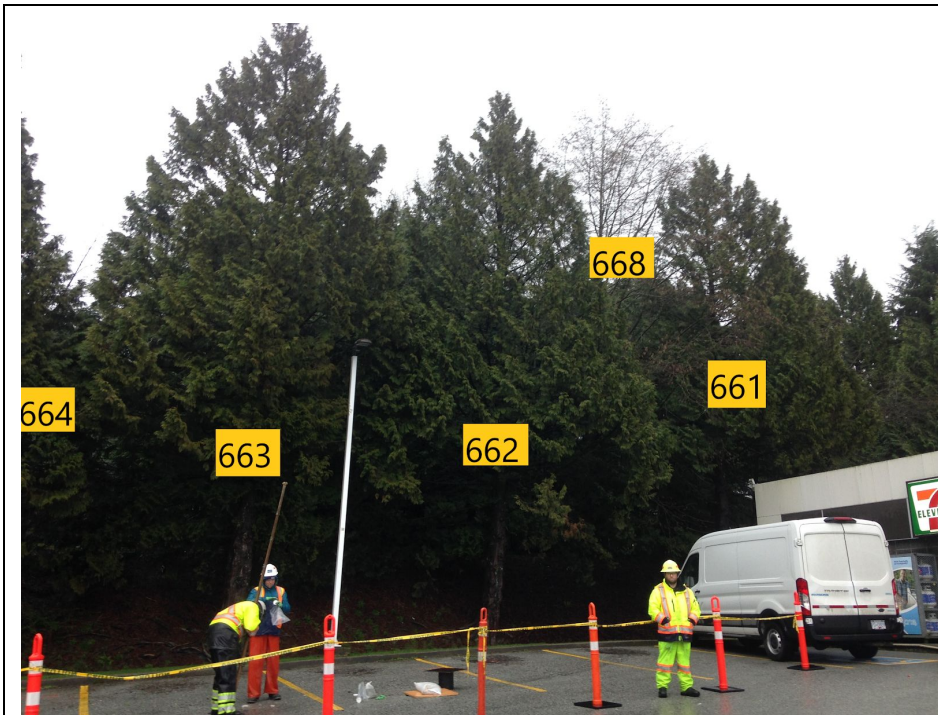
IMAGE 5- Trees 661, 662, 663, 664 and 668

ID#	Surv eyed	Common Name	Botanical Name	DBH (cm)	Condition & Comments	Retention Suitability	Action	TPZ (m)
661	y	Western Red Cedar	<i>Thuja plicata</i>	60	Single, straight stem. Natural form. Full crown. Located on a slope. Located in conflict with proposed construction	Good	Remove	3.60
662	y	Western Red Cedar	<i>Thuja plicata</i>	52	Single, straight stem. Natural form. Full crown. Located on a slope. Located in conflict with proposed construction	Good	Remove	3.12
663	y	Western Red Cedar	<i>Thuja plicata</i>	64	Single, straight stem. Natural form. Full crown. Located on a slope. Located in conflict with proposed construction	Good	Remove	3.84
664	y	Western Red Cedar	<i>Thuja plicata</i>	68	Single, straight stem. Natural form. Full crown. Located on a slope. Located in conflict with proposed construction	Good	Remove	4.08
665	y	Western Red Cedar	<i>Thuja plicata</i>	62	Single, straight stem. Natural form. Full crown. Located on a slope. Located in conflict with proposed construction	Good	Remove	3.72

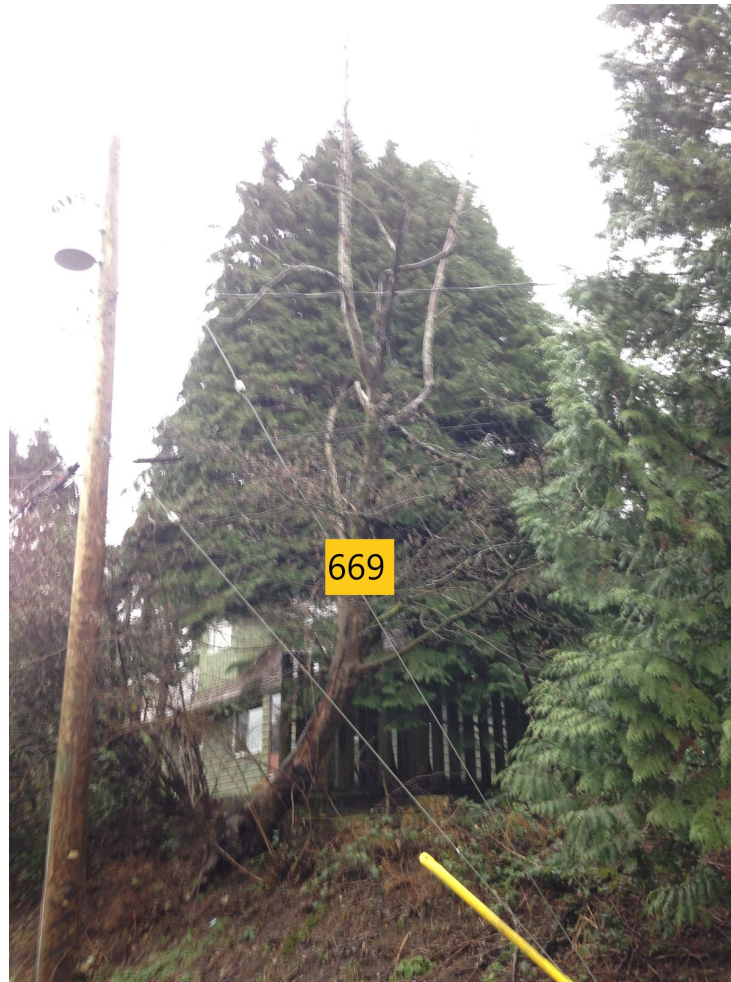
IMAGE 7- Tree 669

ID#	Surveyed	Common Name	Botanical Name	DBH (cm)	Condition & Comments	Retention Suitability	Action	TPZ (m)
669	y	Red Alder	<i>Alnus Rubra</i>	34	Mostly dead. Significant sweep Southwest. Sloughing bark at base. Mechanical damage on the West side of the lower trunk. Located on a slope. Likely to fail.	Poor	Remove	2.04
