Conservation Plan

Nielsen Residence – 112 Moray Street, Port Moody

July 2021

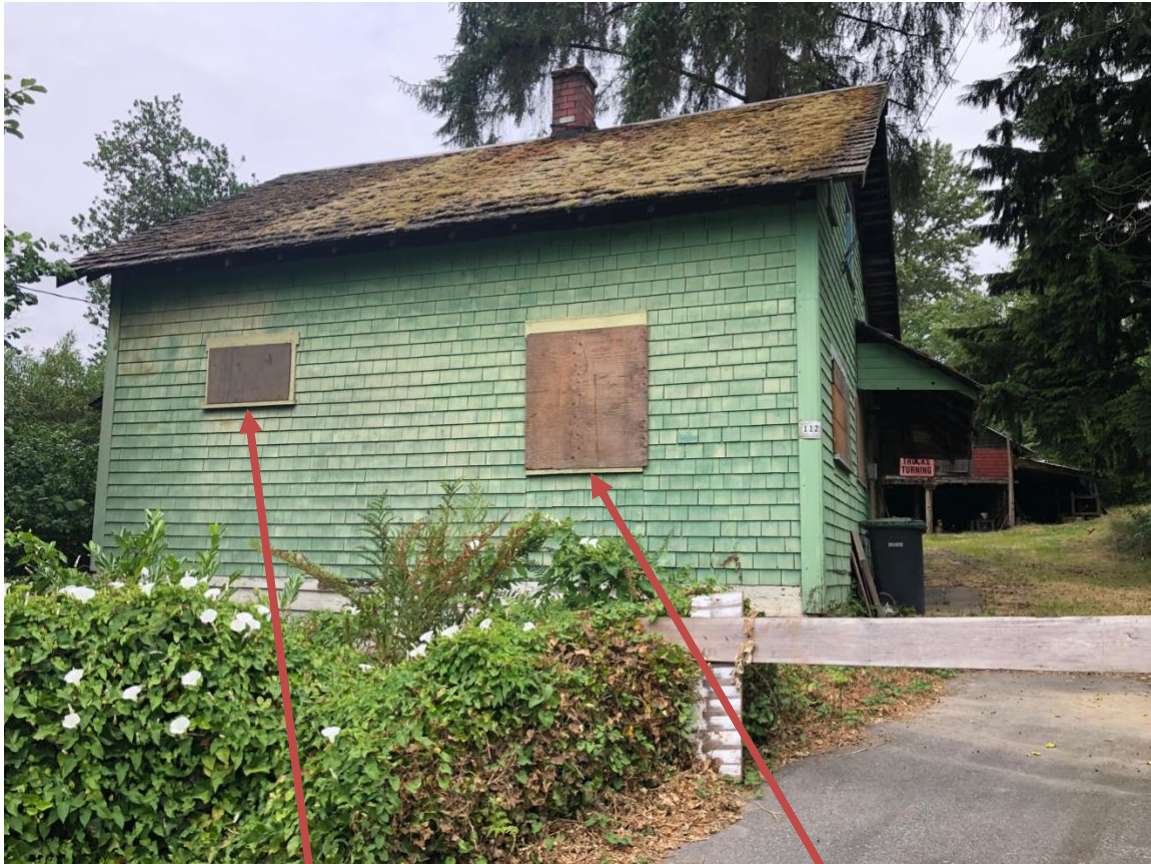
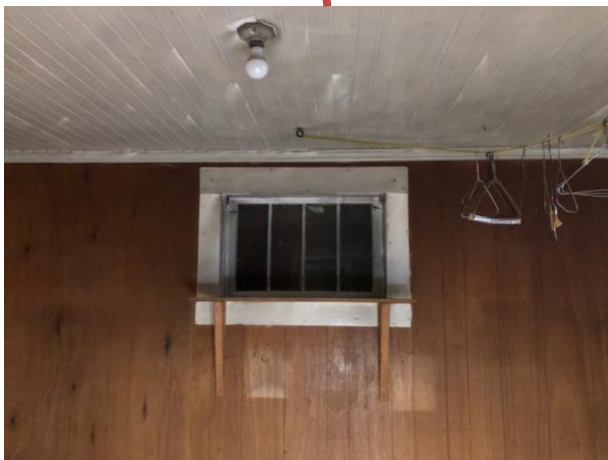
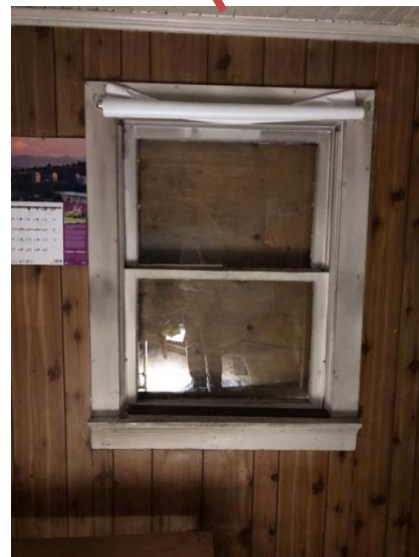
The overall condition of the windows and trim is good. Windows on the west side are in good condition (Figure 6). Windows on the south side, main floor, are in good condition, while the upper centre-set window is in fair condition with damage to the trim. The small windows set in the crawlspace, on either side of the centre-set window, have unusually narrow sills which are not standard but are in good condition otherwise (Figure 7). Windows on the east side are each set at different heights but otherwise are in good condition, as are the trim and sills (Figures 8 and 9). On the north side, the windows and trim are in good condition, while the sills are in fair condition except for the most westerly of the north side windows, which is good (Figures 9 and 10).

Figure 6: West and Partial South Side, as seen from Moray Street, corresponding windows: fixed and double-hung. Note the corner boards, which do not exist on the east side.

- All of the original wood frame windows of the house should be preserved. Repairs should be done where necessary, using the least intrusive method.
- All window trim is to be retained, repaired where necessary and reinstated.
- Windows on the basement level are expected to be new, as this will be an upgraded living space after the house is relocated. Therefore, this level should be restored with new wood windows in a style complementary to those on the main floor, in consultation with the heritage consultant.

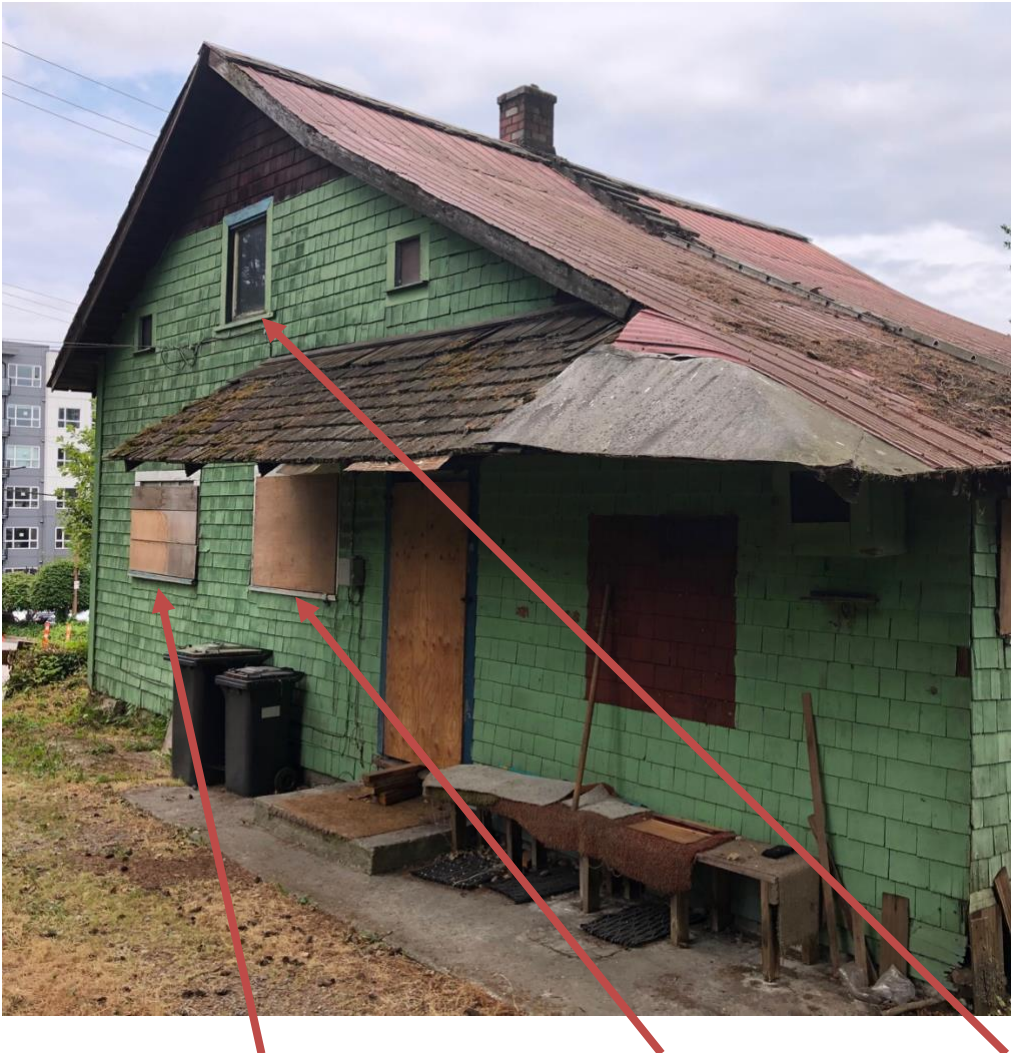
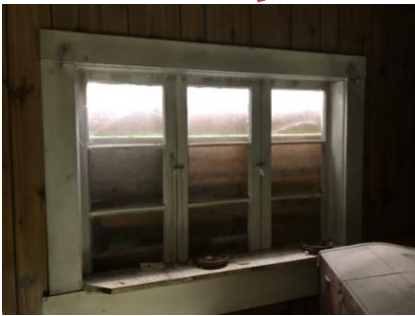
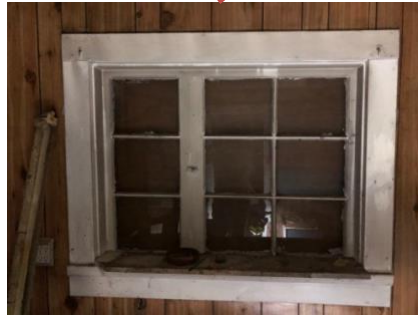
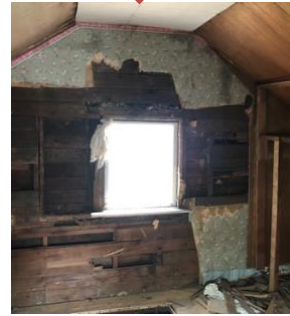
Figure 7: South Side – corresponding windows: (left to right) casement with fixed centre, casement/fixed, fixed.

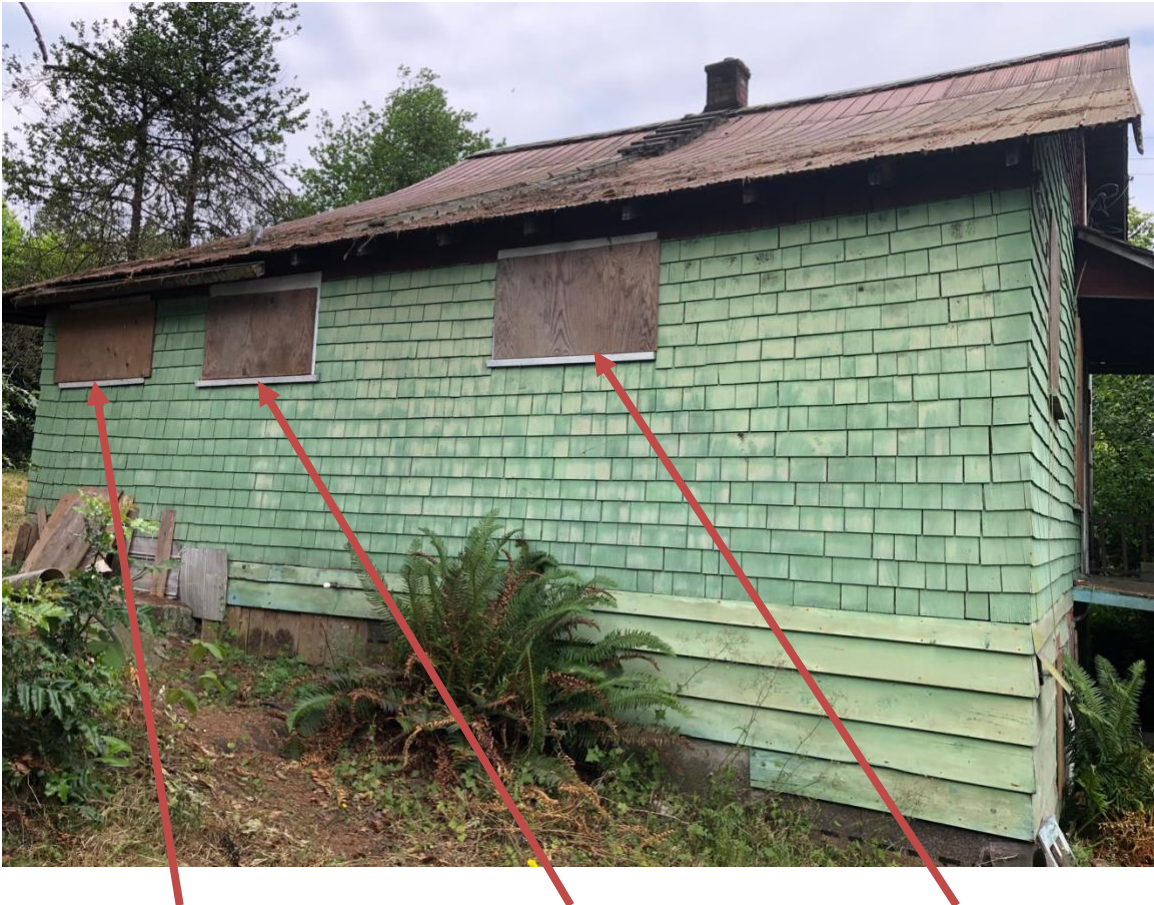
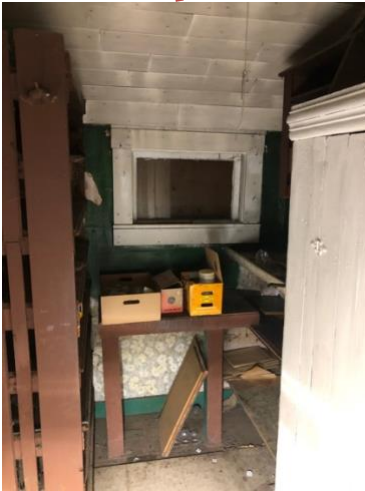
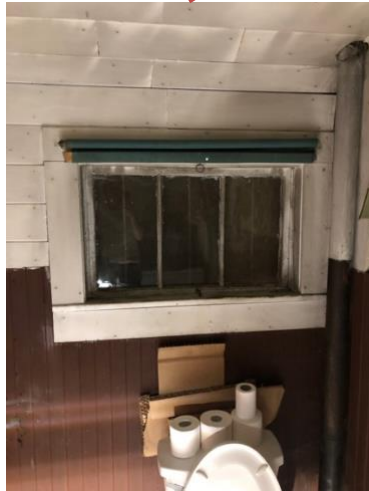
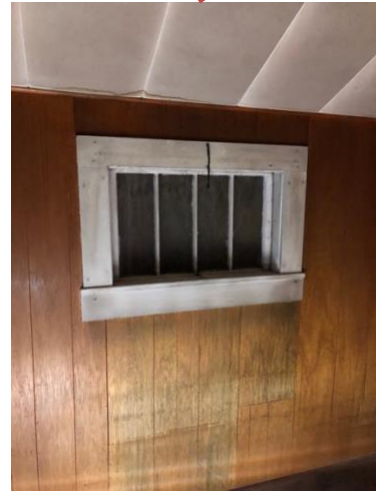
several window sills (esp. south side): while the shingles themselves are in good shape, they appear to have been re-applied due to either window repair or replacement and as such do not quite follow the same pattern as the rest of the wall (Figures 8, 9, 12 and 14)

The overall condition of the cedar shakes is poor, with accumulated moss and decay, while the metal roofing appears to be fair. The structural integrity of the roof trusses is intact and the exposed rafter tails on the east side are in fair condition, while on the west side they are in good condition. However, the trusses most likely do not conform to current code. The soffit is in fair condition on the west side (Figure 6). The roofing material on the south side overhang is exhibiting advanced stages of deterioration, and there is some deterioration of the soffit framework (Figures 13, 14). The only existing gutter is in poor condition and has no downspout (Figure 8).

Figure 8: East Side – corresponding windows: all are awning operation. This is the only section of the house with a gutter remaining.

- The historic cladding should be preserved. Repair those shingles that are irregularly applied (esp. under sills) to be consistent with the rest of the wall.
- Any structural and/or seismic upgrades should be designed from the inside without affecting the exterior appearance of the heritage building.
- Utilize alternative compliance methods, wherever applicable, in the BC Building Code for fire and spatial separations. The heritage consultant can review proposed interventions to meet code requirements.

- Replace all roofing material with new weathered wood asphalt shingles, with a colour and brand selected based on input from the heritage consultant.
- Structural reinforcement of the roof trusses will involve pairing with new material to bring it to current standards. The roof overhang on the south side will also require repair of the soffit and reinforcement in lieu of any posts to connect it to the ground.
- Preserve the exposed rafter tails.
- Install new gutters and downspouts on the west and east sides, and on the south overhang, and on the porch on the north side.

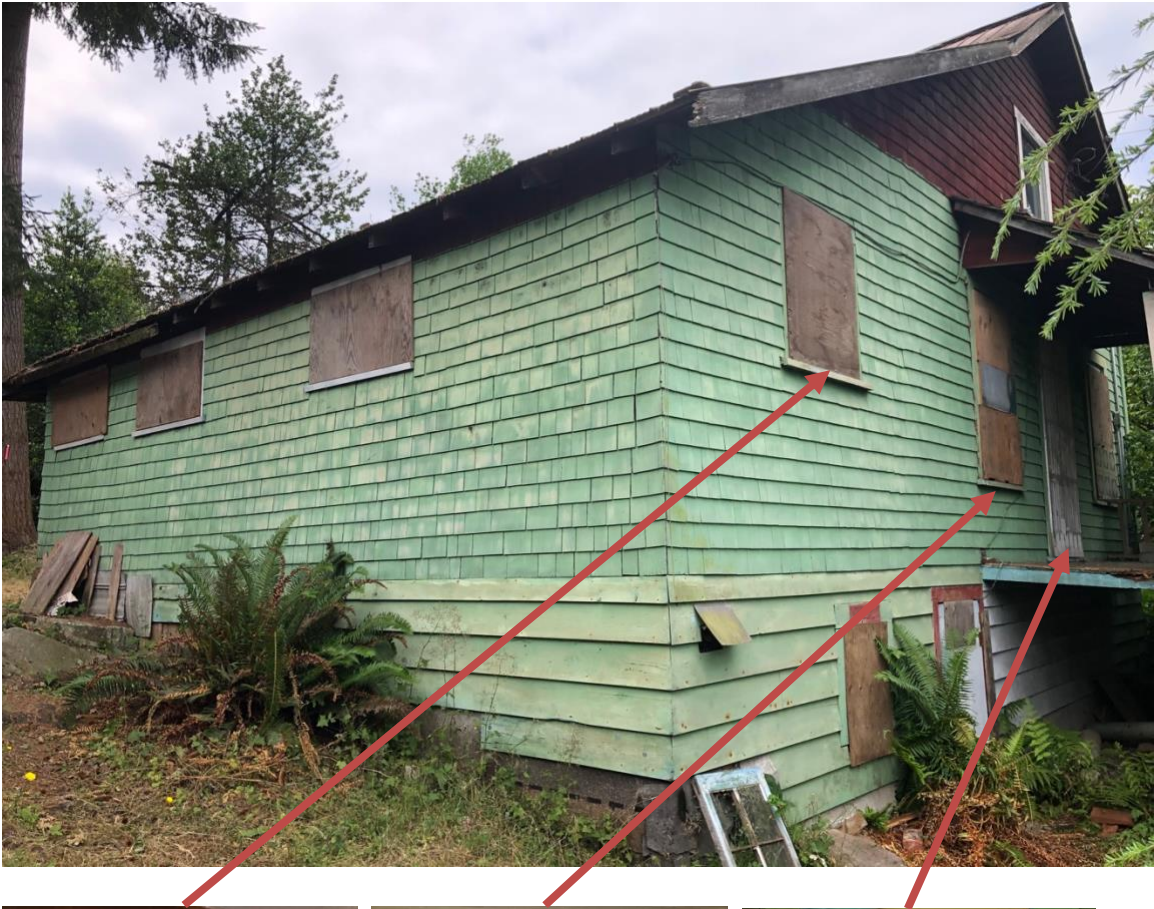
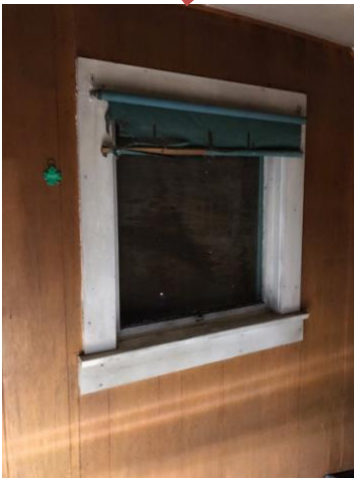
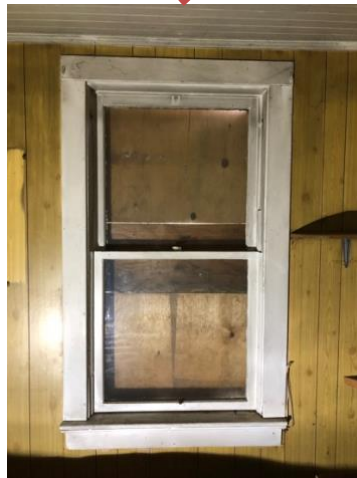
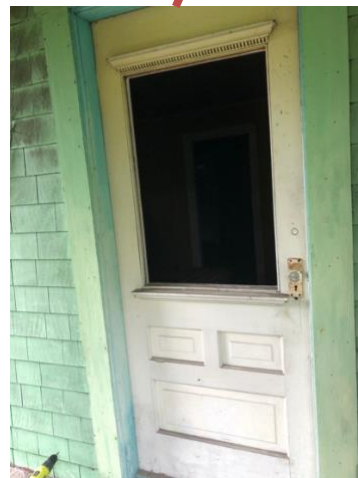
The overall condition of the doors and trim is good. The front door in particular is in very good condition, although it is missing the inset glazing (Figure 9). The rear door is a plain faced door, no glazing, which is not original to the house.

Figure 9: North Side – corresponding windows: fixed and double-hung; detail of original front door.

- Rehabilitate the front door and reinstate the glazing.
- Restore the rear door as a solid wood door, in a period-appropriate appearance, with or without inset glazing.
- Retain and repair all trim.

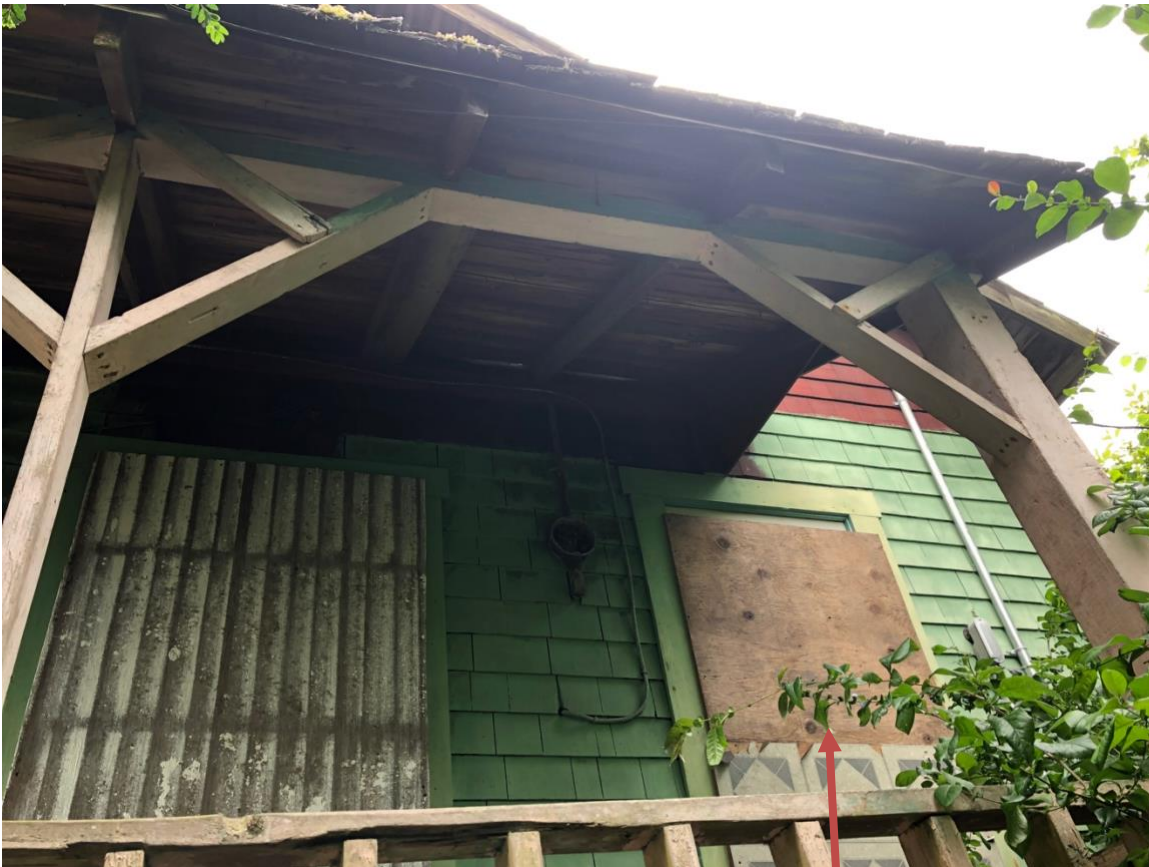
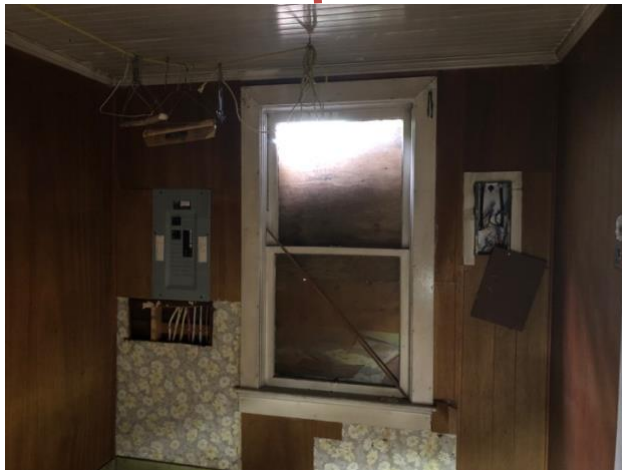
The overall condition of the front porch is fair. Structurally the floor has deteriorated in parts while the balustrade, posts, brackets and overhang are generally good. The roofing material of the porch, similar to the rest of the roofing on the house, is poor (Figures 10 and 11).

Figure 10: North Side (Front) Porch – corresponding double-hung window.

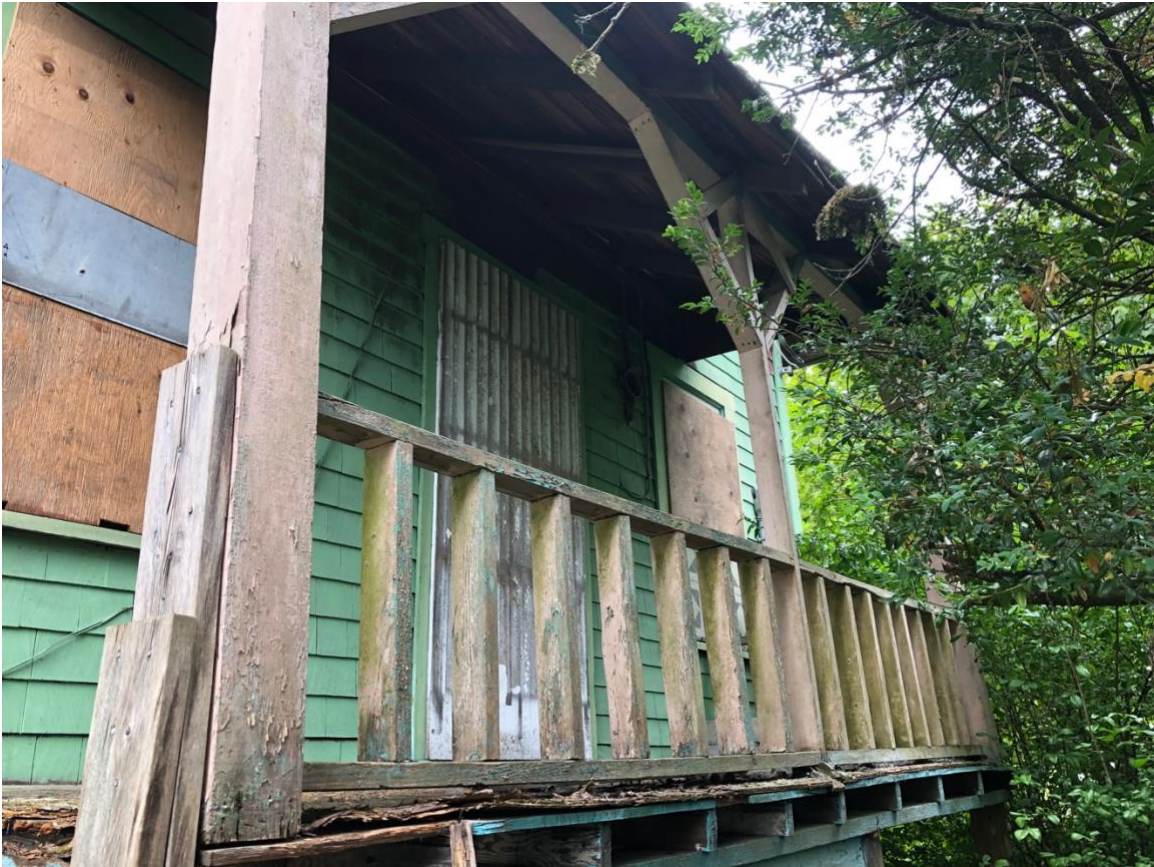
Figure 11: Full view of Front Porch along North Side, illustrating the deteriorated condition of the porch floor and sub-structure.

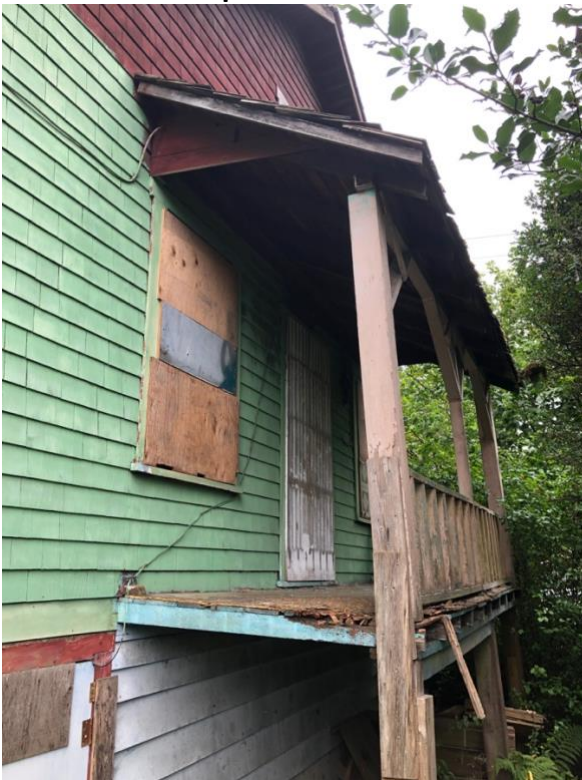
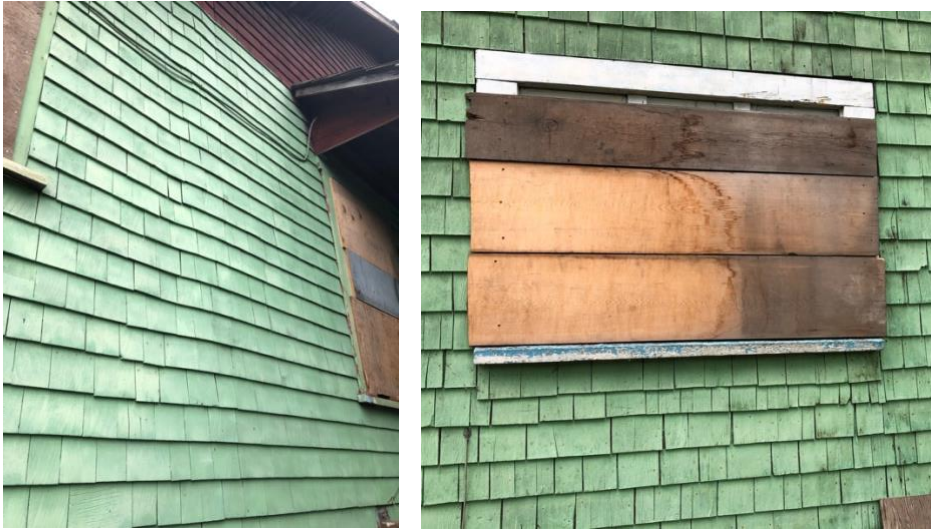
Figure 12: Example of Irregular Application of Cedar Shakes – north side (left), south side (right). The former illustrates the joining of the later addition to the original house while the latter illustrates either an enlargement or alteration to the original window and the siting of the sill.

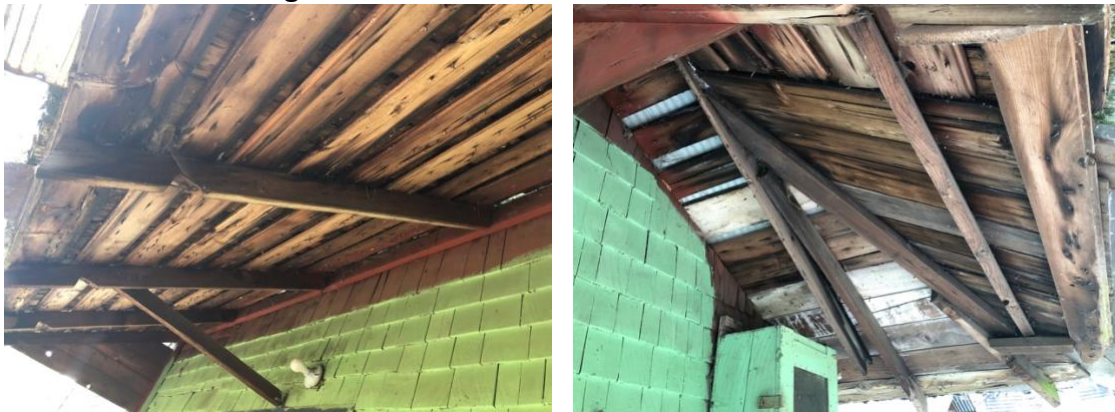
Figure 13: Condition of Soffit and Roof Structure, South Side Overhang

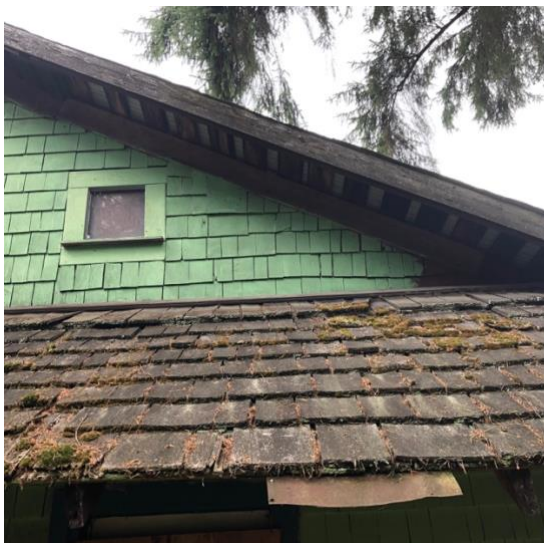
Figure 14: Roofing Material, South Side Overhang. Also note the irregular (thin) window sill above, and the slightly off-set shingle pattern below the sill.
