Completion of Heritage Conservation Work: Moiso Residence, 2101 Clarke Street (formerly 2614 St. Johns Street)

Please accept this letter as confirmation that the Heritage Conservation work at the Moiso Residence, addressed 2101 Clarke Street in Port Moody, is substantially complete as verified by Donald Luxton & Associates on June 15th, 2021.

Completion of Heritage Conservation Work: Siddall Residence, 2901 St. Johns Street

Completion of Heritage Conservation Work: Sutherland Residence, 2133 St. Andrews Street

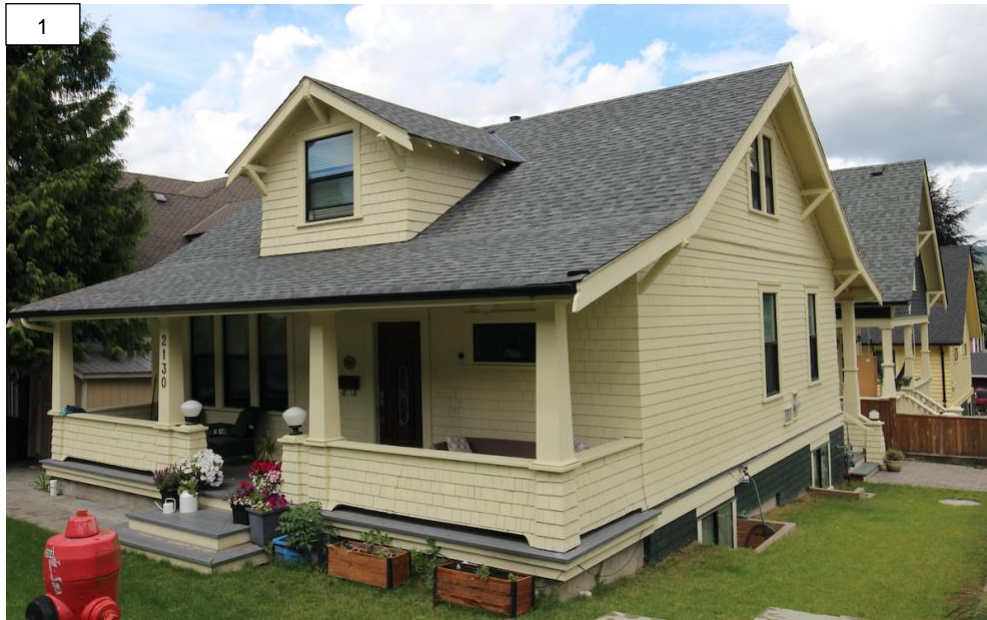
Figure 1: Context photo, as viewed from St. George Street and Douglas Street intersection.

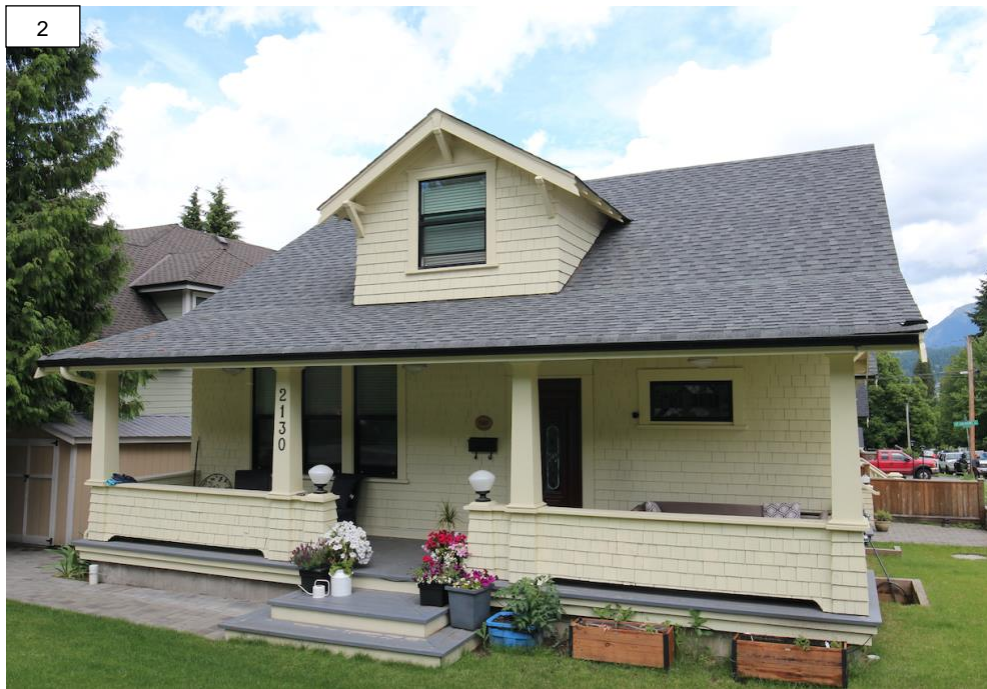
Figure 2: Front elevation of Moisio Residence, as viewed from St. George Street.

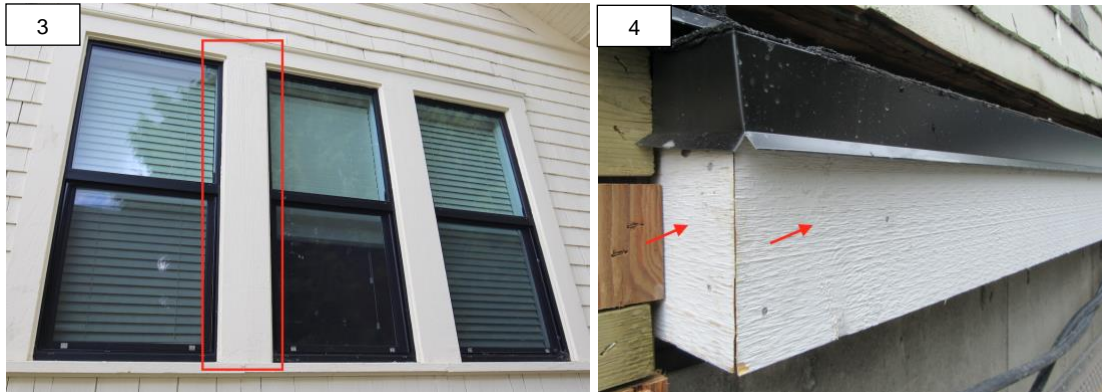
5.4.2	WOOD SIDING (Restoration) <ul style="list-style-type: none"> Retain cedar shingle siding and restore in-place where possible. Replace any damaged cedar shingle siding to match existing in material, size, profile. Combed or textured lumber, vinyl or fibre cement siding are not acceptable replacement materials on the historic house. Install new cedar shingles at the basement level closely matching the originals in overall 	Comments: <ol style="list-style-type: none"> Cedar shingle siding was retained and restored as required. Textured lumber was identified at a number of locations including watertable and window casings at basement level. Note that there was no consultation with the Heritage Consultant prior to installation. Cedar shingle siding of appropriate size and

dimensions and installation pattern.	dimensions installed at the basement level. 4. Wood siding restoration work is substantially complete.
5.4.3	WOOD TRIM (Restoration) <ul style="list-style-type: none"> Original trim that is in good or repairable condition may be retained, including window and door trim, fascia boards and bargeboards, and watertable. Cut out deteriorated trim sections and install matching trim board that is visually and physically compatible with the original. 	Comments: <ol style="list-style-type: none"> Original trim in good condition was retained and restored as required. Trim deteriorated beyond repair was replaced with textured lumber at a number of locations including watertable and window casings at basement level. Note that there was no consultation with the Heritage Consultant prior to installation. Wood trim restoration work is substantially complete.

Figure 3 and 4: Detail photos showing textured lumber applications at window casing and watertable.

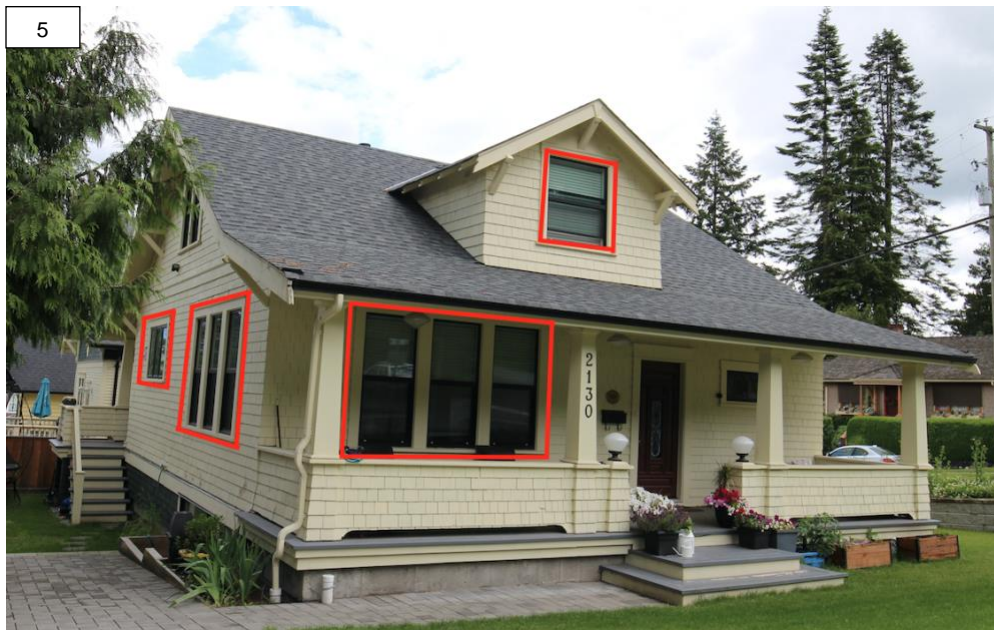
5.6	WINDOW & WINDOW TRIM (Restoration) <ul style="list-style-type: none"> Retain all original wood sash windows and surrounding trim in their original openings where possible. Deteriorated or damaged wood elements may be restored (e.g. sashes, trim, sills). Missing or deteriorated elements can be replaced. Overhaul, tighten/reinforce joints of original windows where possible. Repair frame, trim and hardware. Each original window can be made weather tight by re-puttying and weather-stripping as necessary. Retain historic glass of original windows where possible. Retain the existing storm sashes if possible and install new storm sashes, where desired, to improve the thermal performance of the single-glazed windows. New windows at the basement level can be made of wood and the design should be respectful to the historic character of the house. Prime and paint all wood windows as required in appropriate colours, based on colour schedule devised by the Heritage Consultant. 	Comments: <ol style="list-style-type: none"> Original wood sash windows and historic glass in good condition were retained and restored as required. Wood sash windows beyond repair were replaced with non-wood windows, without consultation with the Heritage Consultant prior to installation. Window shop drawings or specifications were not reviewed by the Heritage Consultant prior to installation. Windows were painted in accordance with the colour schedule devised by the Heritage Consultant. Window and window trim restoration work is substantially complete.

Figure 5: South-west view of Moisio Residence outlining non-wood new and replacement windows.

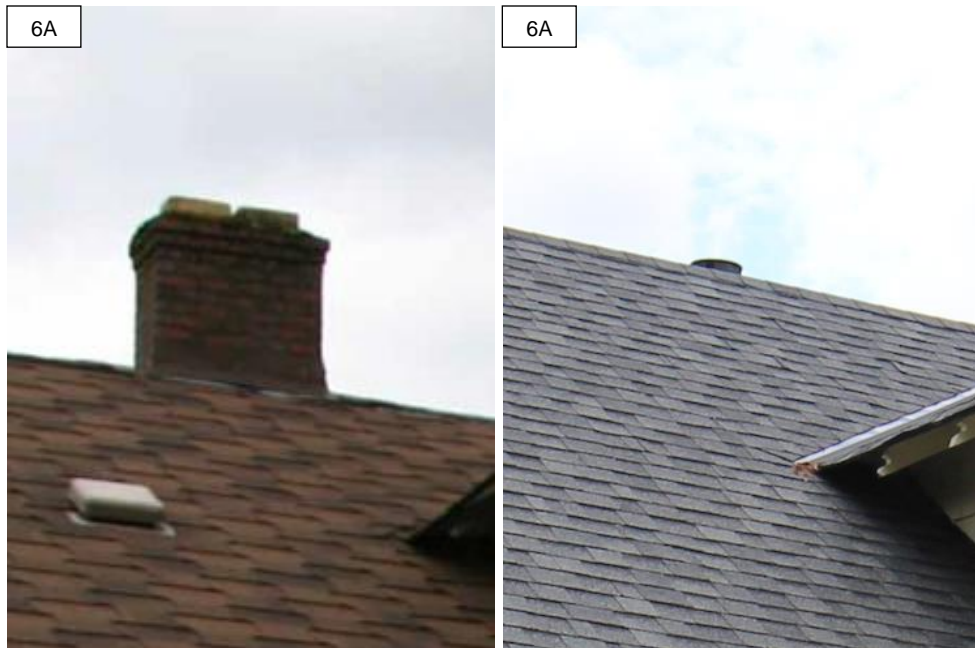
5.9	CHIMNEY (Restoration) <ul style="list-style-type: none"> • The brick chimney may be reconstructed in its original location and original dimensions as shown in photographs. Use red-common bricks and replicate corbelling detail. Install metal flashings at the base. 	Comments: <ol style="list-style-type: none"> 1. Brick chimney was not reconstructed in original dimensions or configuration. 2. Chimney restoration work is substantially complete.

Figure 6A: Internal brick chimney with corbelling before removal.

Figure 6B: Observed chimney at time of review.

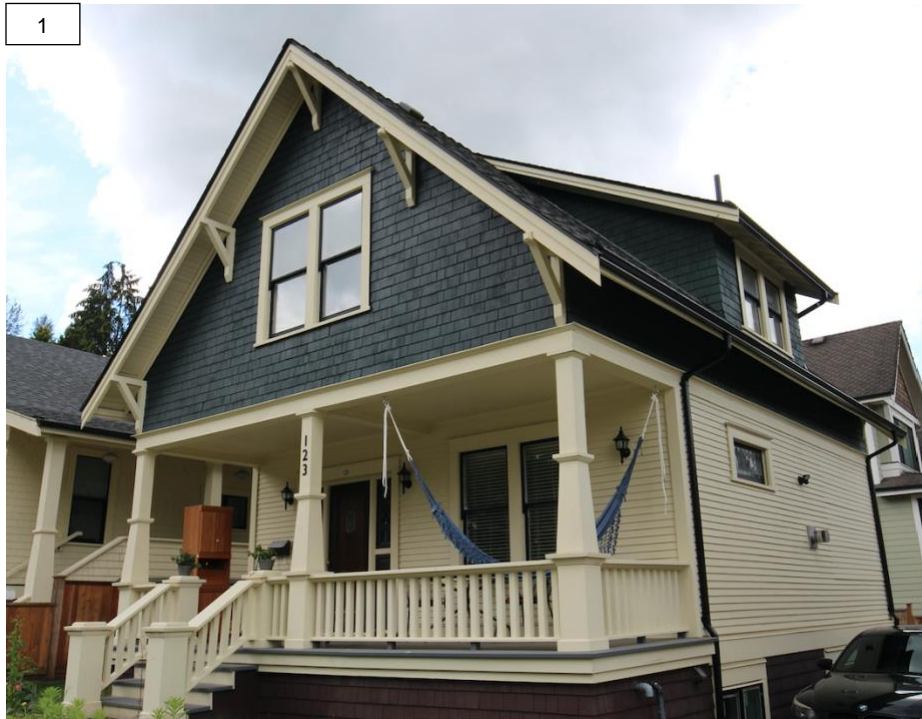
Figure 1: Context photo, as viewed from Douglas Street.

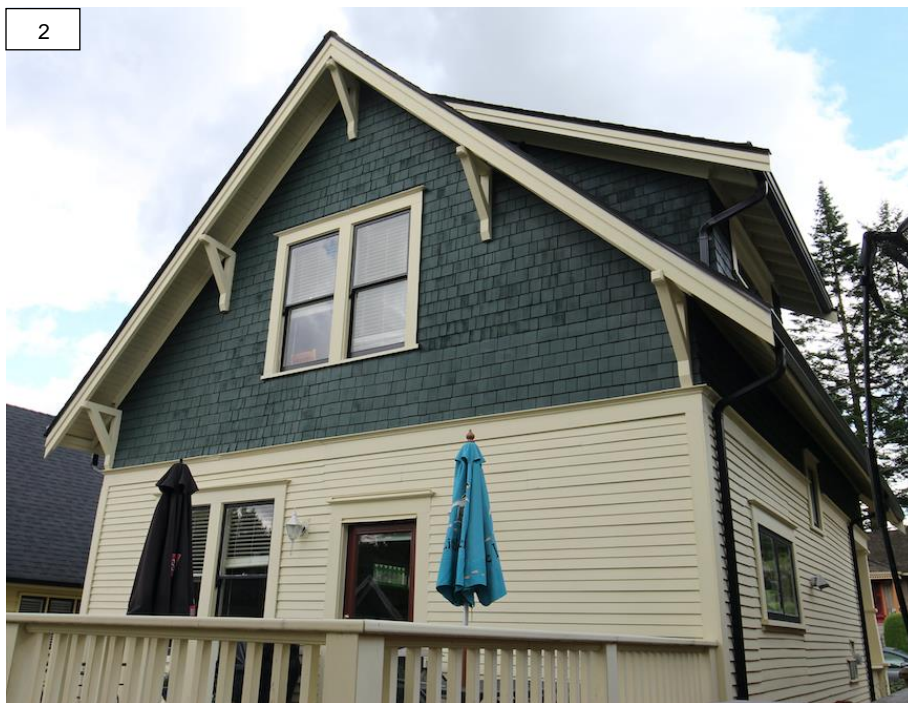
Figure 2: Rear elevation of Siddall Residence.

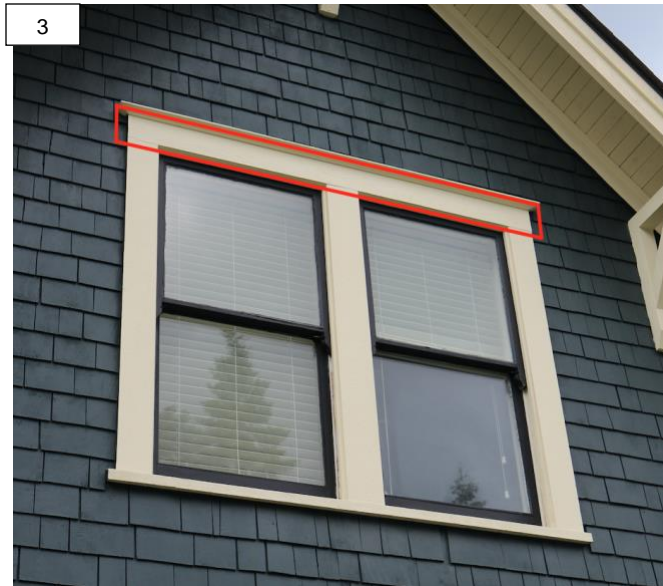
5.4.2	WOOD SIDING (Restoration) <ul style="list-style-type: none"> Retain lap and shingle siding and cornerboards and restore in-place. Replace any damaged lap siding to match existing in material, size, profile. Combed or textured lumber, vinyl or fibre cement 	Comments: <ol style="list-style-type: none"> Wood lap siding was retained and restored as required. Textured lumber was identified at a number of locations including watertable and window

<p>siding are not acceptable replacement materials on the historic house.</p> <ul style="list-style-type: none"> Install new cedar shingles at the basement level matching the originals in overall dimensions and installation pattern. 	<p>casings at basement level. Note that there was no consultation with the Heritage Consultant prior to installation.</p> <ol style="list-style-type: none"> Cedar shingle siding of appropriate size and dimensions installed at the basement level and gable walls. Wood siding restoration work is substantially complete.

Figure 3: Detail photo showing textured lumber application at window casing.

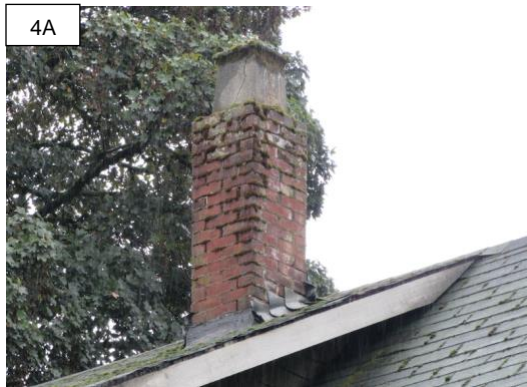
5.9	<p>CHIMNEY (Restoration)</p> <ul style="list-style-type: none"> The existing brick chimney should be retained in place and relocated with the house, if possible. The brickwork can be gently cleaned of dirt and the brickwork re-pointed as necessary with suitable mortar. The brickwork will remain unpainted. New metal flashings should be installed. 	<p>Comments:</p> <ol style="list-style-type: none"> Brick chimney was not reconstructed in original dimensions or configuration. No consultation with the Heritage Consultant prior to installation. Chimney restoration work is substantially complete.

Figure 4A: Internal brick chimney with corbelling before removal.

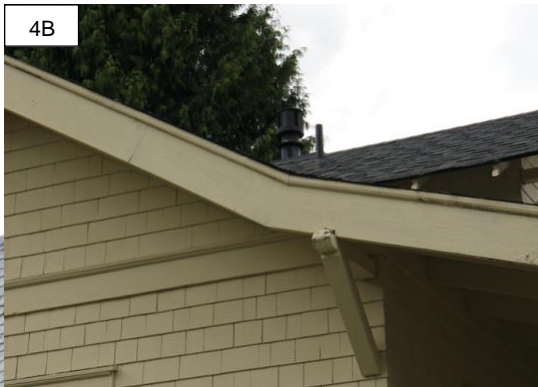
Figure 4B: Observed chimney at time of review.

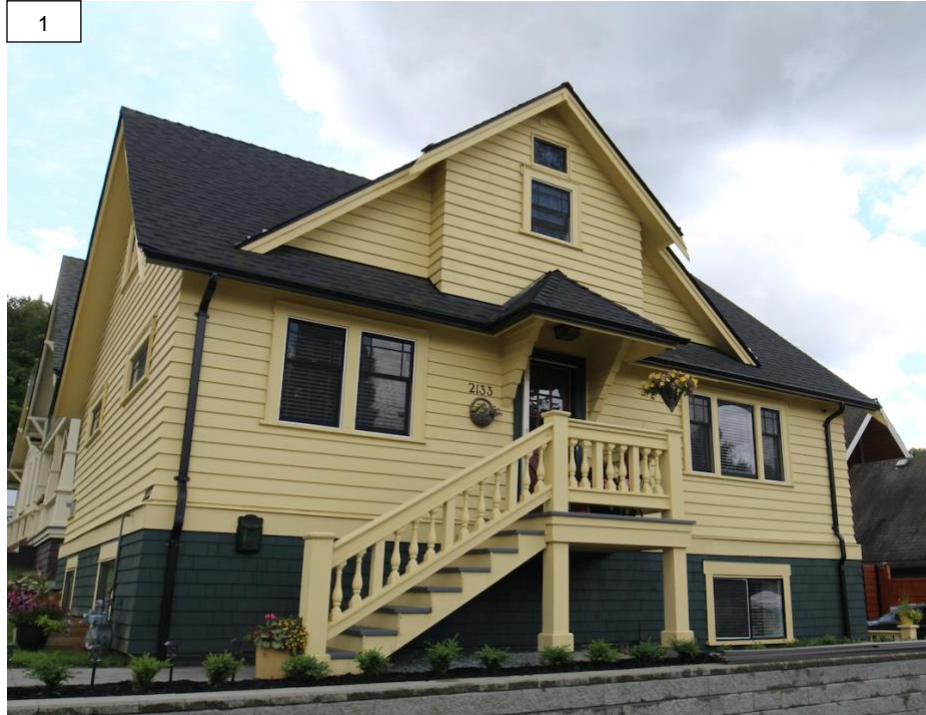
Figure 1: Context photo, as viewed from corner of St. Andrews Street and Douglas Street.

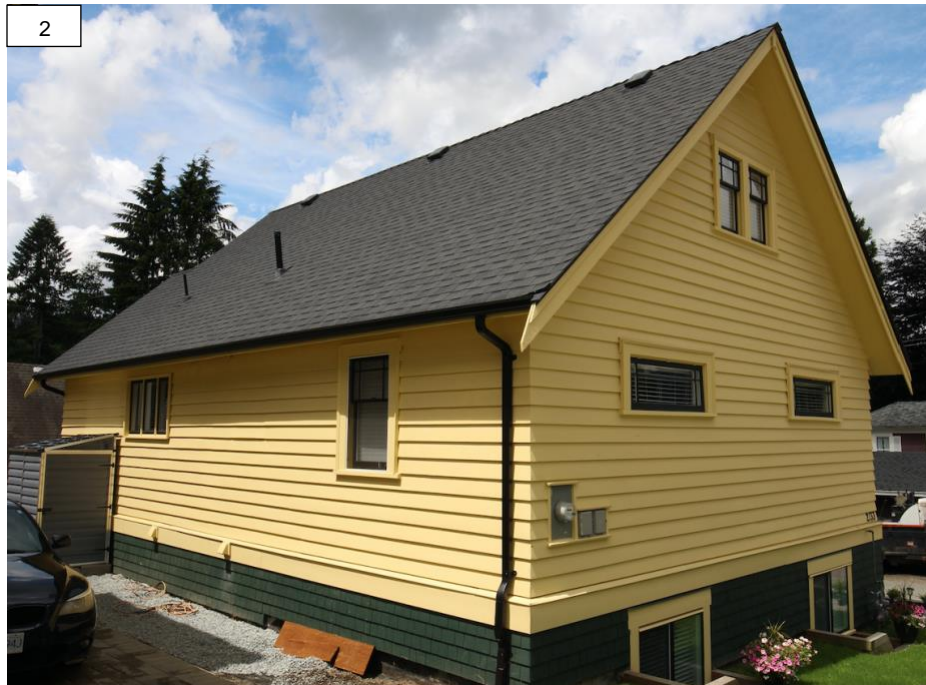
Figure 2: North-west elevation of Sutherland Residence.

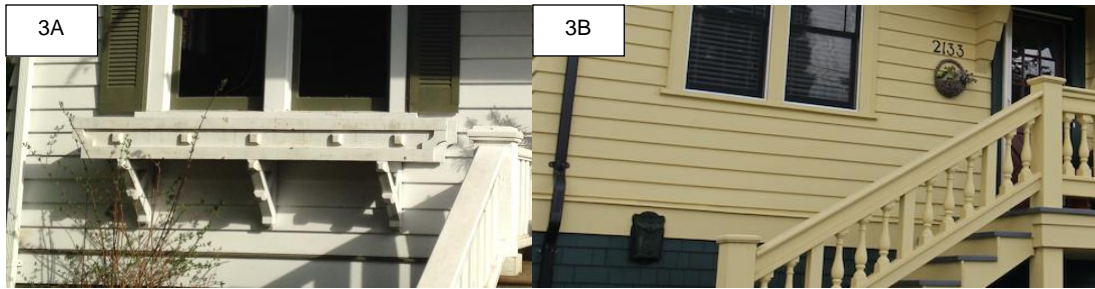
5.5	<p>FRONT ENTRY (Preservation)</p> <ul style="list-style-type: none"> Rebuild the front deck at the new location using salvaged material, if possible. Construct a new side-facing stair with wooden treads. The original height of the balustrade should be preserved. Only if necessary use alternate compliance method to meet building code requirements, e.g. installing glass panels or metal railings. Preserve the hip roof above the entry. Restore wood elements as required. 	<p>Comments:</p> <ol style="list-style-type: none"> Front deck was relocated with the historic structure and reconstructed. Original balustrade height not retained. Note that there was no consultation with the Heritage Consultant prior to installation. Hip roof above the entry was preserved and rehabilitated. Note that there was no consultation with the Heritage Consultant prior to installation. Front entry preservation work is substantially complete.

Figure 3A: Front façade wood planter boxes before removal.

Figure 3B: Front façade at time of review.

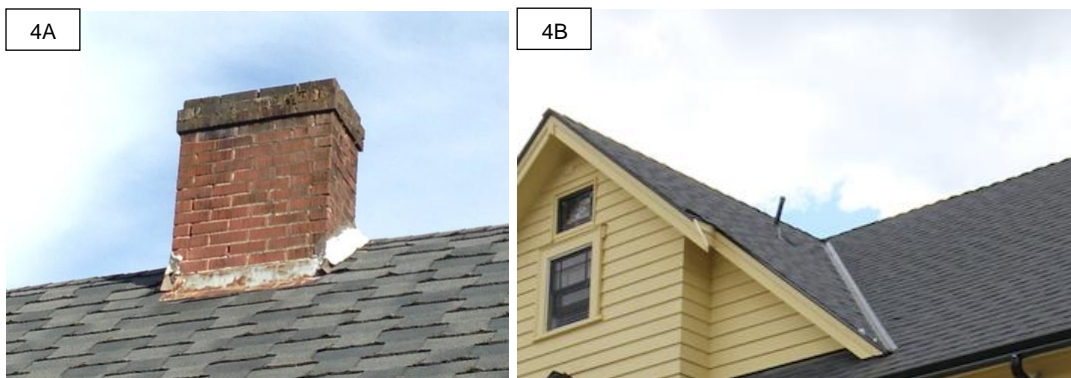
5.9	CHIMNEY (Preservation) <ul style="list-style-type: none"> The existing brick chimney should be retained in place and relocated with the house. The brickwork can be gently cleaned of dirt and the brickwork re-pointed as necessary with suitable mortar. The brick chimney will remain unpainted. The condition of the existing metal flashings should be reviewed and new flashings installed as necessary. 	Comments: <ol style="list-style-type: none"> Brick chimney was not reconstructed in original dimensions or configuration. No consultation with the Heritage Consultant prior to installation. Chimney restoration work is substantially complete.

Figure 4A: Internal brick chimney with corbelling before removal.

Figure 4B: Observed chimney at time of review.

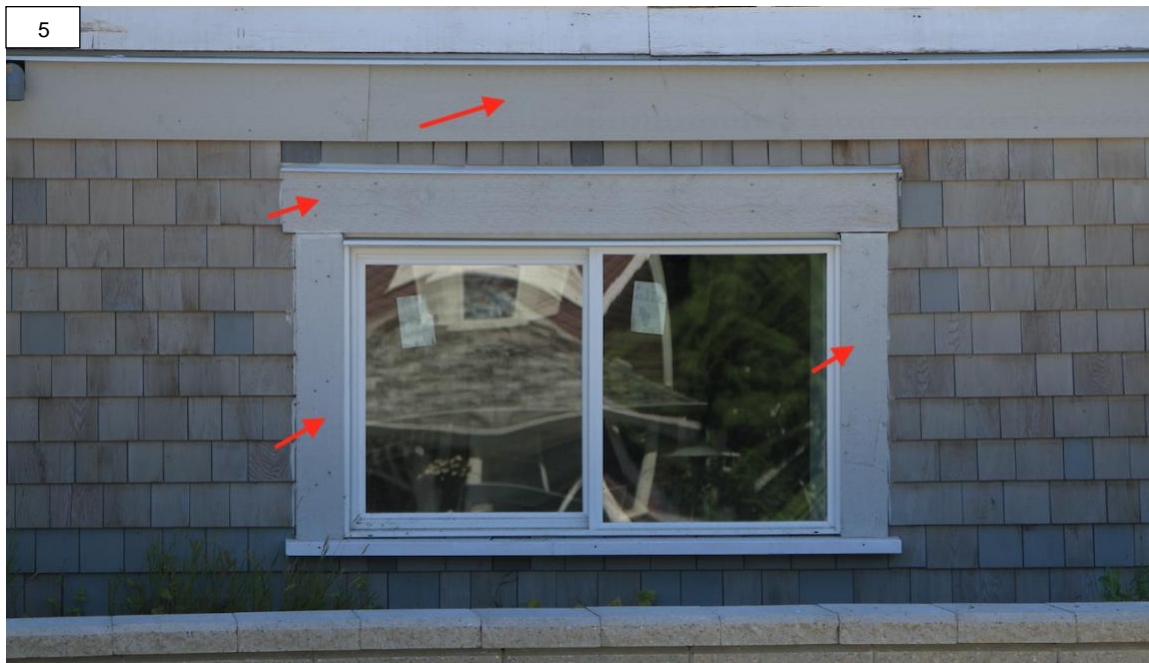
5.4.2	WOOD SIDING (Preservation) <ul style="list-style-type: none"> Retain lap siding and restore in-place. Replace any damaged lap siding to match existing in material, size, profile. Combed or textured lumber, vinyl or fibre cement 	Comments: <ol style="list-style-type: none"> Wood lap siding was retained and restored as required. Textured lumber was identified at a number of locations including watertable and window

<p>siding are not acceptable replacement materials on the historic house.</p> <ul style="list-style-type: none"> Install new double-coursed cedar shingles at the basement level matching the originals in overall dimensions and installation pattern. 	<p>casings at basement level. Note that there was no consultation with the Heritage Consultant prior to installation.</p> <ol style="list-style-type: none"> Cedar shingle siding of appropriate size and dimensions installed at the basement level. Wood siding restoration work is substantially complete.

Figure 5: Detail photo showing textured lumber applications at window casing and watertable prior to painting.
