Conservation Plan

Nielsen Residence – 112 Moray Street, Port Moody

July 2021

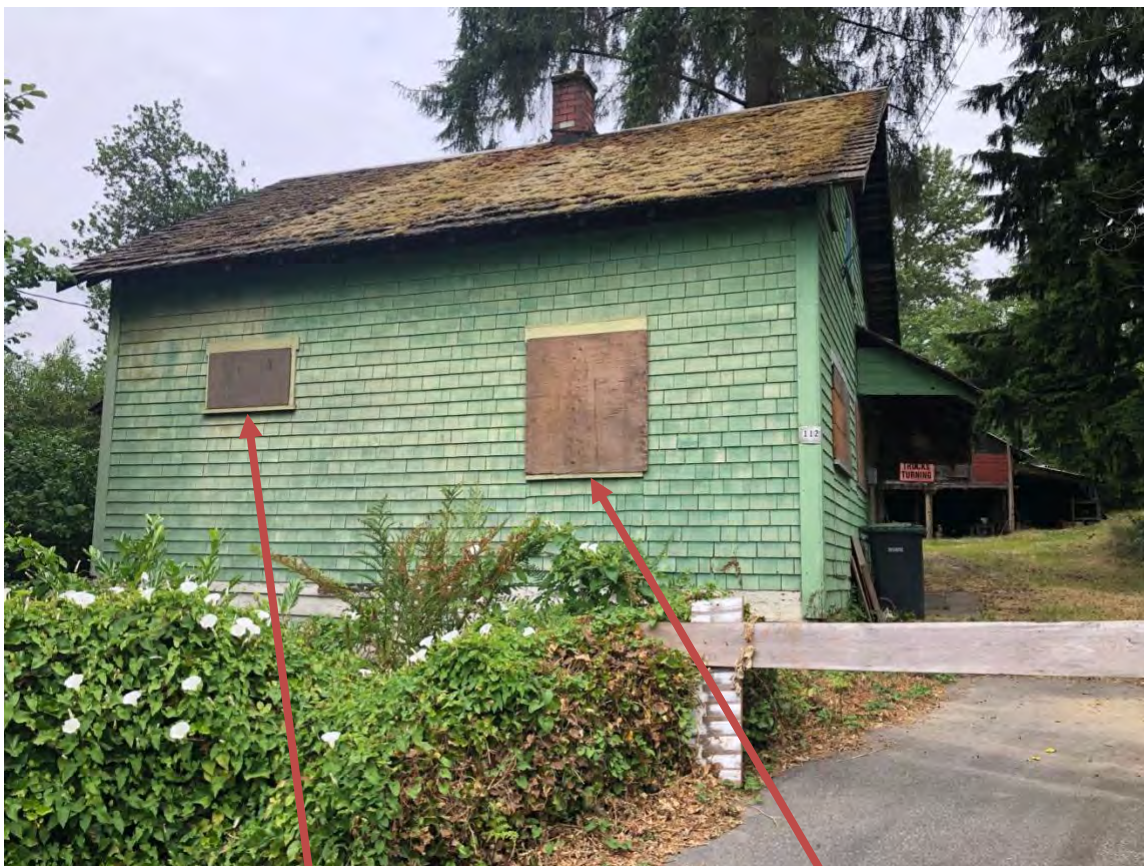
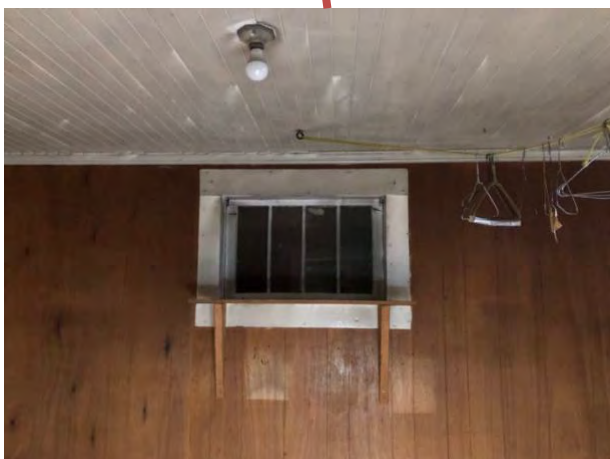
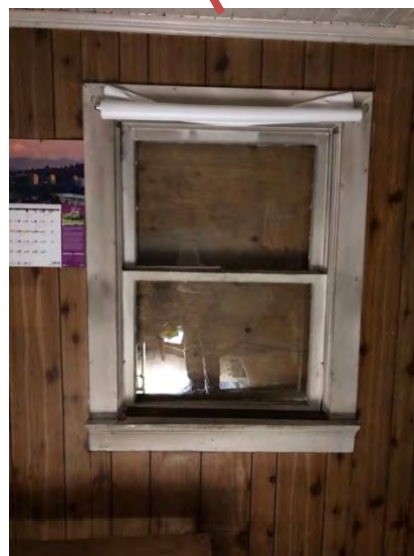
The overall condition of the windows and trim is good. Windows on the west side are in good condition (Figure 6). Windows on the south side, main floor, are in good condition, while the upper centre-set window is in fair condition with damage to the trim. The small windows set in the crawlspace, on either side of the centre-set window, have unusually narrow sills which are not standard but are in good condition otherwise (Figure 7). Windows on the east side are each set at different heights but otherwise are in good condition, as are the trim and sills (Figures 8 and 9). On the north side, the windows and trim are in good condition, while the sills are in fair condition except for the most westerly of the north side windows, which is good (Figures 9 and 10).

Figure 6: West and Partial South Side, as seen from Moray Street, corresponding windows: fixed and double-hung. Note the corner boards, which do not exist on the east side.

- All of the original wood frame windows of the house should be preserved. Repairs should be done where necessary, using the least intrusive method.
- All window trim is to be retained, repaired where necessary and reinstated.
- Windows on the basement level are expected to be new, as this will be an upgraded living space after the house is relocated. Therefore, this level should be restored with new wood windows in a style complementary to those on the main floor, in consultation with the heritage consultant.

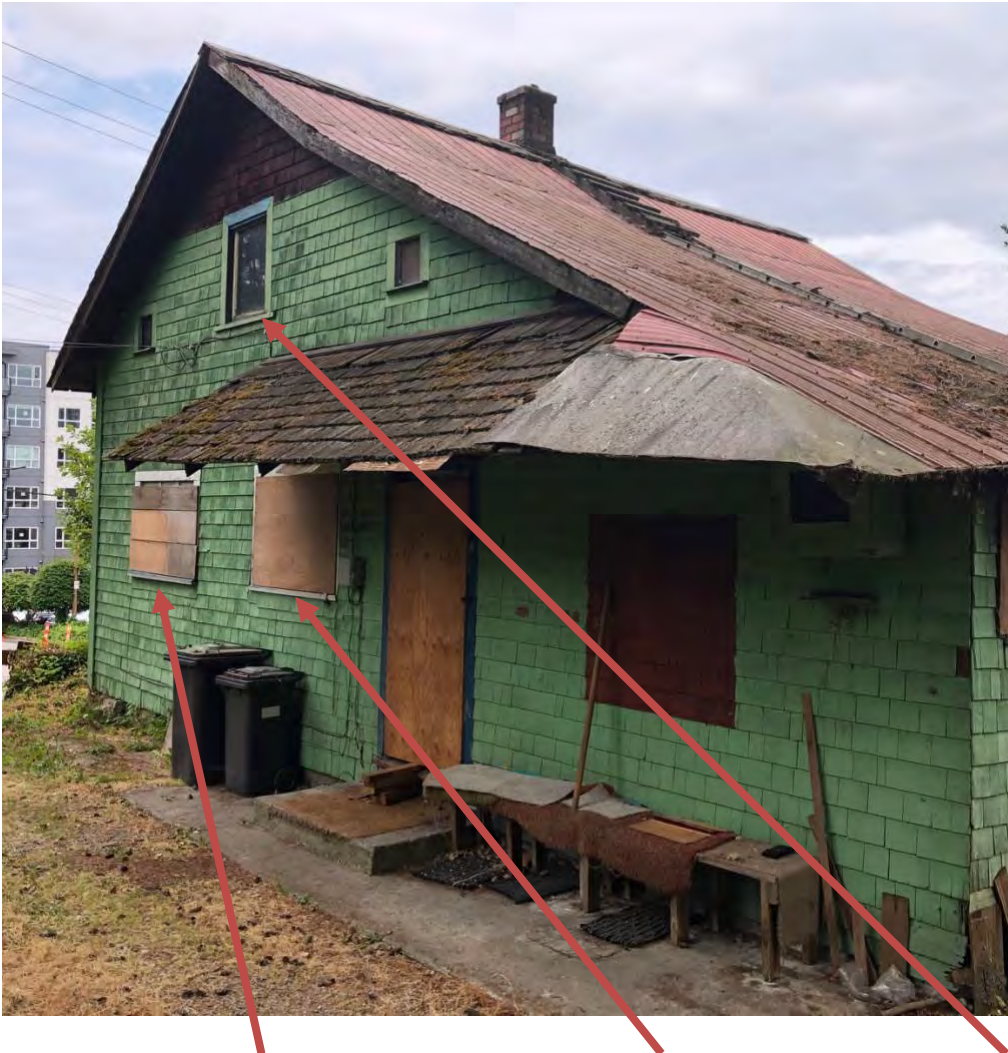
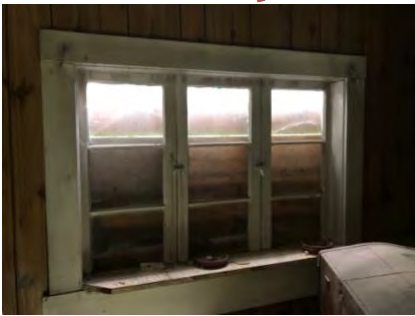
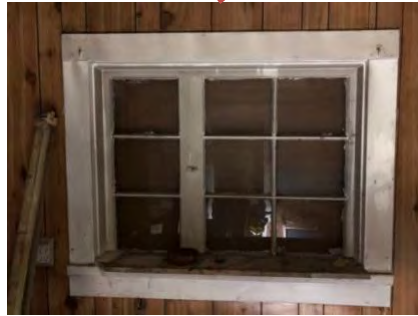
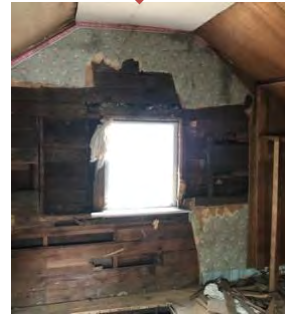
Figure 7: South Side – corresponding windows: (left to right) casement with fixed centre, casement/fixed, fixed.

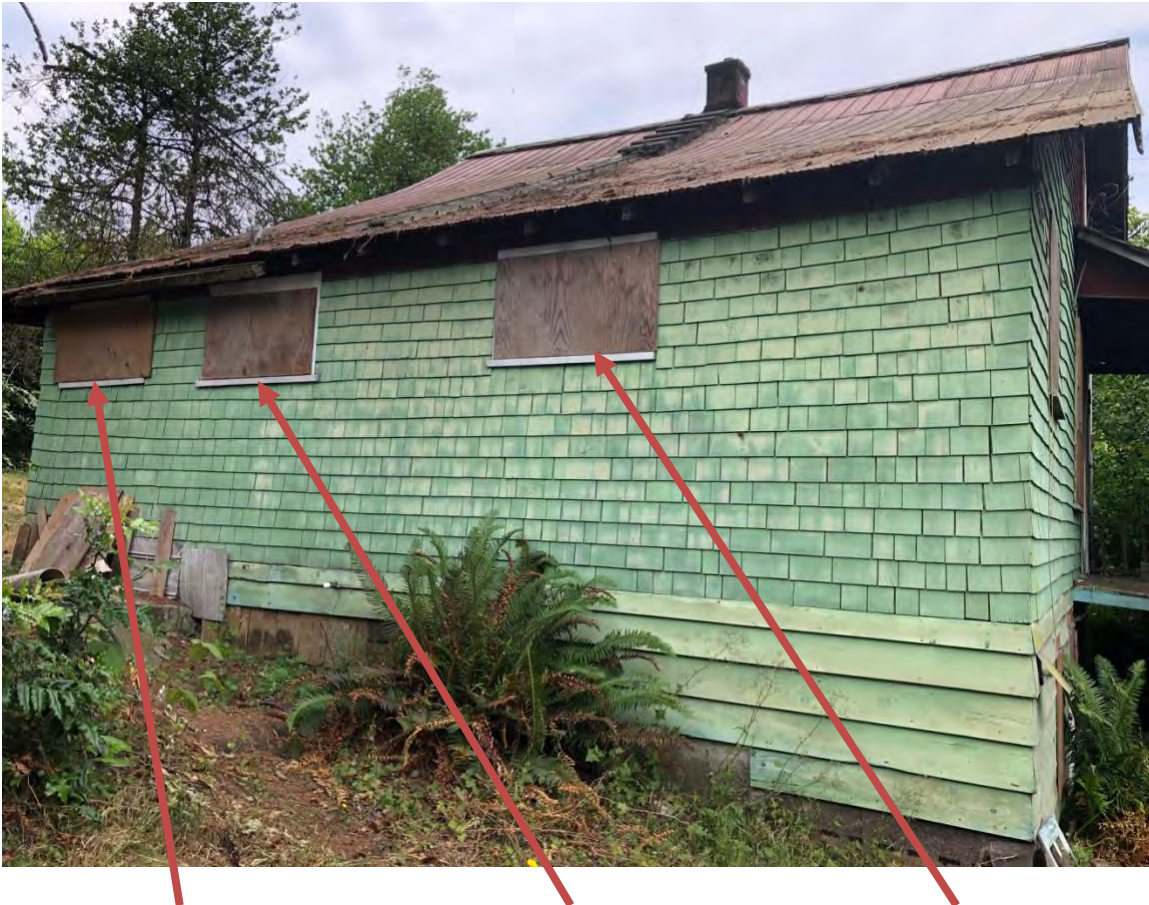
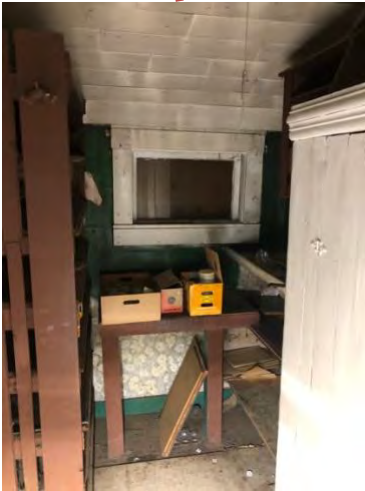
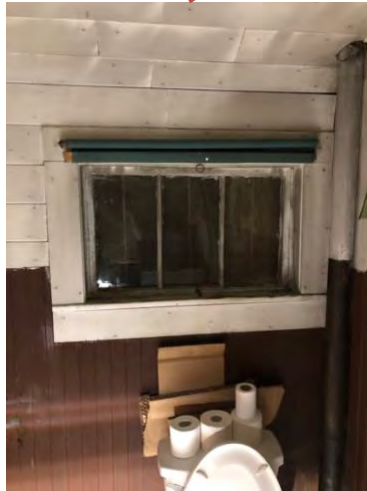
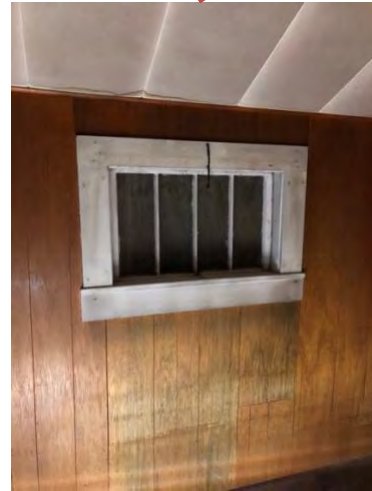
The overall condition of the cedar shakes is poor, with accumulated moss and decay, while the metal roofing appears to be fair. The structural integrity of the roof trusses is intact and the exposed rafter tails on the east side are in fair condition, while on the west side they are in good condition. However, the trusses most likely do not conform to current code. The soffit is in fair condition on the west side (Figure 6). The roofing material on the south side overhang is exhibiting advanced stages of deterioration, and there is some deterioration of the soffit framework (Figures 13, 14). The only existing gutter is in poor condition and has no downspout (Figure 8).

Figure 8: East Side – corresponding windows: all are awning operation. This is the only section of the house with a gutter remaining.

- Replace all roofing material with new weathered wood asphalt shingles, with a colour and brand selected based on input from the heritage consultant.
- Structural reinforcement of the roof trusses will involve pairing with new material to bring it to current standards. The roof overhang on the south side will also require repair of the soffit and reinforcement in lieu of any posts to connect it to the ground.
- Preserve the exposed rafter tails.
- Install new gutters and downspouts on the west and east sides, and on the south overhang, and on the porch on the north side.

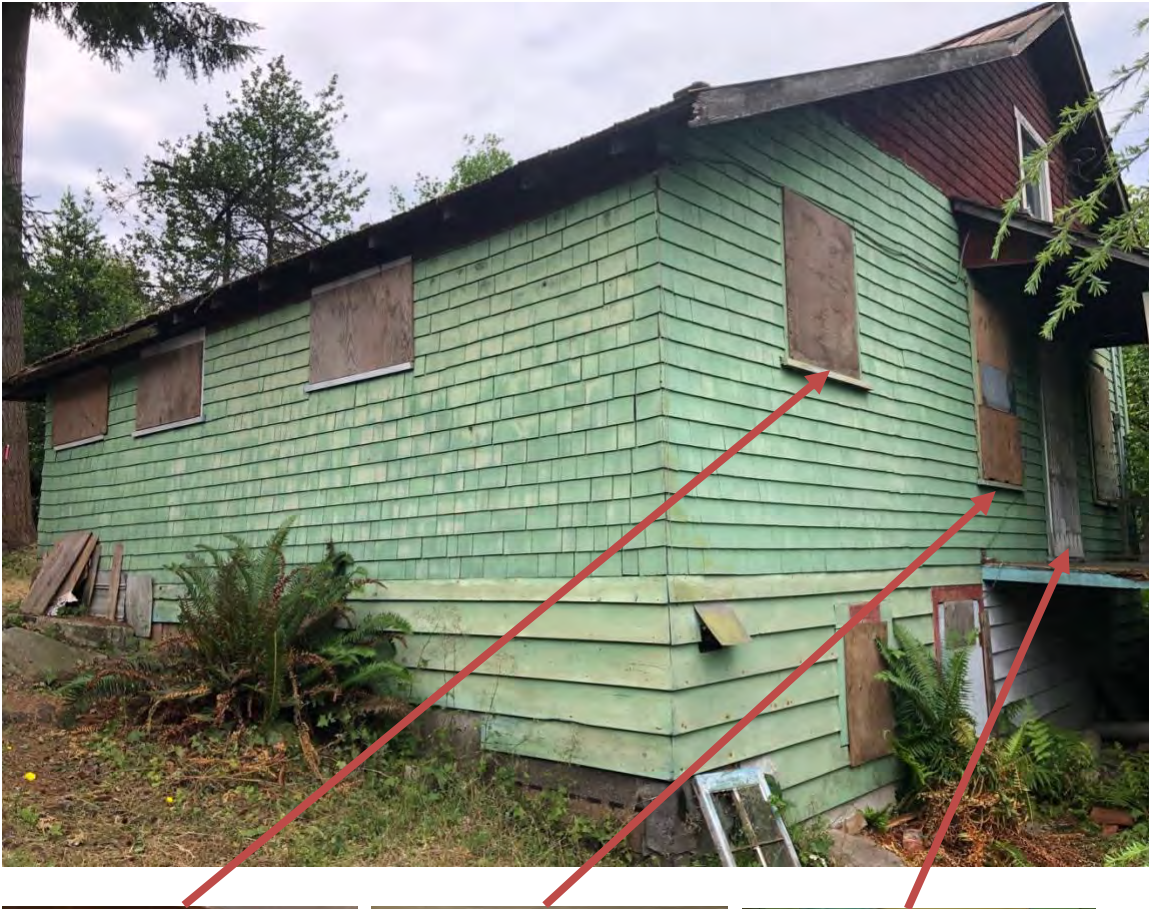
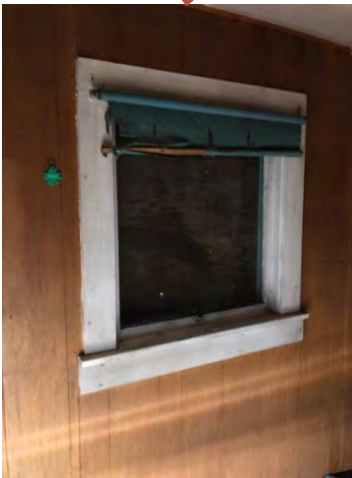
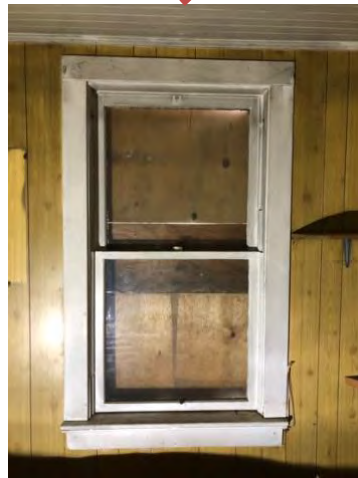
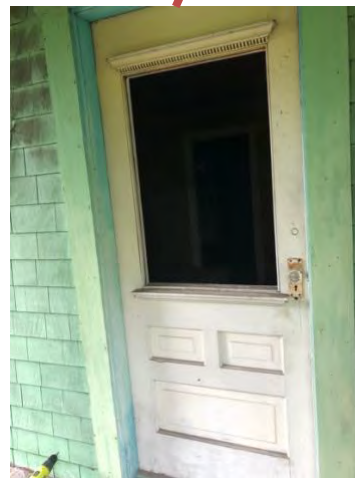
The overall condition of the doors and trim is good. The front door in particular is in very good condition, although it is missing the inset glazing (Figure 9). The rear door is a plain faced door, no glazing, which is not original to the house.

Figure 9: North Side – corresponding windows: fixed and double-hung; detail of original front door.

- Rehabilitate the front door and reinstate the glazing.
- Restore the rear door as a solid wood door, in a period-appropriate appearance, with or without inset glazing.
- Retain and repair all trim.

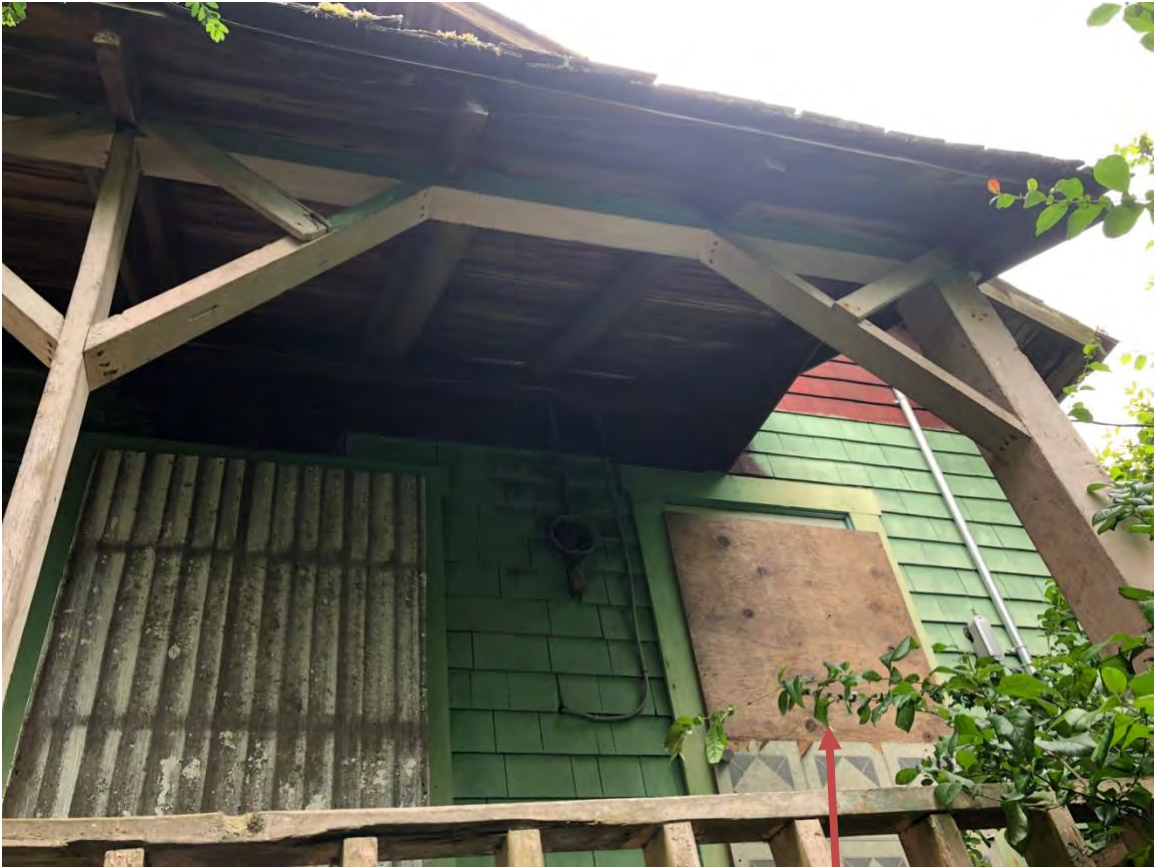
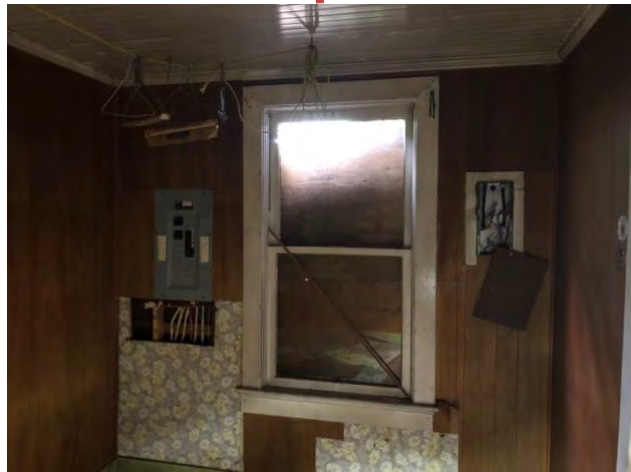
The overall condition of the front porch is fair. Structurally the floor has deteriorated in parts while the balustrade, posts, brackets and overhang are generally good. The roofing material of the porch, similar to the rest of the roofing on the house, is poor (Figures 10 and 11).

Figure 10: North Side (Front) Porch – corresponding double-hung window.

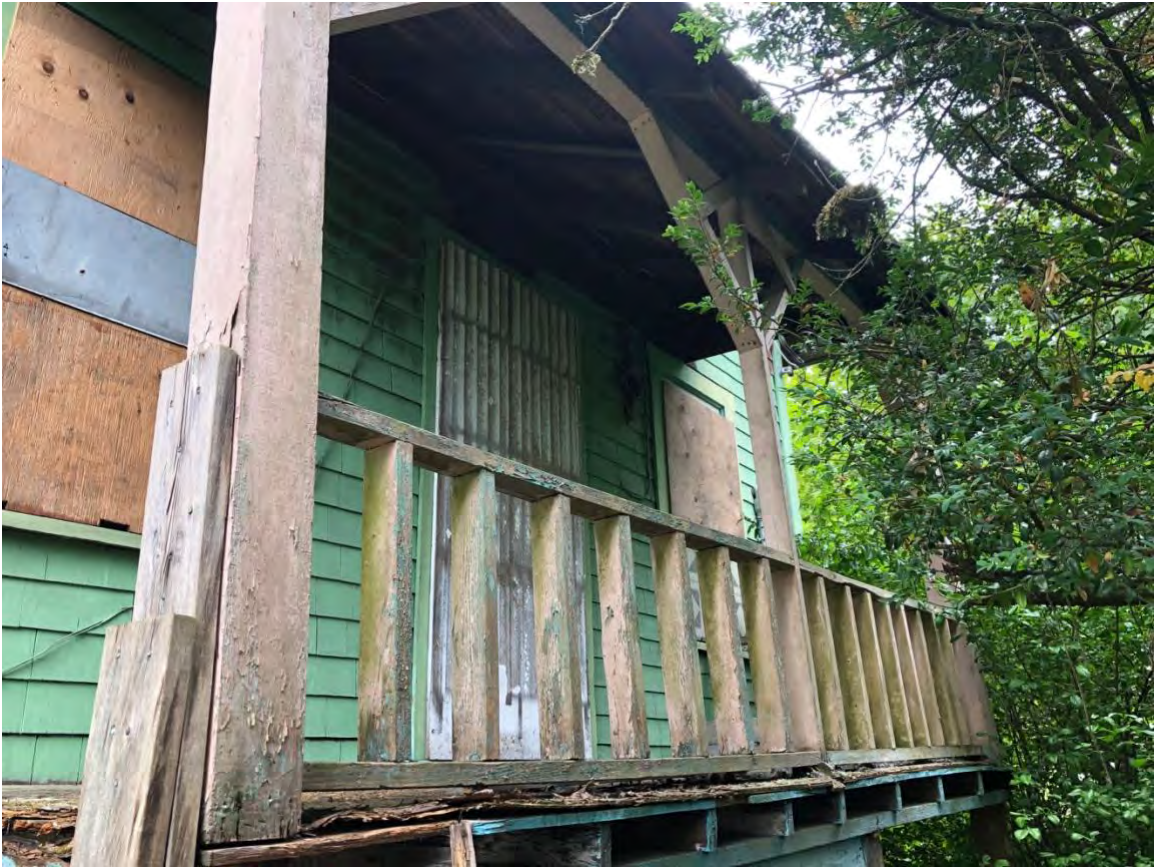
Figure 11: Full view of Front Porch along North Side, illustrating the deteriorated condition of the porch floor and sub-structure.

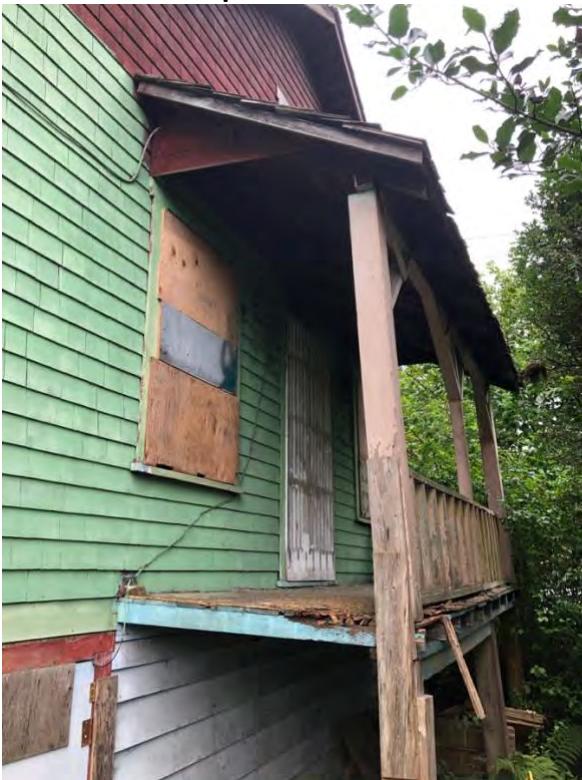
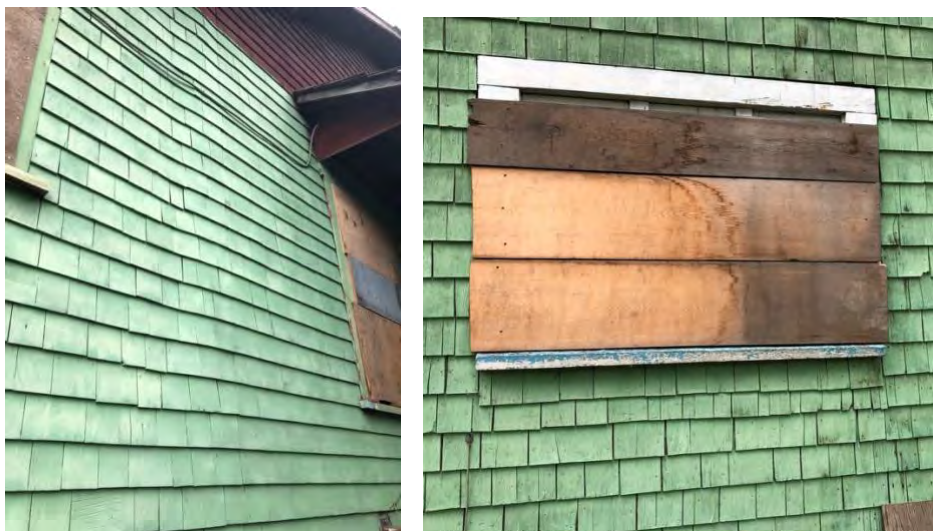
The overall condition of the cladding varies from one wall to another, ranging from fair to good. One noticeable variation in the cladding is found under

several window sills (esp. south side): while the shingles themselves are in good shape, they appear to have been re-applied due to either window repair or replacement and as such are do not quite follow the same pattern as the rest of the wall (Figures 8, 9, 12 and 14)

Figure 12: Example of Irregular Application of Cedar Shakes – north side (left), south side (right). The former illustrates the joining of the later addition to the original house while the latter illustrates either an enlargement or alteration to the original window and the siting of the sill.

- The historic cladding should be preserved. Repair those shingles that are irregularly applied (esp. under sills) to be consistent with the rest of the wall.
- Any structural and/or seismic upgrades should be designed from the inside without affecting the exterior appearance of the heritage building.
- Utilize alternative compliance methods, wherever applicable, in the BC Building Code for fire and spatial separations. The heritage consultant can review proposed interventions to meet code requirements.

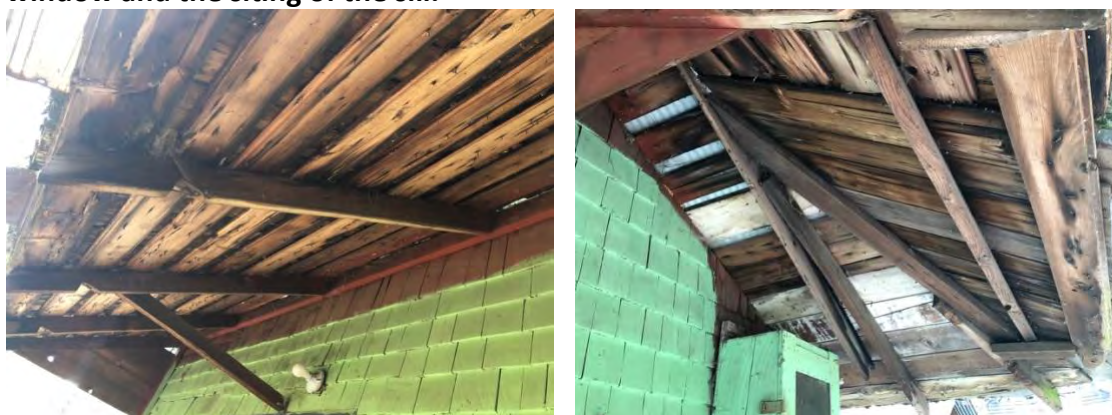
Figure 13: Condition of Soffit and Roof Structure, South Side Overhang

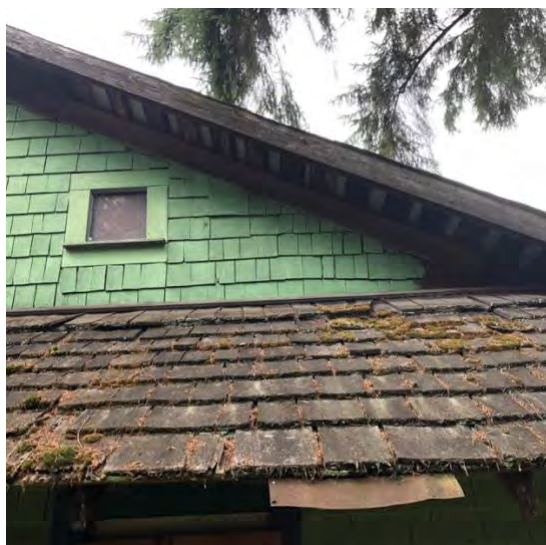
Figure 14: Roofing Material, South Side Overhang. Also note the irregular (thin) window sill above, and the slightly off-set shingle pattern below the sill.
