## **BUILDING ENVELOPE CONDITION ASSESSMENT**

### **KYLE CENTER**

125 KYLE STREET  
PORT MOODY, BC

July 14, 2020

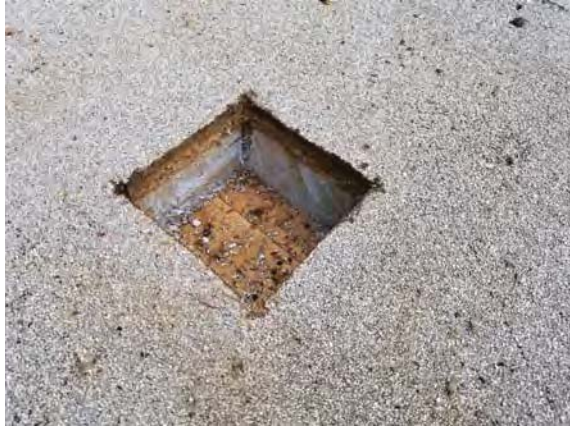
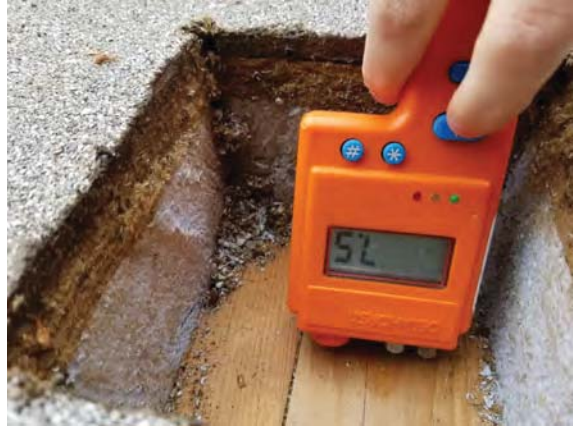
<b>Location:</b>	Roof E – (south-east corner)	<b>EO 1</b>
<b>Detail:</b>	2-ply SBS roof, field of roof	
<b>Moisture Content:</b>	7.5%

Assembly	Condition
<ul style="list-style-type: none"> <li>• 2-Ply SBS-modified bitumen membrane</li> <li>• 2 layers 5/8" fibreboard, adhered</li> <li>• 2 layers 1½" extruded polystyrene insulation</li> <li>• Tongue and groove plank decking</li> </ul>	<ul style="list-style-type: none"> <li>• Membrane was well-adhered to fireboard.</li> <li>• Fibreboard and insulation appeared dry.</li> <li>• Deck is in good condition.</li> </ul>

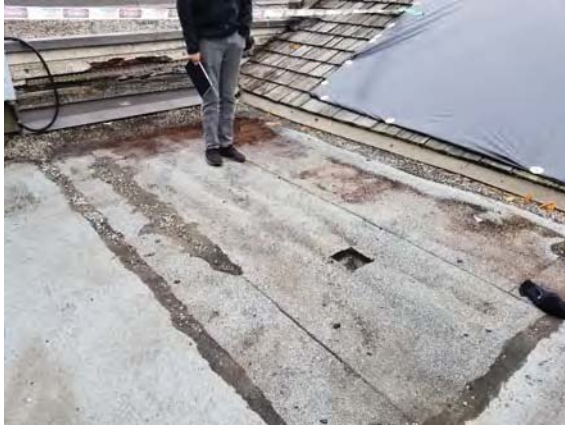
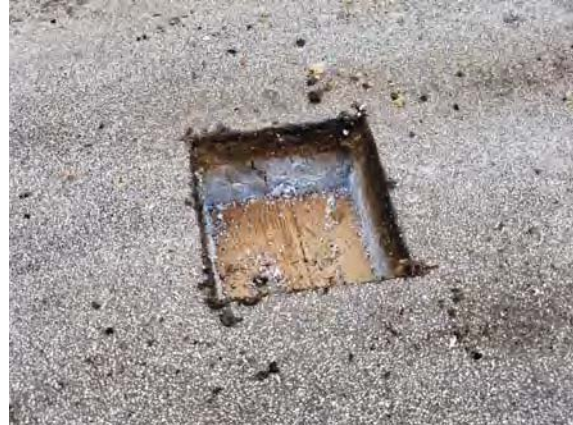
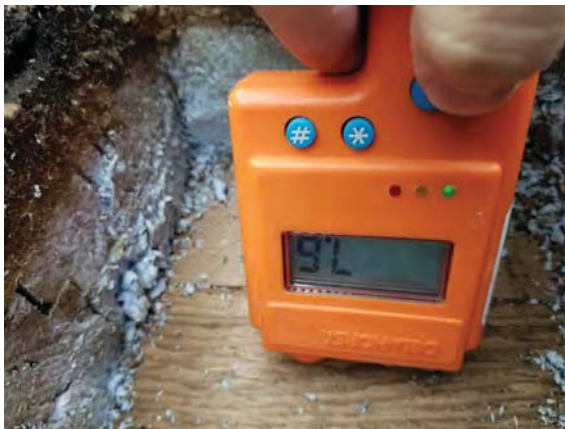
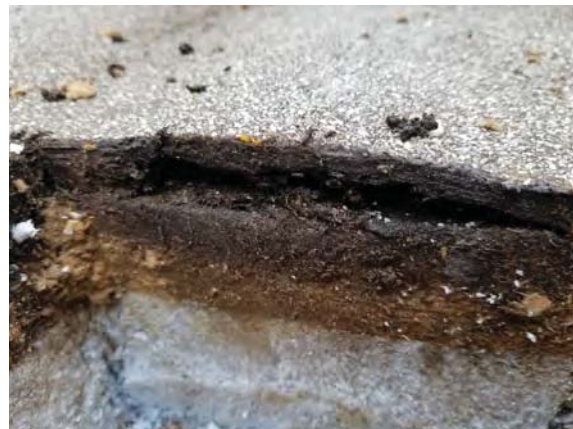
**EO 2**

- 2-Ply SBS-modified bitumen membrane
- 2 layers 5/8" fibreboard, adhered
- 2 layers 1 1/2" extruded polystyrene insulation
- Tongue and groove plank decking

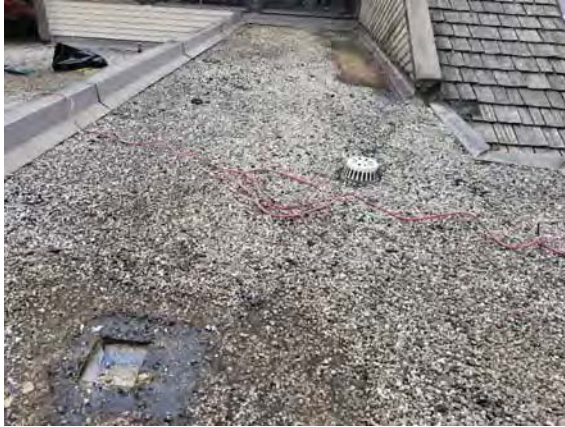
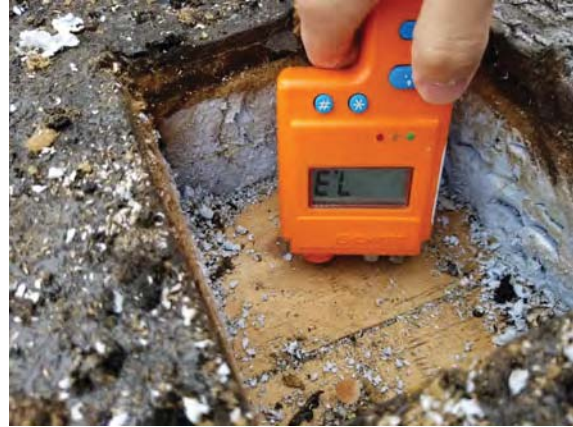
# EO 3

Assembly	Condition
<ul style="list-style-type: none"> <li>• 4-ply BUR (asphalt and felt)</li> <li>• 2 layers 5/8" fibreboard, adhered.</li> <li>• 2 layers 1 1/2" extruded polystyrene insulation</li> <li>• Tongue and groove plank decking</li> </ul>	<ul style="list-style-type: none"> <li>• BUR was well-adhered to fireboard.</li> <li>• Fibreboard and insulation appeared dry.</li> <li>• Deck is in good condition.</li> </ul>
Comments	
<ul style="list-style-type: none"> <li>• Cut test was prepared in area where original BUR is still in place.</li> <li>• No moisture detected within assembly</li> </ul>

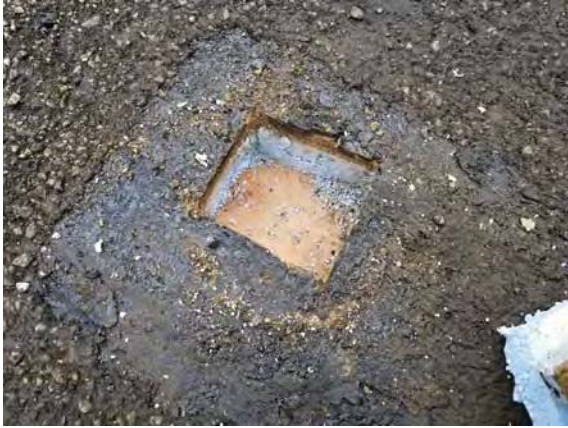
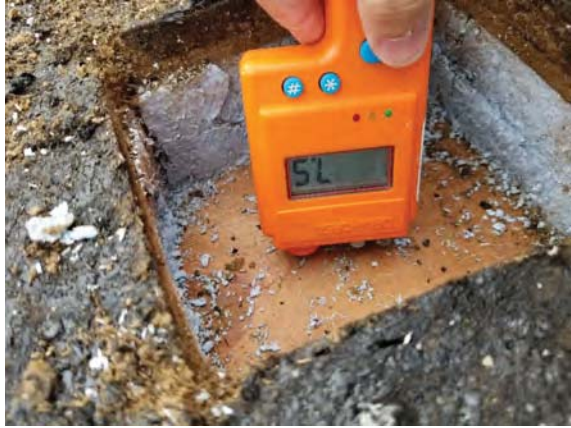
<b>Location:</b>	Roof H – (north-east)	<b>EO 4</b>
<b>Detail:</b>	Asphalt (build-up-roof), field of roof	
<b>Moisture Content:</b>	7.5%

<b>Assembly</b>	<b>Condition</b>	
<ul style="list-style-type: none"> <li>• 4-ply BUR (asphalt and felt)</li> <li>• 2 layers 5/8" fibreboard, adhered.</li> <li>• 2 layers 1 1/2" extruded polystyrene insulation</li> <li>• Tongue and groove plank decking</li> </ul>	<ul style="list-style-type: none"> <li>• BUR was well-adhered to fireboard.</li> <li>• Fibreboard and insulation appeared dry.</li> <li>• Deck is in good condition.</li> </ul>	
<b>Comments</b>		
<ul style="list-style-type: none"> <li>• Cut test was prepared in area where original BUR is still in place.</li> <li>• No moisture detected within assembly</li> </ul>

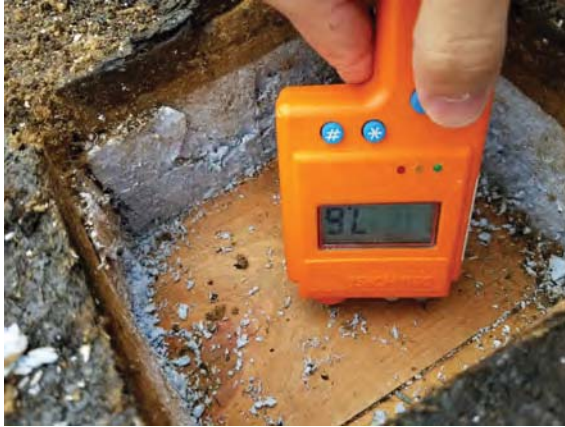
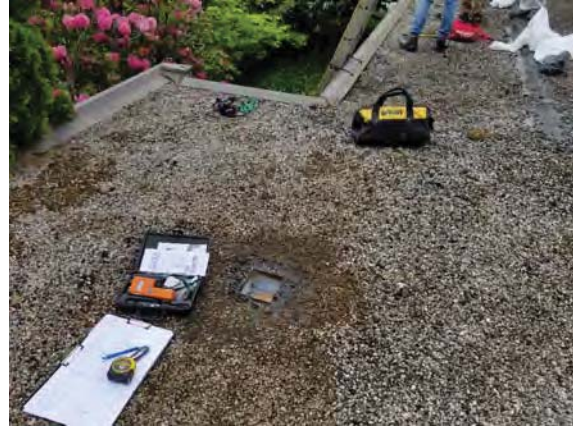
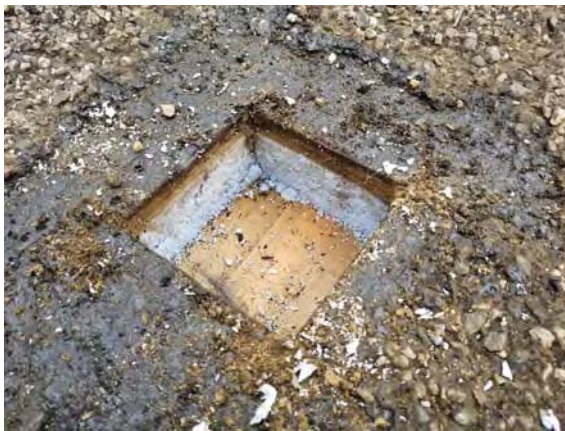
**EO 5**

Assembly	Condition
<ul style="list-style-type: none"> <li>• 4-ply BUR (asphalt and felt)</li> <li>• 2 layers 5/8" fibreboard, adhered.</li> <li>• 2 layers 1 1/2" extruded polystyrene insulation</li> <li>• Tongue and groove plank decking</li> </ul>	<ul style="list-style-type: none"> <li>• BUR was well-adhered to fireboard.</li> <li>• Fibreboard and insulation appeared dry.</li> <li>• Deck is in good condition.</li> </ul>
Comments	
<ul style="list-style-type: none"> <li>• Cut test was prepared in area where original BUR is still in place.</li> <li>• No moisture detected within assembly</li> </ul>

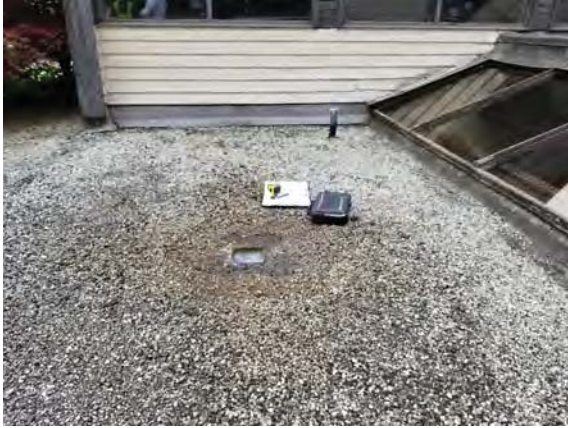
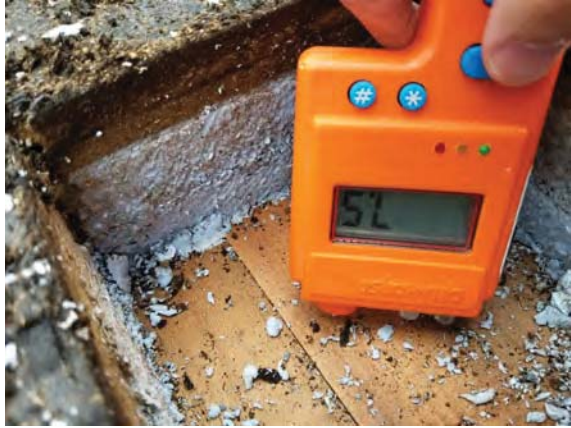
<b>Location:</b>	Roof A – (south-east)	<b>EO 6</b>
<b>Detail:</b>	Asphalt (build-up-roof), field of roof	
<b>Moisture Content:</b>	7.5%

<b>Assembly</b>	<b>Condition</b>	
<ul style="list-style-type: none"> <li>• 4-ply BUR (asphalt and felt)</li> <li>• 2 layers 5/8" fibreboard, adhered.</li> <li>• 2 layers 1 1/2" extruded polystyrene insulation</li> <li>• Tongue and groove plank decking</li> </ul>	<ul style="list-style-type: none"> <li>• BUR was well-adhered to fireboard.</li> <li>• Fibreboard and insulation appeared dry.</li> <li>• Deck is in good condition.</li> </ul>	
<b>Comments</b>		
<ul style="list-style-type: none"> <li>• Cut test was prepared in area where original BUR is still in place.</li> <li>• No moisture detected within assembly</li> </ul>

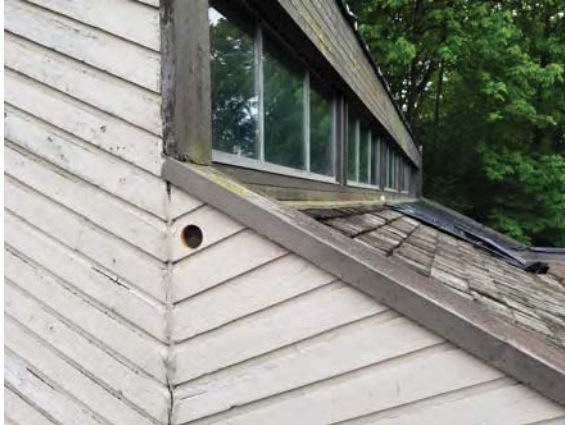
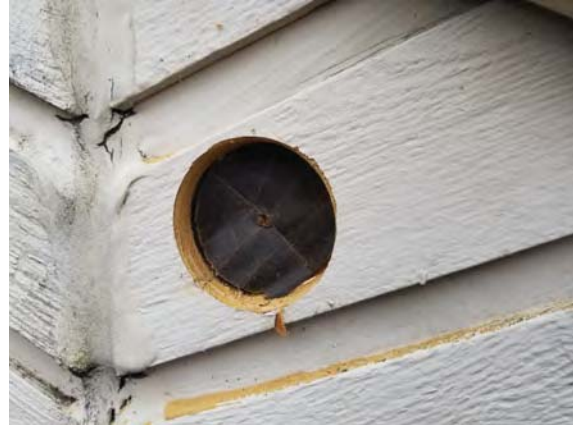
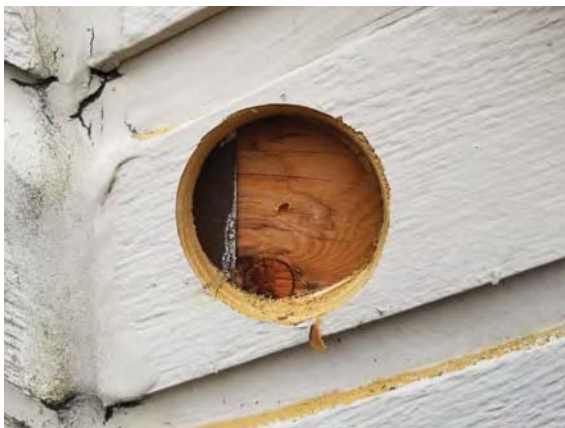
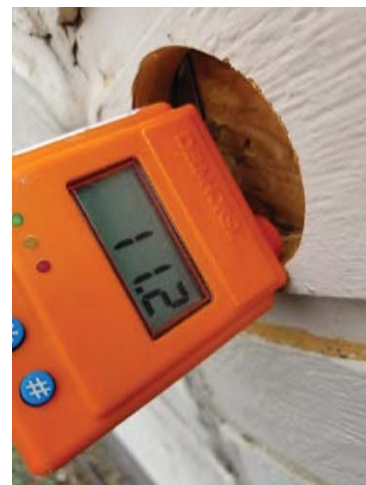
<b>Location:</b>	East-facing wall on roof	<b>EO 7</b>
<b>Detail:</b>	Cedar cladding, at interface with roof slope	
<b>Moisture Content:</b>	11.2%

Assembly	Condition
<ul style="list-style-type: none"> <li>Channel cedar siding</li> <li>Building Paper</li> <li>1/2" plywood</li> <li>2"x6" wood framing at 16" o/c</li> <li>6" batt insulation between studs</li> <li>6 mil polyethylene vapour barrier</li> <li>Interior finishes</li> </ul>	<ul style="list-style-type: none"> <li>Cladding in fair condition at this location.</li> <li>Nearby sealant was in poor condition.</li> <li>Building paper was in generally good condition at the time of our review.</li> <li>Some staining visible on plywood sheathing.</li> </ul>
Comments	
<ul style="list-style-type: none"> <li>Stains on sheathing indicate prior water ingress behind building paper.</li> <li>Assembly was dry at the time of review.</li> </ul>

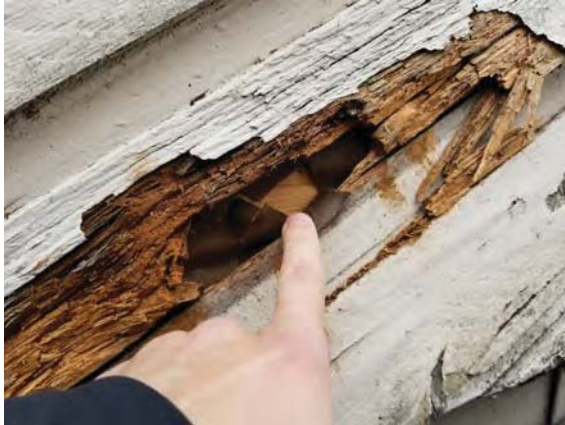
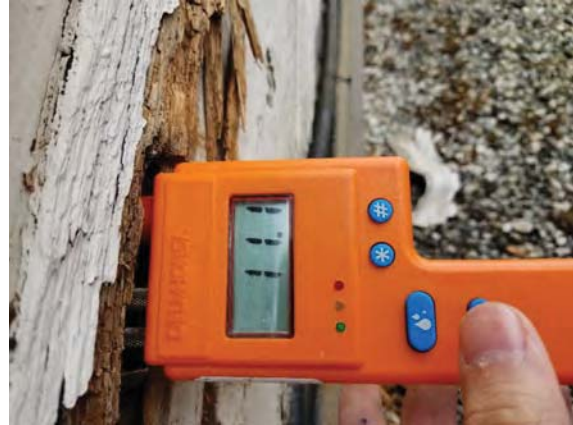
<b>Location:</b>	East-facing wall on roof	<b>EO 8</b>
<b>Detail:</b>	Cedar cladding, base of wall detail	
<b>Moisture Content:</b>	11.1%

Assembly	Condition
<ul style="list-style-type: none"> <li>• Channel cedar siding</li> <li>• Building Paper</li> <li>• 1/2" plywood</li> <li>• 2"x6" wood framing at 16" o/c</li> <li>• 6" batt insulation between studs</li> <li>• 6 mil polyethylene vapour barrier</li> <li>• Interior finishes</li> </ul>	<ul style="list-style-type: none"> <li>• Significantly deteriorated cladding.</li> <li>• Missing and torn building paper</li> <li>• Sheathing appeared to be in good condition and was dry at the time of our review.</li> </ul>
Comments	
<ul style="list-style-type: none"> <li>• Significant damage to cladding.</li> <li>• Assembly was dry at the time of review.</li> </ul>

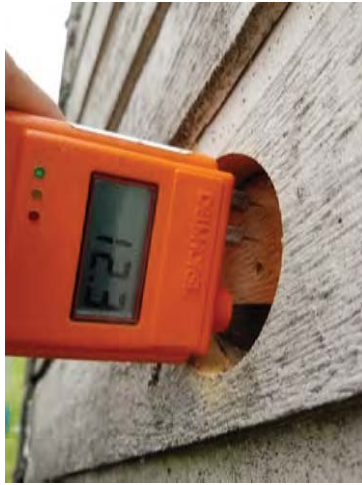
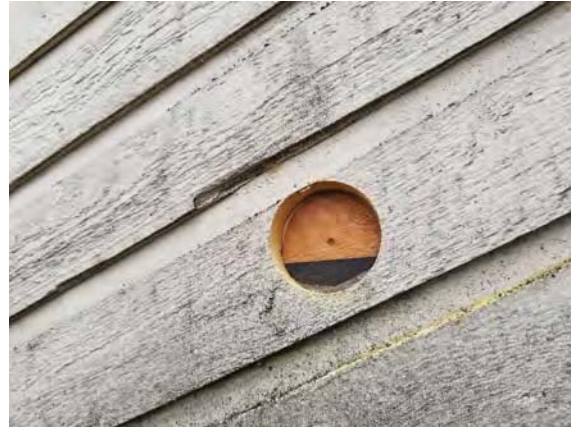
<b>Location:</b>	North-facing wall on roof	<b>EO 9</b>
<b>Detail:</b>	Cedar cladding	
<b>Moisture Content:</b>	12.3%

Assembly	Condition
<ul style="list-style-type: none"> <li>• Channel cedar siding</li> <li>• Building Paper</li> <li>• 1/2" plywood</li> <li>• 2"x6" wood framing at 16" o/c</li> <li>• 6" batt insulation between studs</li> <li>• 6 mil polyethylene vapour barrier</li> <li>• Interior finishes</li> </ul>	<ul style="list-style-type: none"> <li>• Cladding in fair condition at this location.</li> <li>• Building paper was in generally good condition at the time of our review.</li> <li>• Sheathing appeared dry at the time of our review.</li> </ul>
Comments	
<ul style="list-style-type: none"> <li>• Assembly was dry at the time of our review.</li> </ul>

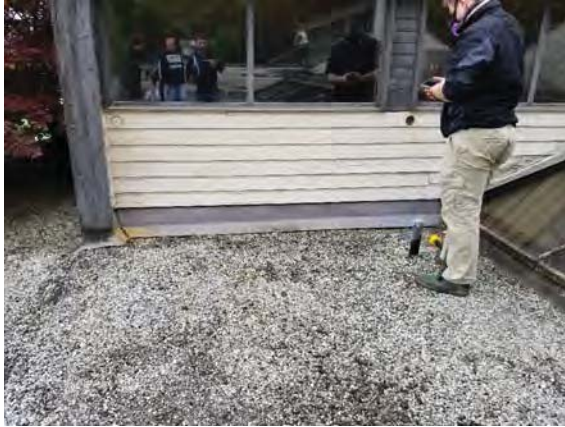
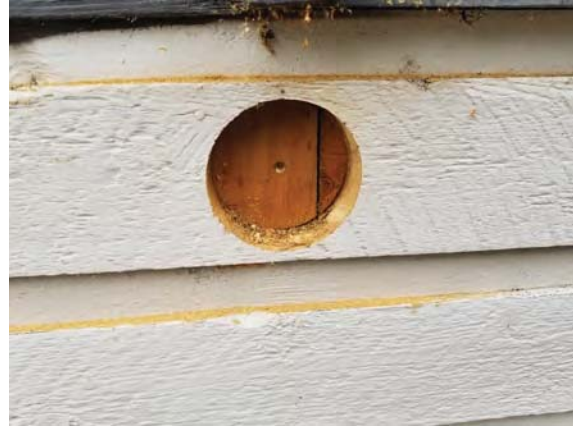
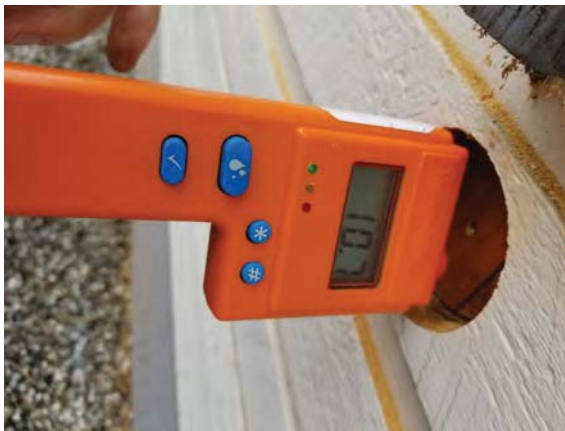
# EO 10

Assembly	Condition
<ul style="list-style-type: none"> <li>Channel cedar siding</li> <li>Building Paper</li> <li>1/2" plywood</li> <li>2"x6" wood framing at 16" o/c</li> <li>6" batt insulation between studs</li> <li>6 mil polyethylene vapour barrier</li> <li>Interior finishes</li> </ul>	<ul style="list-style-type: none"> <li>Cladding in fair condition at this location.</li> <li>Building paper was in generally good condition at the time of our review.</li> <li>Sheathing appeared dry at the time of our review.</li> </ul>
Comments	
<ul style="list-style-type: none"> <li>Assembly was dry at the time of our review.</li> </ul>

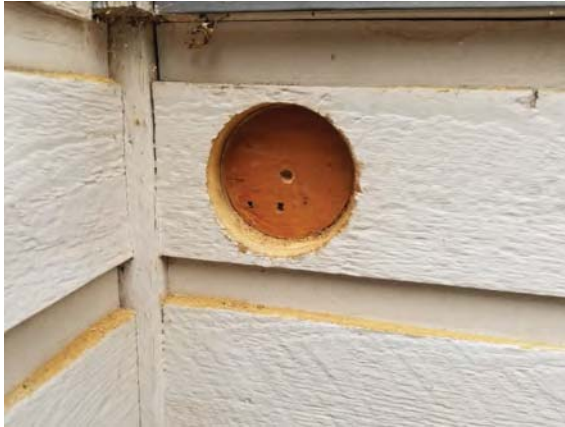
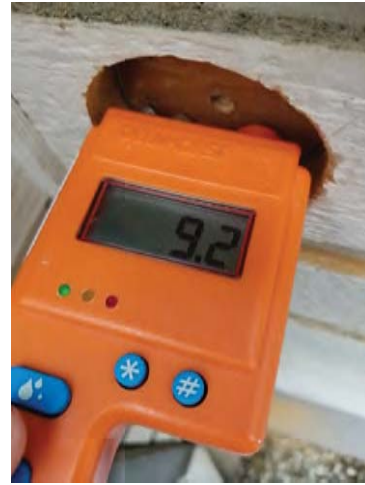
<b>Location:</b>	West-facing wall on roof	<b>EO 11</b>
<b>Detail:</b>	Cedar cladding, below window sill	
<b>Moisture Content:</b>	9.2%

Assembly	Condition
<ul style="list-style-type: none"> <li>• Channel cedar siding</li> <li>• Building Paper</li> <li>• 1/2" plywood</li> <li>• 2"x6" wood framing at 16" o/c</li> <li>• 6" batt insulation between studs</li> <li>• 6 mil polyethylene vapour barrier</li> <li>• Interior finishes</li> </ul>	<ul style="list-style-type: none"> <li>• Cladding in fair condition at this location.</li> <li>• Building paper was in generally good condition at the time of our review.</li> <li>• Sheathing appeared dry at the time of our review.</li> </ul>
Comments	
<ul style="list-style-type: none"> <li>• Assembly was dry at the time of our review.</li> </ul>

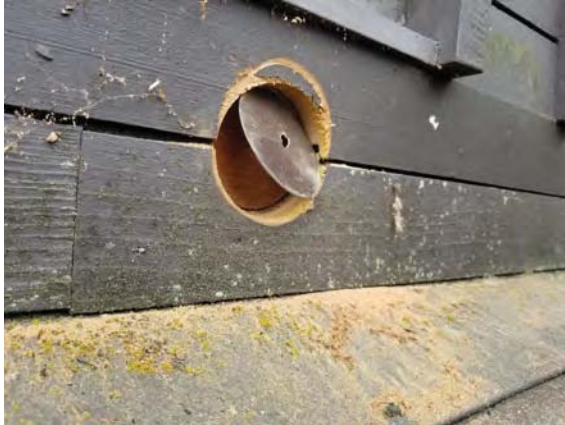
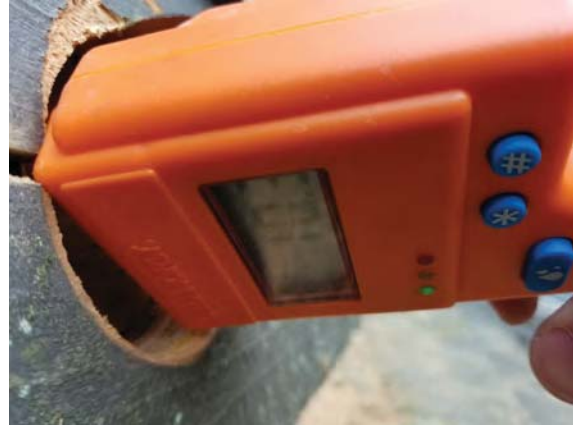
# EO 13

Assembly	Condition
<ul style="list-style-type: none"> <li>• Channel cedar siding</li> <li>• Building Paper</li> <li>• 1/2" plywood</li> <li>• 2"x6" wood framing at 16" o/c</li> <li>• 6" batt insulation between studs</li> <li>• 6 mil polyethylene vapour barrier</li> <li>• Interior finishes</li> </ul>	<ul style="list-style-type: none"> <li>• Cladding in fair condition at this location.</li> <li>• Building paper was in generally good condition at the time of our review.</li> <li>• Sheathing appeared dry at the time of our review.</li> </ul>
Comments	
<ul style="list-style-type: none"> <li>• Assembly was dry at the time of our review.</li> </ul>

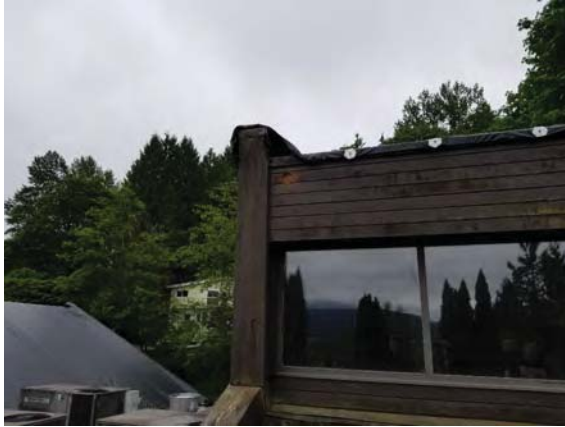
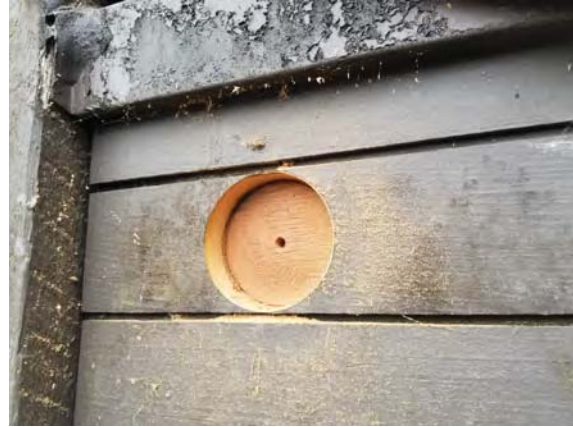
# EO 14

Assembly	Condition
<ul style="list-style-type: none"> <li>Channel cedar siding</li> <li>Building Paper</li> <li>1/2" plywood</li> <li>2"x6" wood framing at 16" o/c</li> <li>6" batt insulation between studs</li> <li>6 mil polyethylene vapour barrier</li> <li>Interior finishes</li> </ul>	<ul style="list-style-type: none"> <li>Cladding in poor condition at this location.</li> <li>Building paper was in generally good condition at the time of our review.</li> <li>Moisture observed behind building paper.</li> <li>High moisture content in sheathing.</li> </ul>
Comments	
<ul style="list-style-type: none"> <li>Moisture noted behind building paper.</li> <li>Poor sealant and separated cladding noted at roof parapet above this location.</li> </ul>

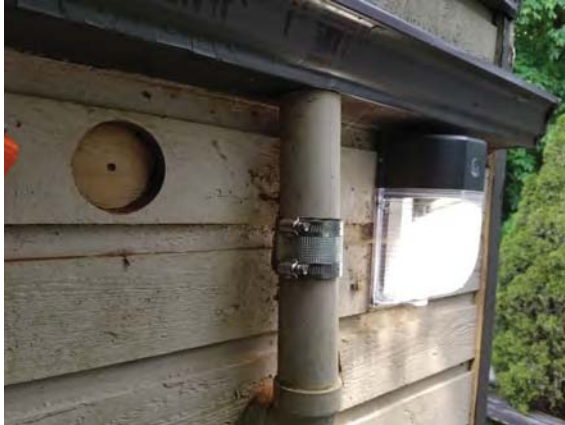
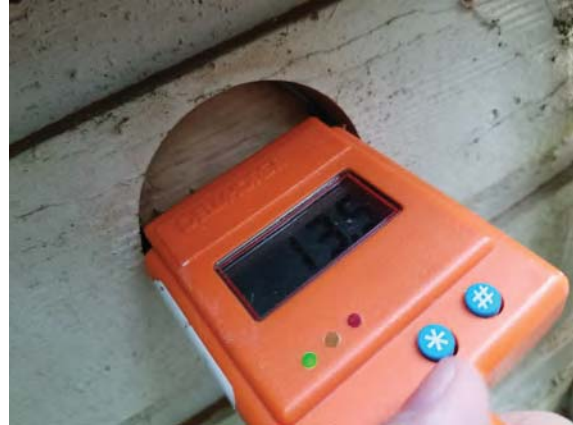
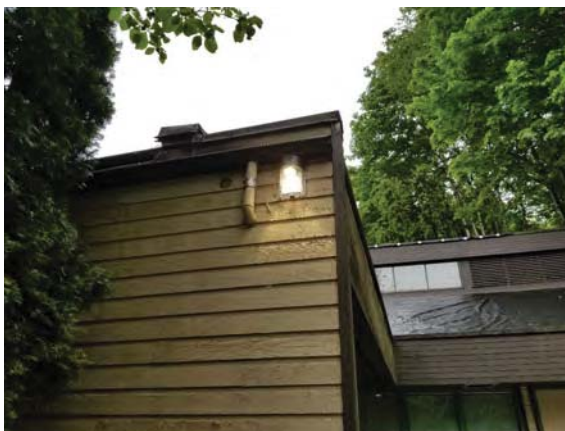
# EO 15

Assembly	Condition
<ul style="list-style-type: none"> <li>Channel cedar siding</li> <li>Building Paper</li> <li>1/2" plywood</li> <li>2"x6" wood framing at 16" o/c</li> <li>6" batt insulation between studs</li> <li>6 mil polyethylene vapour barrier</li> <li>Interior finishes</li> </ul>	<ul style="list-style-type: none"> <li>Cladding in fair condition at this location.</li> <li>Building paper was in generally good condition at the time of our review.</li> <li>Sheathing appeared dry at the time of our review.</li> </ul>
Comments	
<ul style="list-style-type: none"> <li>Assembly was dry at the time of our review.</li> </ul>

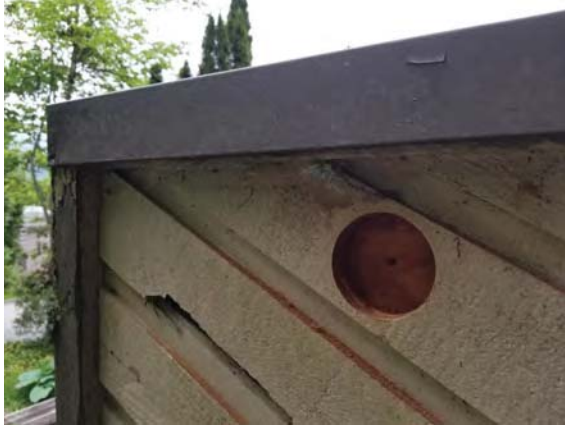
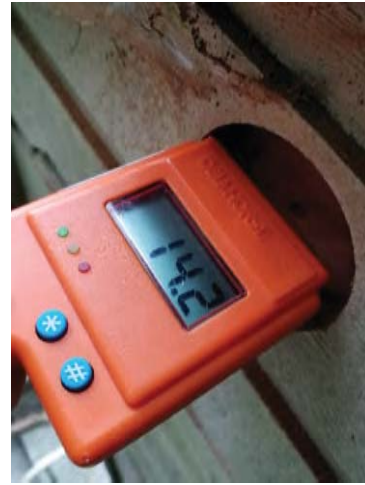
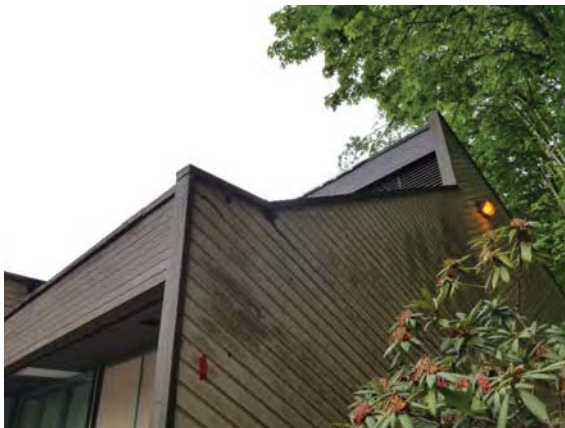
# EO 16

Assembly	Condition
<ul style="list-style-type: none"> <li>Channel cedar siding</li> <li>Building Paper</li> <li>1/2" plywood</li> <li>2"x6" wood framing at 16" o/c</li> <li>6" batt insulation between studs</li> <li>6 mil polyethylene vapour barrier</li> <li>Interior finishes</li> </ul>	<ul style="list-style-type: none"> <li>Cladding in poor condition at this location.</li> <li>Building paper was in generally good condition at the time of our review.</li> <li>Sheathing appeared dry at the time of our review.</li> </ul>
Comments	
<ul style="list-style-type: none"> <li>Assembly was dry at the time of our review.</li> </ul>

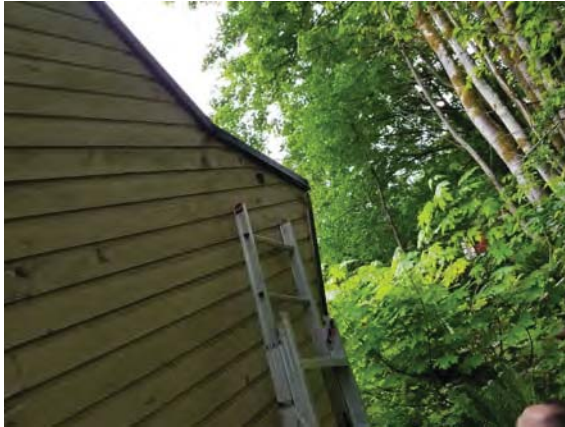
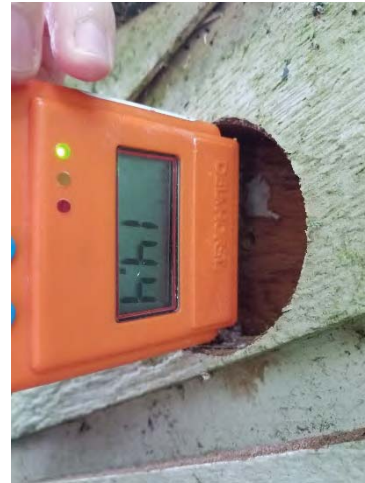
# EO 17

Assembly	Condition
<ul style="list-style-type: none"> <li>Channel cedar siding</li> <li>Building Paper</li> <li>1/2" plywood</li> <li>2"x6" wood framing at 16" o/c</li> <li>6" batt insulation between studs</li> <li>6 mil polyethylene vapour barrier</li> <li>Interior finishes</li> </ul>	<ul style="list-style-type: none"> <li>Cladding in poor condition at this location.</li> <li>Building paper was in generally good condition at the time of our review.</li> <li>Staining visible on sheathing.</li> </ul>
Comments	
<ul style="list-style-type: none"> <li>Evidence of past moisture ingress behind building paper at this location.</li> </ul>

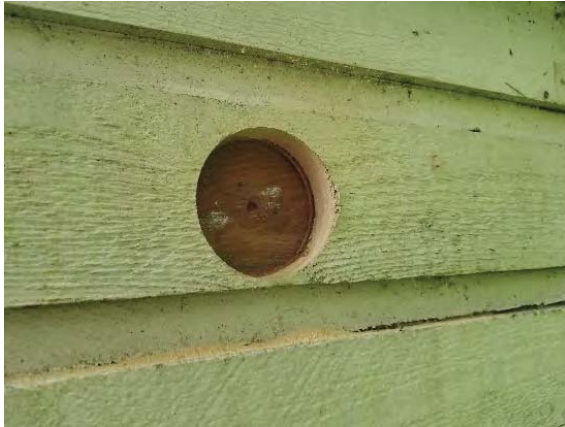
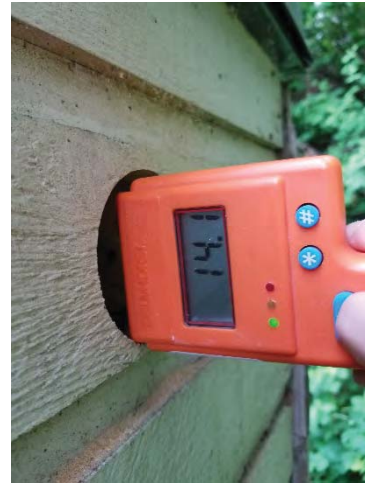
<b>Location:</b>	West-elevation, south corner	<b>EO 18</b>
<b>Detail:</b>	Cedar cladding, below parapet flashing.	
<b>Moisture Content:</b>	14.1%

Assembly	Condition
<ul style="list-style-type: none"> <li>• Channel cedar siding</li> <li>• Building Paper</li> <li>• 1/2" plywood</li> <li>• 2"x6" wood framing at 16" o/c</li> <li>• 6" batt insulation between studs</li> <li>• 6 mil polyethylene vapour barrier</li> <li>• Interior finishes</li> </ul>	<ul style="list-style-type: none"> <li>• Cladding in fair condition at this location.</li> <li>• Building paper was in generally good condition at the time of our review.</li> <li>• Staining visible on sheathing.</li> </ul>
Comments	
<ul style="list-style-type: none"> <li>• Evidence of past moisture ingress behind building paper at this location.</li> </ul>

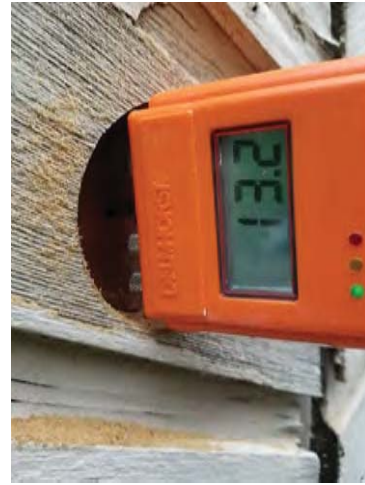
<b>Location:</b>	South-elevation	<b>EO 19</b>
<b>Detail:</b>	Cedar cladding, adjacent to vertical sealant joint	
<b>Moisture Content:</b>	13.2%

Assembly	Condition
<ul style="list-style-type: none"> <li>• Channel cedar siding</li> <li>• Building Paper</li> <li>• 1/2" plywood</li> <li>• 2"x6" wood framing at 16" o/c</li> <li>• 6" batt insulation between studs</li> <li>• 6 mil polyethylene vapour barrier</li> <li>• Interior finishes</li> </ul>	<ul style="list-style-type: none"> <li>• Cladding in poor condition at this location.</li> <li>• Building paper was in generally fair condition at the time of our review.</li> <li>• Sheathing appeared dry at the time of our review.</li> </ul>
Comments	
<ul style="list-style-type: none"> <li>• Assembly was dry at the time of our review.</li> </ul>

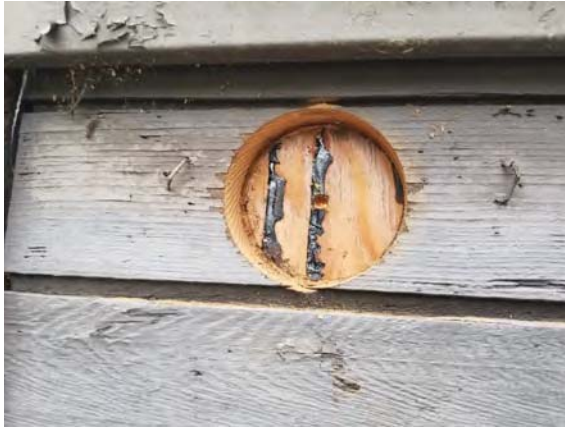
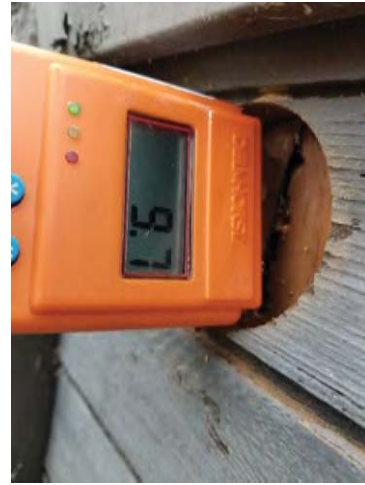
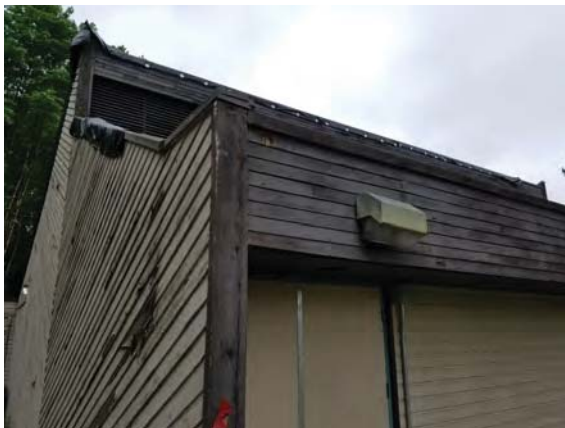
# EO 20

Assembly	Condition
<ul style="list-style-type: none"> <li>Channel cedar siding</li> <li>Building Paper</li> <li>1/2" plywood</li> <li>2"x6" wood framing at 16" o/c</li> <li>6" batt insulation between studs</li> <li>6 mil polyethylene vapour barrier</li> <li>Interior finishes</li> </ul>	<ul style="list-style-type: none"> <li>Cladding in poor condition at this location.</li> <li>Building paper was in generally fair condition at the time of our review.</li> <li>Sheathing appeared dry at the time of our review.</li> </ul>
Comments	
<ul style="list-style-type: none"> <li>Assembly was dry at the time of our review.</li> </ul>

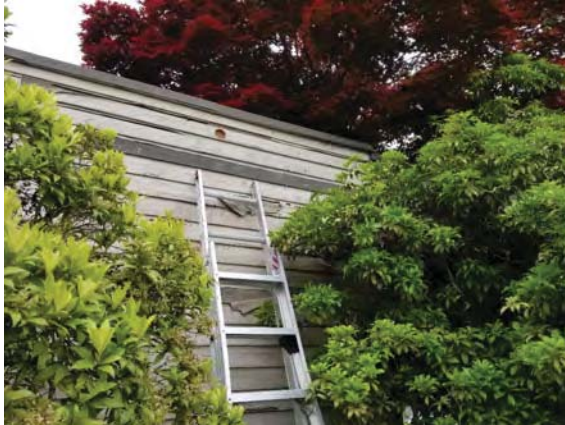
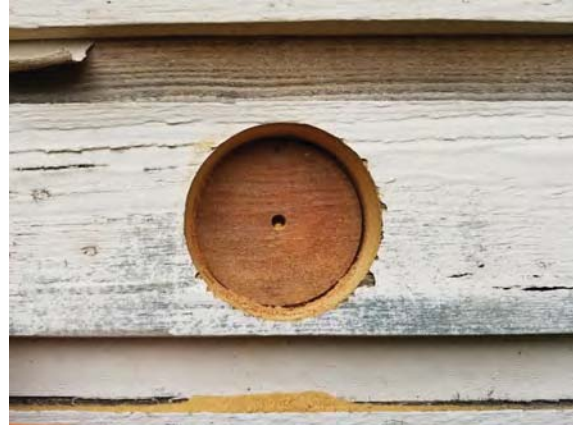
EO 21

Assembly	Condition
<ul style="list-style-type: none"> <li>Channel cedar siding</li> <li>Building Paper</li> <li>1/2" plywood</li> <li>2"x6" wood framing at 16" o/c</li> <li>6" batt insulation between studs</li> <li>6 mil polyethylene vapour barrier</li> <li>Interior finishes</li> </ul>	<ul style="list-style-type: none"> <li>Cladding in poor condition at this location.</li> <li>Building paper was in generally fair condition at the time of our review.</li> <li>Sheathing appeared dry at the time of our review.</li> </ul>
Comments	
<ul style="list-style-type: none"> <li>Assembly was dry at the time of our review.</li> </ul>

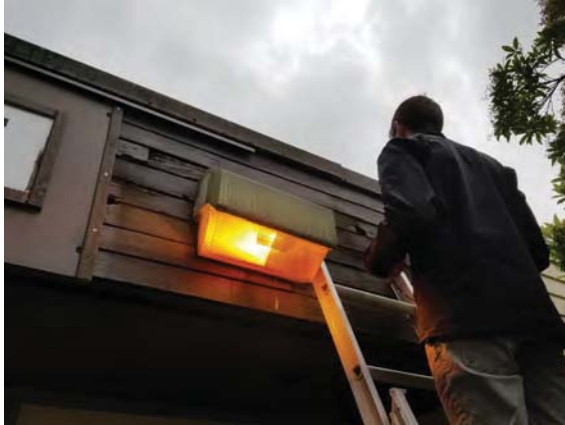
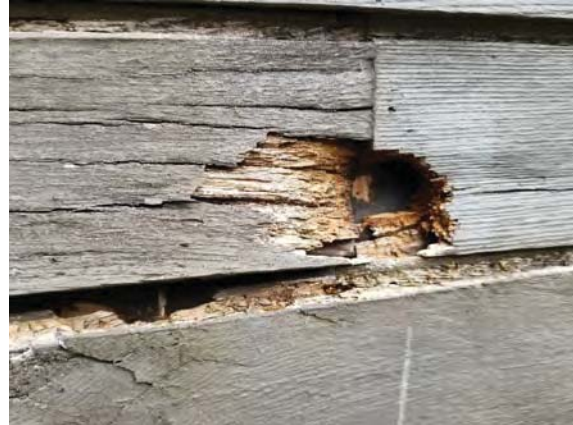
# EO 22

Assembly	Condition
<ul style="list-style-type: none"> <li>• Channel cedar siding</li> <li>• Building Paper</li> <li>• 1/2" plywood</li> <li>• 2"x6" wood framing at 16" o/c</li> <li>• 6" batt insulation between studs</li> <li>• 6 mil polyethylene vapour barrier</li> <li>• Interior finishes</li> </ul>	<ul style="list-style-type: none"> <li>• Cladding significantly deteriorated at this location.</li> <li>• Building paper was in generally fair condition at the time of our review.</li> </ul>
Comments	
<ul style="list-style-type: none"> <li>• Assembly was dry at the time of our review.</li> </ul>

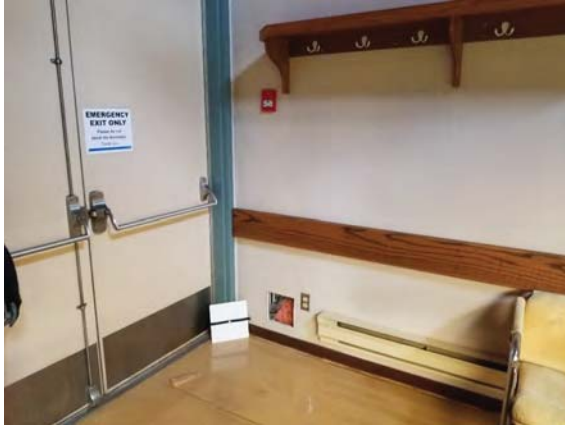
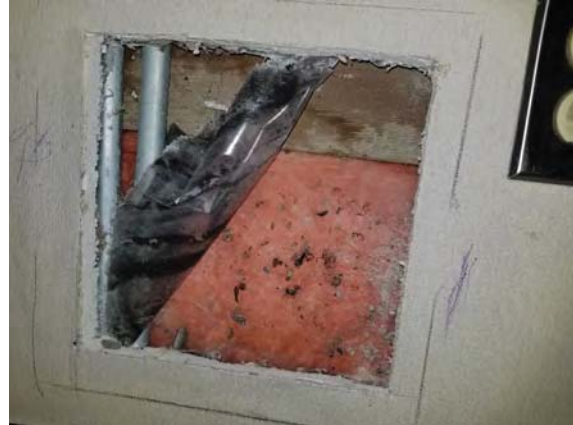
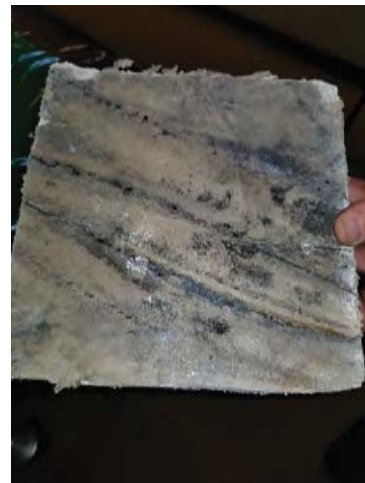
<b>Location:</b>	Billiards Room, west elevation (See Appendix C)	<b>IO 1</b>
<b>Detail:</b>	Cedar cladding, base of wall.	
<b>Moisture Content:</b>	Sheathing: 14.3% / Framing: 10.1%

Assembly	Condition
<ul style="list-style-type: none"> <li>Channel cedar siding</li> <li>Building Paper</li> <li>1/2" plywood</li> <li>2"x6" wood framing at 16" o/c</li> <li>6" batt insulation between studs</li> <li>6 mil polyethylene vapour barrier</li> <li>Interior finishes</li> </ul>	<ul style="list-style-type: none"> <li>Organic growth between drywall and poly.</li> <li>Stained studs, sill plate and sheathing.</li> <li>Fibreglass batt insulation is dirty, indicating air movement across the wall assembly.</li> </ul>
Comments	
<ul style="list-style-type: none"> <li>Organic growth observed on backside of interior gypsum finish.</li> <li>Fungal air sampling was conducted at this location (see Appendix D, Sample S4).</li> <li>Evidence of moisture related deterioration observed at this location.</li> </ul>

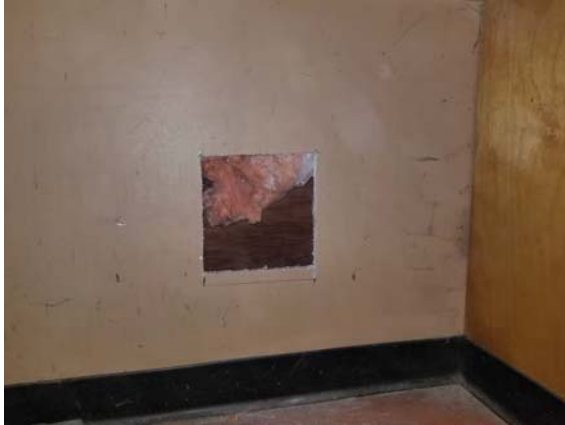
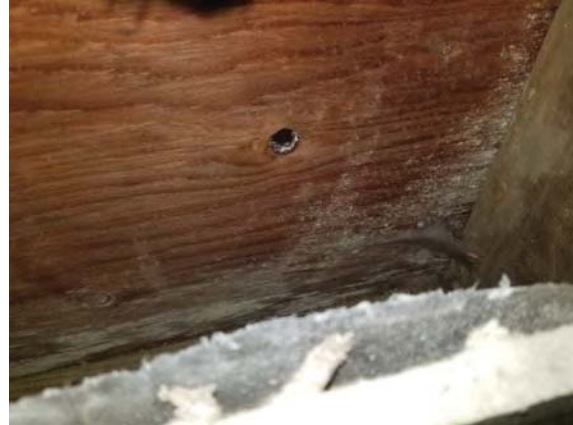
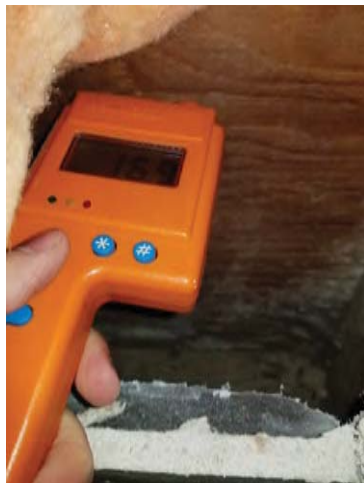
<b>Location:</b>	Rock & Gem Room, south elevation (See Appendix C)	<b>IO 2</b>
<b>Detail:</b>	Cedar cladding, base of wall.	
<b>Moisture Content:</b>	Sheathing: 16.9% / Framing: 10.3%

Assembly	Condition
<ul style="list-style-type: none"> <li>• Channel cedar siding</li> <li>• Building Paper</li> <li>• 1/2" plywood</li> <li>• 2"x6" wood framing at 16" o/c</li> <li>• 6" batt insulation between studs</li> <li>• 6 mil polyethylene vapour barrier</li> <li>• Interior finishes</li> </ul>	<ul style="list-style-type: none"> <li>• Staining and organic growth observed on interior face of sheathing.</li> <li>• Fibreglass batt insulation is dirty, indicating air movement across the wall assembly.</li> </ul>
Comments	
<ul style="list-style-type: none"> <li>• Fungal air sampling was conducted at this location (see Appendix D, Sample S6).</li> <li>• Evidence of moisture related deterioration observed at this location.</li> </ul>

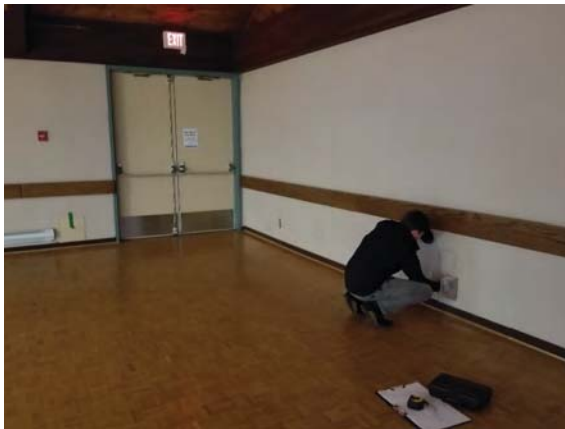
<b>Location:</b>	Ball Room, south elevation (see Appendix C)	<b>IO 3</b>
<b>Detail:</b>	Cedar cladding, base of wall	
<b>Moisture Content:</b>	Sheathing: 10.6% / Framing: 10.5%

Assembly	Condition
<ul style="list-style-type: none"> <li>Channel cedar siding</li> <li>Building Paper</li> <li>1/2" plywood</li> <li>2"x6" wood framing at 16" o/c</li> <li>6" batt insulation between studs</li> <li>6 mil polyethylene vapour barrier</li> <li>Interior finishes</li> </ul>	<ul style="list-style-type: none"> <li>Stained studs, sill plate and sheathing.</li> <li>Fibreglass batt insulation is dirty, indicating air movement across the wall assembly.</li> </ul>
Comments	
<ul style="list-style-type: none"> <li>Evidence of moisture related deterioration observed at this location.</li> </ul>

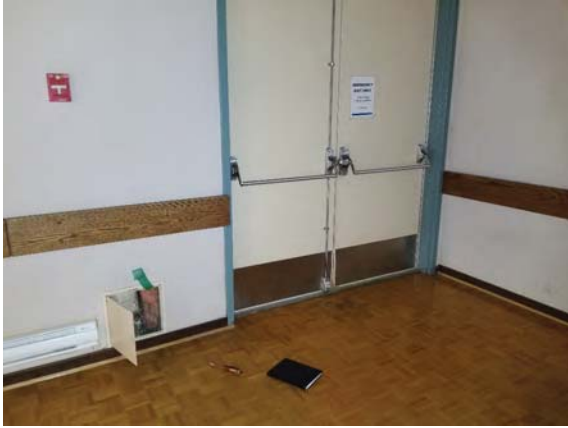
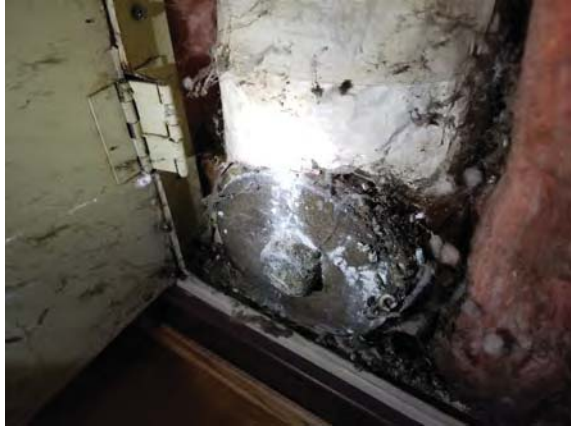
<b>Location:</b>	Ball Room, east elevation (see Appendix C)	<b>IO 4</b>
<b>Detail:</b>	Cedar cladding, base of wall	
<b>Moisture Content:</b>	Sheathing: 9%

Assembly		Condition
<ul style="list-style-type: none"> <li>• Channel cedar siding</li> <li>• Building Paper</li> <li>• 1/2" plywood</li> <li>• 2"x6" wood framing at 16" o/c</li> <li>• 6" batt insulation between studs</li> <li>• 6 mil polyethylene vapour barrier</li> <li>• Interior finishes</li> </ul>		<ul style="list-style-type: none"> <li>• Sheathing not visible at this location.</li> <li>• Fibreglass batt insulation is dirty, indicating air movement across the wall assembly.</li> <li>• Polyethylene vapour barrier is discontinuous across this area.</li> </ul>
Comments		
<ul style="list-style-type: none"> <li>• Exploratory opening was conducted at plumbing cleanout access hatch.</li> <li>• Wall assembly behind access hatch should be cleaned.</li> <li>• Evidence of moisture related deterioration observed at this location.</li> </ul>

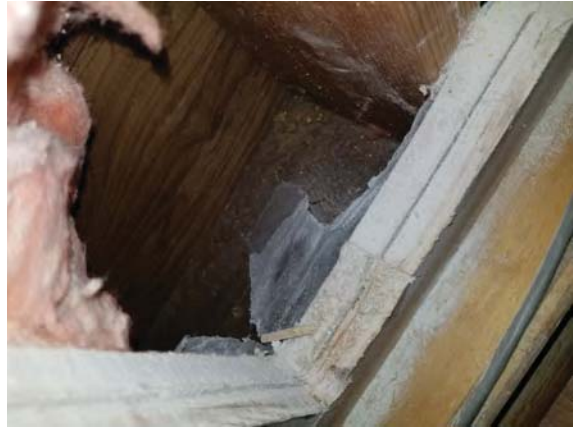
</div>
Assembly		Condition
<ul style="list-style-type: none"><li>• Channel cedar siding</li><li>• Building Paper</li><li>• 1/2" plywood</li><li>• 2"x6" wood framing at 16" o/c</li><li>• 6" batt insulation between studs</li><li>• 6 mil polyethylene vapour barrier</li><li>• Interior finishes</li></ul>		<ul style="list-style-type: none"><li>• Sheathing was clean and generally good condition at this location.</li><li>• Fibreglass batt insulation is dirty, indicating air movement across the wall assembly.</li></ul>
Comments		
<ul style="list-style-type: none"><li>• No evidence of moisture-related deterioration was observed at this location.</li><li>• Fungal air sampling was conducted at this location (see Appendix D, Sample S2).</li></ul>

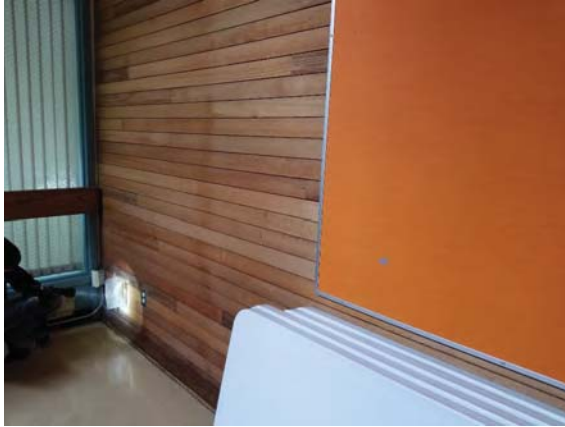
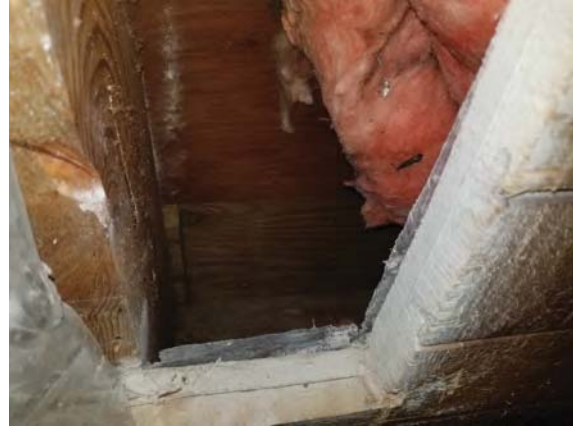
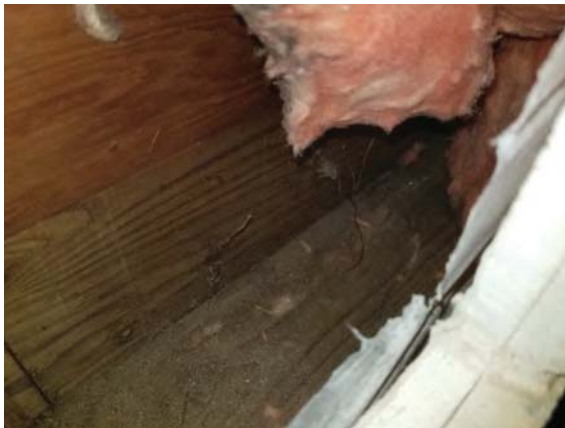
10 6

Assembly	Condition
<ul style="list-style-type: none"> <li>• Channel cedar siding</li> <li>• Building Paper</li> <li>• 1/2" plywood</li> <li>• 2"x6" wood framing at 16" o/c</li> <li>• 6" batt insulation between studs</li> <li>• 6 mil polyethylene vapour barrier</li> <li>• Interior finishes</li> </ul>	<ul style="list-style-type: none"> <li>• Sheathing was clean and generally good condition at this location.</li> <li>• Fibreglass batt insulation is dirty, indicating air movement across the wall assembly.</li> </ul>
Comments	
<ul style="list-style-type: none"> <li>• No evidence of moisture-related deterioration was observed at this location.</li> </ul>

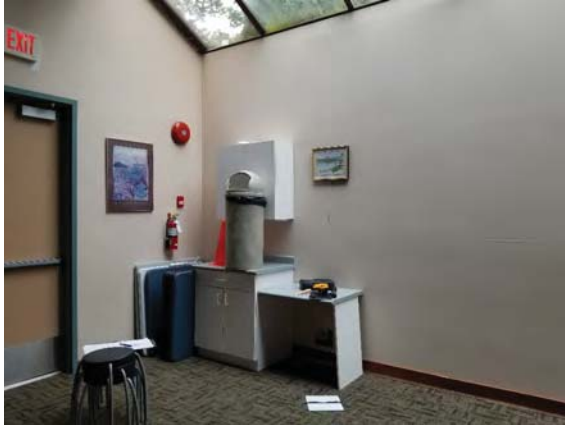
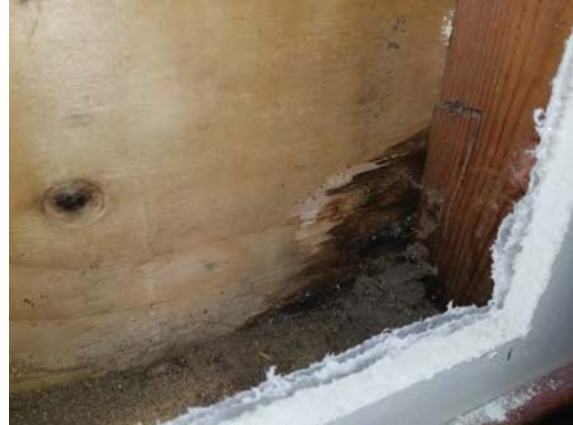
<b>Location:</b>	Activity Room, north elevation (see Appendix C)	<b>107</b>
<b>Detail:</b>	Cedar cladding, base of wall	
<b>Moisture Content:</b>	Sheathing: 24.8% / Framing 13.2%

Assembly	Condition
<ul style="list-style-type: none"> <li>• Channel cedar siding</li> <li>• Building Paper</li> <li>• 1/2" plywood</li> <li>• 2"x6" wood framing at 16" o/c</li> <li>• 6" batt insulation between studs</li> <li>• 6 mil polyethylene vapour barrier</li> <li>• Interior finishes</li> </ul>	<ul style="list-style-type: none"> <li>• Stained and deteriorated sheathing observed at base of wall.</li> <li>• Sheathing was wet at the time of our review.</li> <li>• Staining observed on studs at sill plate.</li> <li>• Fibreglass batt insulation is dirty, indicating air movement across the wall assembly</li> </ul>
Comments	
<ul style="list-style-type: none"> <li>• Evidence of moisture-related deterioration was observed at this location.</li> <li>• Fungal air sampling was conducted at this location (see Appendix D, Sample S3).</li> </ul>

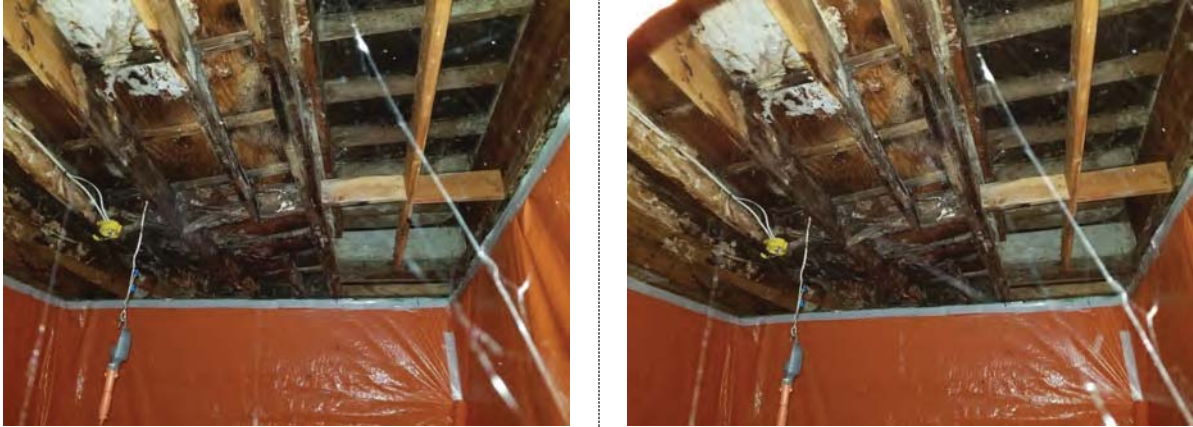
<b>Location:</b>	Storage Room, southwest corner of building	<b>IO 8</b>
<b>Detail:</b>	Cedar cladding	
<b>Moisture Content:</b>	Could not be measured at this location

<b>Assembly</b>		<b>Condition</b>
<ul style="list-style-type: none"> <li>• Channel cedar siding</li> <li>• Building Paper</li> <li>• 1/2" plywood</li> <li>• 2"x6" wood framing at 16" o/c</li> <li>• 6" batt insulation between studs</li> <li>• 6 mil polyethylene vapour barrier</li> <li>• Interior finishes</li> </ul>		<ul style="list-style-type: none"> <li>• Framing is in poor condition due to moisture-related deterioration.</li> <li>• Strong musty smell within the room.</li> <li>• Visible organic growth on exposed framing within the room.</li> </ul>
<b>Comments</b>		
<ul style="list-style-type: none"> <li>• Access to this room has been closed off due to past issues with leaks and deterioration of the wood structure.</li> <li>• Significant evidence of moisture-related deterioration was observed at this location, including organic growth and deterioration of the wood structure.</li> <li>• Fungal air sampling was conducted at this location (see Appendix D, Sample S5).</li> </ul>
