Conservation Plan

Martha Johnston Residence – 2131 St. Johns Street, Port Moody

January 2022

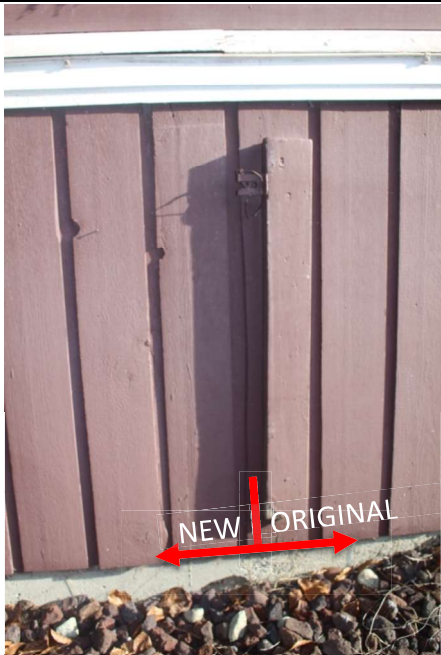
DESCRIPTION AND CONDITION	PHOTO DOCUMENTATION
<p>5.3 FOUNDATION AND PERIMETER</p>	<p>The foundation of the Martha Johnston Residence consists of a poured-in-place concrete wall on all sides. The floor is a poured-in-place concrete floor slab. Overall it is in good condition.</p> <p>The foundation is older board-formed concrete except for one small section on the north-west corner which is newer. This defines the point between the original basement and a secondary front porch accessed off the west protrusion. This is confirmed by the archival photo (see Sections 2.1 and 5.2).</p> <p>The foundation under the kitchen extension (rear) was not visible.</p>

The foundation of the Martha Johnston Residence consists of a poured-in-place concrete wall on all sides. The floor is a poured-in-place concrete floor slab. With the proposed relocation, the building will have a new foundation and floor slab, and undergo seismic upgrades. New minimally-invasive seismic interventions that might be required should be discreet and not be visible from the exterior, and require the absolute minimal degree of removal of material. Any such materials removed must be inventoried and safely stored on a temporary basis, and be reincorporated so as to not impact any character-defining elements.

- Rehabilitate the house and provide seismic reinforcement by providing a new concrete foundation on which the house will be set.
- Where the opportunity allows, consider new perimeter features that speak to the original configuration of the site, such as a small set of concrete stairs set back from the house leading to the front porch.

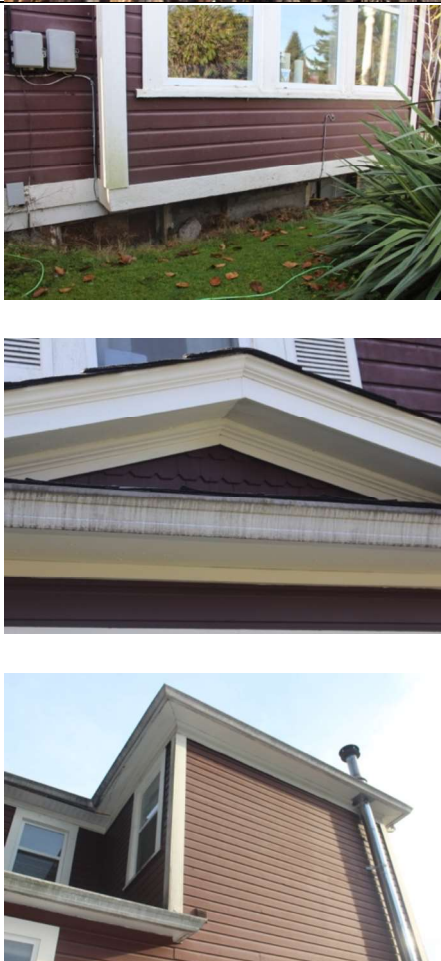
<p>5.4 CLADDING</p>	<p>The cladding on the main and upper floor is drop tongue-and-groove. There is an accent cladding in the low-pitched gabled bay on the east side, which features squared shingles. The tongue-and-groove cladding is in very good condition overall, and in excellent condition in those areas where it has been protected such as on the inside of the front porch. The shingles in the east side gable are in excellent condition.</p> <p>The cladding on the lower level is a vertical tongue-and-groove board that is lacking the same curved profile of the original on the main and upper floors. It appears to be a newer application, nevertheless it is in good condition overall.</p>

- Preserve the cladding in its existing state, with minor repair and replacement of any components only where deterioration has occurred that is not repairable.
- Removal of entire sections or faces of the cladding is not acceptable. Any replacement cladding must be milled to match the profile of the existing cladding.

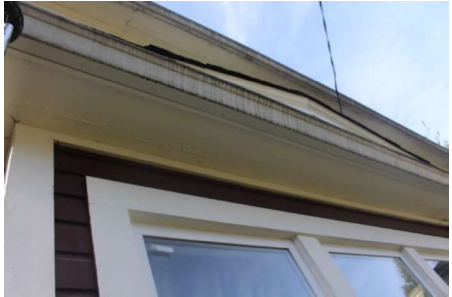
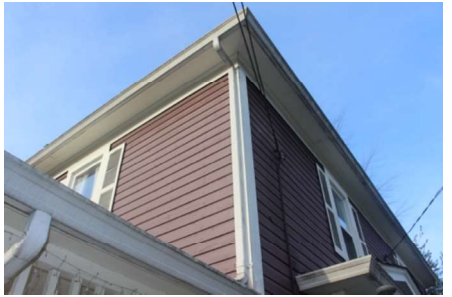
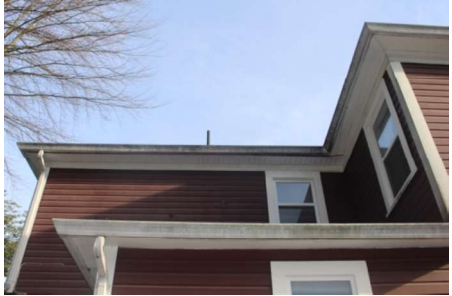
DESCRIPTION AND CONDITION	PHOTO DOCUMENTATION
5.5 FACIA AND SOFFITS	<p>The soffits are enclosed around the entire perimeter of the house, on both the upper floor, the main floor bay on the west side, and around the porches. Along the west side, in front of the upper interior corner, the soffits have been replaced by aluminum, indicating a prior problem. Along the east side they appear to have been replaced with a board and are in fair condition.</p> <p>In many areas, the soffits are displaying signs of deterioration caused by water ingress. This is particularly notable around the rear porch, and west sides. (See further comments in Section 5.9 Rear Porch.)</p> <p>Facia trim boards under the soffits are all in good condition.</p>

- The fascia boards are to largely remain intact, with select repair where necessary.
- The soffits of the upper floor, and those around the perimeter of the front and rear porches, are to be rehabilitated in their entirety, the majority of which will require restoring it to its original appearance. Replacement material shall be wood tongue-and-groove boards to match the dimensions and profile of the ceiling boards of the front porch.

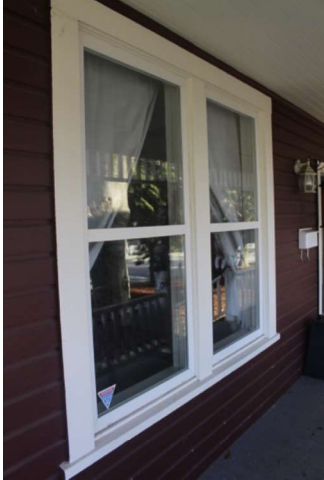
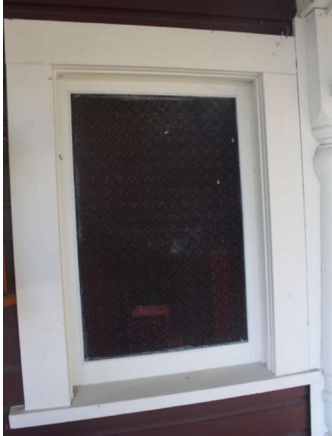
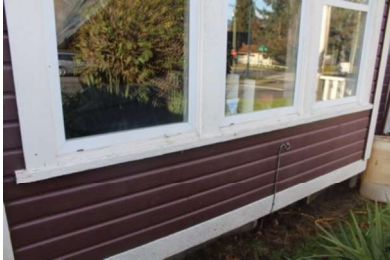
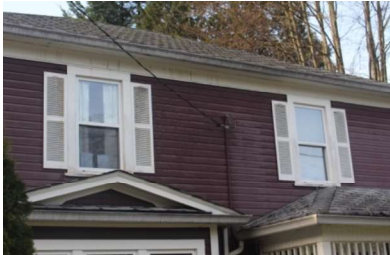
DESCRIPTION AND CONDITION	PHOTO DOCUMENTATION
<p>5.7 WINDOWS, SILLS AND TRIM</p>	<p>All of the windows on the house have been replaced except those in the basement, west side, and the fixed window to the right of the front door.</p> <p>The basement windows on the east side are in poor condition, missing sashes. Dirt and vegetation have accumulated against what were two windows on the east side under the bay, and all that is left is the frame. The basement windows on the west side, including sills, frames and sashes, are in fair to poor condition. The one exception is the single window adjacent the basement stairwell entry, which is in good condition.</p> <p>On the main floor, the front window sills and trim are in excellent condition, and the fixed window with original sash and glazing adjacent the door is also excellent. The east side window sills and trim along the porch are also in excellent condition. The east side bay, sills and trim boards are in good condition, showing minor sign of paint loss but no rot or wood grain exposure. On the west side main floor, the single window sill and trim are in good condition, while the kitchen window is in fair condition. The rear kitchen window is in very good condition.</p> <p>The window sills and trim on the upper floor are in fair to good condition overall. Specifically at the rear, the left window shows some deterioration on the sill, while the middle and right window sills are in good condition, and the trim boards for all three windows are in very good condition.</p>

- On the main and upper floors, restore the windows with new wood windows to match existing in terms of material and profile. Most will be double hung windows, with an equal proportion (height) of lower and upper sash.
- The one remaining original window on the main floor, the fixed window adjacent the entry door, shall be preserved in its existing state, including its decorative translucent glazing.
- Preserve the sills and trim of all main and upper floor windows except where deterioration is evident and repair and replication is necessary with materials and dimensions to match existing.

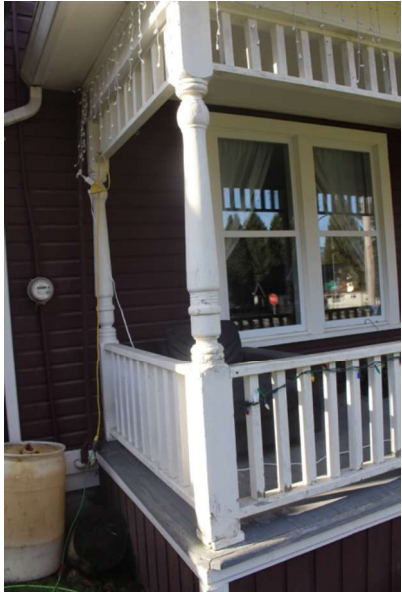
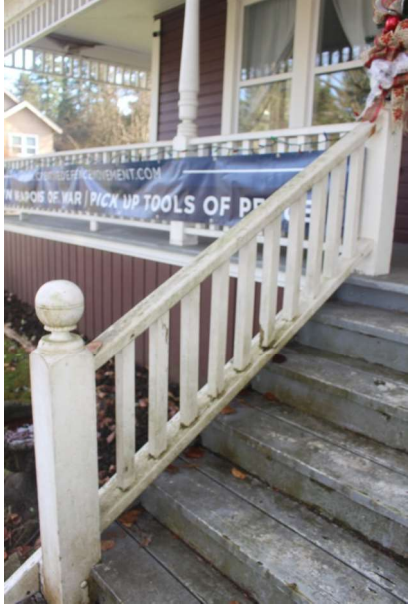
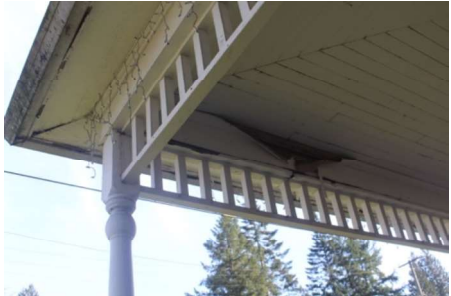
DESCRIPTION AND CONDITION	PHOTO DOCUMENTATION
5.8 FRONT PORCH AND STAIRS	<p>The front porch includes the turned posts, balustrade, decorative grille along the top, flooring, and stairs with railing and posts. There are varying levels of condition, depending on the element and its degree of exposure.</p> <p>The trim boards around the outer flooring are in fair condition and require repair and replacement. There is paint deterioration on the porch floor, but otherwise in good condition.</p> <p>The posts have varying conditions. The one at the south east corner is showing advanced signs of wood grain exposure and its base is in rough shape. (It has had a wood insert at the bottom.) The next two posts (east side and northeast corner) are in good condition, no sign of decay but bottom is rough with some exposed paint. The front post, to the left of stairs, is in good condition, although it has had a new wood piece insert at bottom. Northwest corner post has also had an insert piece at the bottom, otherwise it is in good condition besides some peeling paint. Half posts on the façade are in very good condition.</p> <p>The balustrade is in good condition, along with the vertical decorative grid running along the top of the porch.</p> <p>The stairs are in fair condition. While the left post at the bottom of the stairs is in poor condition, showing signs of decay, the right post is in good condition, as are the posts at the top of the stairs. The bottom edges of both railings are in poor condition, showing signs of decay.</p> <p>The porch ceiling, in tongue-and-groove board, is good condition. The inside face of the support beam on the east side is showing significant signs of paint deterioration, likely the result of moisture penetration from above (i.e. roof). The soffit is in fair condition.</p>

- Restore the front porch post situated at the south-east corner. This will require using one of the other front porch posts to achieve an exact copy. The remainder of the front porch posts, including the shorter posts set at either side of the top of the stairs, require rehabilitation by way of retention, repair and reinstatement.

- Retain and rehabilitate the floor of the front porch, with the outer edge boards replaced on an as-needed basis depending on their condition.
- The balustrade and decorative upper grill are to be rehabilitated, with select repair and replacement limited to only those components that cannot be repaired.

- The ceiling of the front porch shall be retained and rehabilitated, with select repair and replacement with material and profile to match the existing tongue-and-groove wood board, with select repair and replacement limited to only those components that cannot be repaired. Any replacement is to match existing in terms of material and profile.

- Restore the front stairs, with the number of treads either the same or different depending on the new relationship of the house to grade.
- Restore the deteriorated lower left post to match existing, and rehabilitate the lower right post.

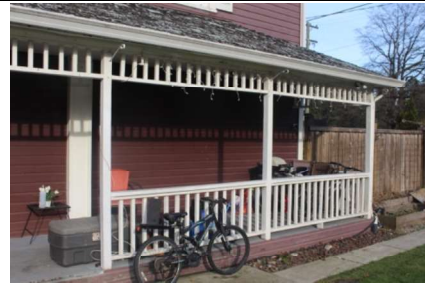
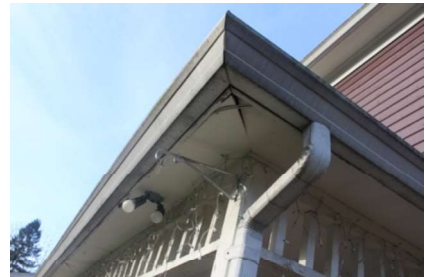
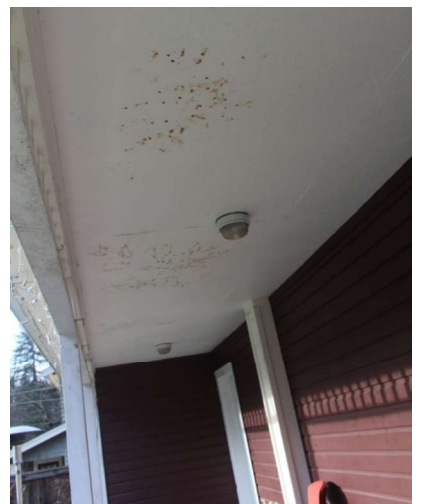
The rear porch has had the flooring replaced with plywood. It is generally in fair condition. Deterioration on the outer edges is evident.

The porch posts are in good condition.

The balustrade is in fair condition but some connections to the posts, along the bottom and at the outer (south-east) corner, are in poor condition.

The soffits around the rear porch are in poor condition due to water ingress (see Section 5.11 Roof for more detail.) The ceiling has been replaced with a type of wood chip board and is similarly in poor condition.

There is also an enclosure of a vent pipe on the back wall, that appears to be in good condition.

- Restore the floor of the front porch to match that on the front porch.
- Restore the balustrade and rehabilitate the decorative upper grill, with select repair and replacement limited to those components that cannot be repaired, in

particular the balustrade. Any replacement is to match existing in terms of material and profile.

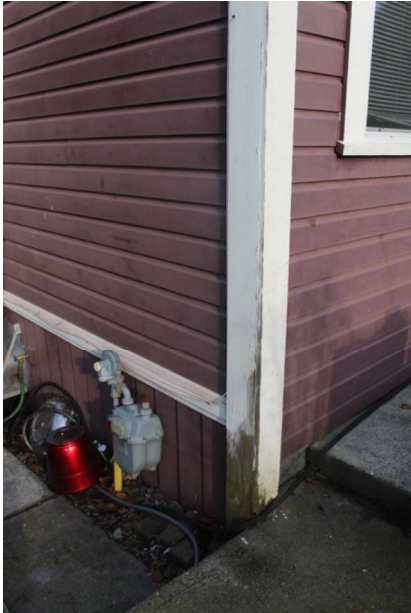
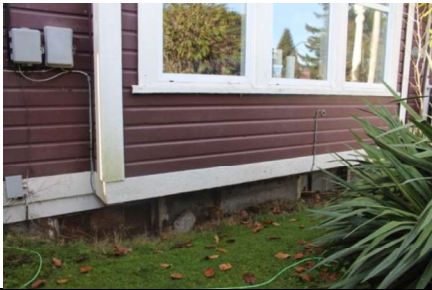
DESCRIPTION AND CONDITION	PHOTO DOCUMENTATION
<p>5.10 BASEBOARDS AND CORNER BOARDS</p>	<p>The corner boards on the front corner, under the porch, are in excellent condition. Those that frame the corners of the east bay appear to have been replaced; those at the southeast corner of the house are in good condition, except for the lower area (closer to ground) displaying some deterioration. Those on the southwest corner are in fair condition, they have lost paint protection and are showing some minor deterioration.</p> <p>The baseboards on the east side are in fair condition with a limited degree of rot visible. Those on the west side are in good condition.</p>

- Retain and, where necessary, repair and replace deteriorated components of the baseboards and corner boards with material and profile to match existing.

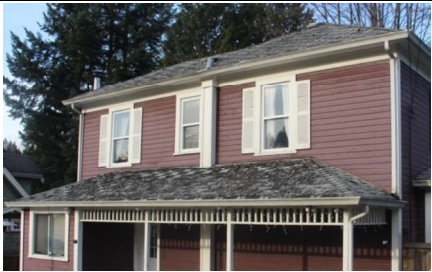
<p>5.11 ROOF</p>	<p>The main roof and the porch roofs are covered with asphalt shingles. They are in poor condition, showing signs of curling and a high degree of granule loss. This has likely contributed to the deterioration in the upper soffits, with certain areas already having had replacement material such as the rear porch ceiling (see Sections 5.5 Facia and Soffits and 5.9 Rear Porch).</p>

- Replace the entire roof – asphalt shingles on the upper roof, and roof of the front and rear porches – with new asphalt shingles in a neutral colour – black, dark grey or weathered wood (see Section 6.12 Colour Scheme).
