# ABC TREE MEN

## CERTIFIED ARBORIST REPORT

2222 Clarke St, Port Moody

April 27, 2018

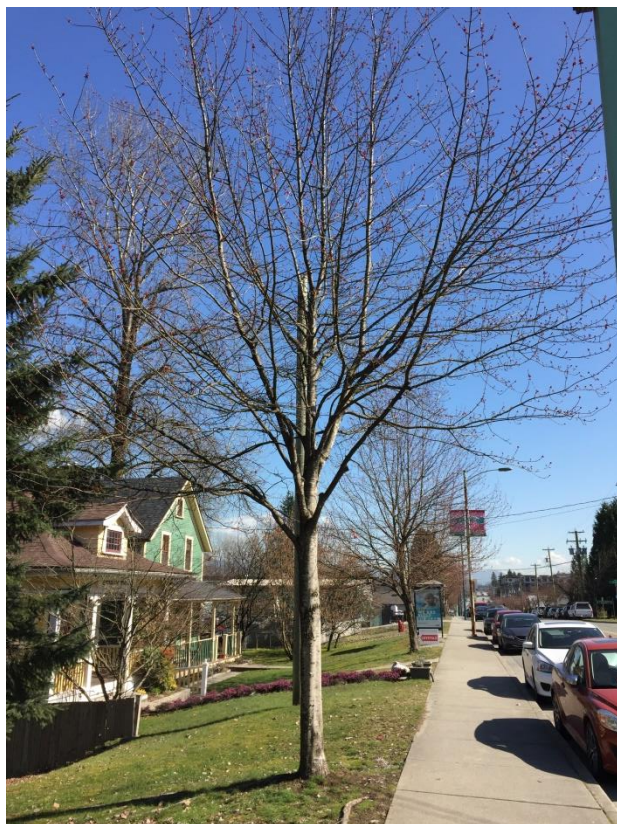
Photo 1. Facing towards the east looking at Tree #1

**Observations:** Tree #1 and #2 are both Maples and are located to the front of the lot. Both are boulevard trees. The DBH measures 21cm and 23cm and both have an overall height of about 8m and a crown spread of 5m.

- Observing the crown and structure on both of the subject trees, there are no major concerns of stress or any major defects. Examining the base and surrounding TPZ, exposed surface roots can be observed on both trees. Tree #2 is situated within two driveways and surface roots have travelled along the native soil. Overall, subject trees are in fair to good condition.

**Recommendations:** Tree #1 and #2 will be both retained. Due to the close proximity to the construction site it is required to place tree protection barriers to protect its trunk, roots, and structure. Place barriers to drip line or to measurements outlined in section 10.0. Only removal of the driveway using low impact methods approved by arborist and under supervision should be implemented. Below are the necessary precautions during removal of the driveway:

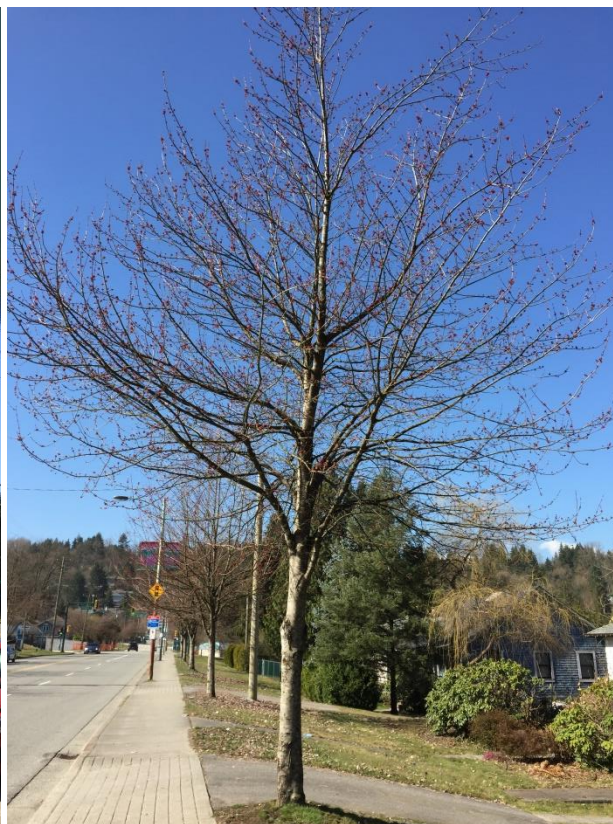
Photo 2. Facing westwards towards the west looking at tree #2

The method of removal is going to be done in a carefully coordinated effort inside the TPZ of the subject tree #2. Only hand tools with the assistance of machinery will be used in the process of removing the existing driveway within the root protection zone, no excavation will go below the grade. During and after the removal process a certified Arborist will be monitoring all activities that will happen around the critical root zone.

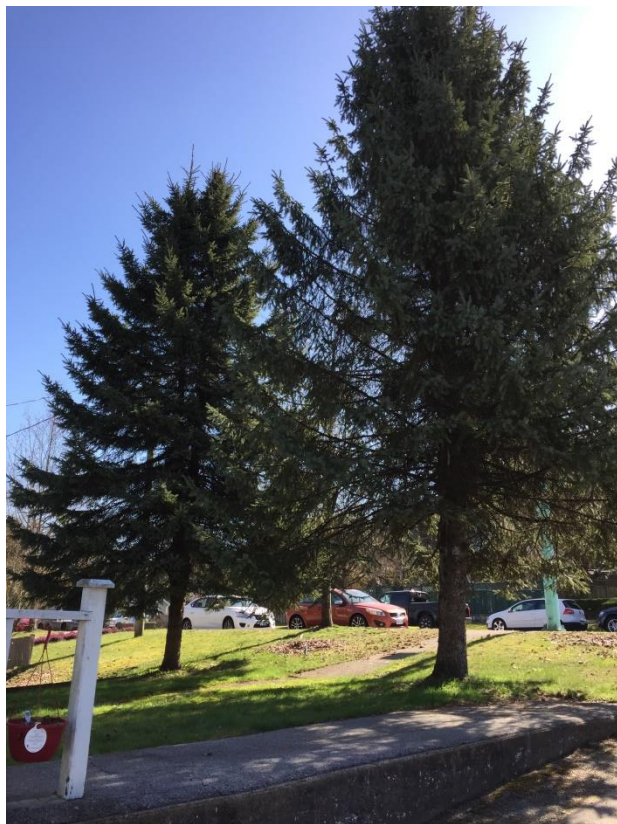
Photo 3. Facing towards the east looking at Tree #3 and #4

**Observations:** Tree #3 and #4 are both Spruces and are located to the front of the lot. Both trees are located on City property. The DBH measures 29cm and 35cm and both have an overall height of about 11m and a crown spread of 4.5m.

- Observing the crown and structure on both of the subject trees, both are co dominant at around 1.8m and 3m. A low live crown ratio on both trees can be examined. While assessing the base and surrounding TPZ, existing hardscapes and structures such as retaining walls and walkways can be observed and will be in conflict during the demolition process. Overall, subject trees are in fair to good condition.

**Recommendations:** Tree #3 and #4 will be both in conflict with the proposed development, and falls just outside the proposed building footprint and underground parkade & within zone of heaviest construction & excavation activity. Removal is recommended.

Substantial grade changes will occur within the TPZ of the subject trees if the excavation goes to specifications for the underground parkade. This will be devastating to its health and overall structure. As observed by the photos other structures such as the retaining wall running from the existing house up to the trunks of tree #3 and a concrete walkway within the CRZ can also be examined, all these structures will be removed and will cause disturbances to the subject trees. It is important to note that these trees have shallow spreading roots that go way beyond the drip line/TPZ and the excavation and grade changes would impact those roots. This can be detrimental and can influence the moisture availability to the subject tree. This is due to a reduction in the total rooting mass, changes in drainage, and overall moisture content

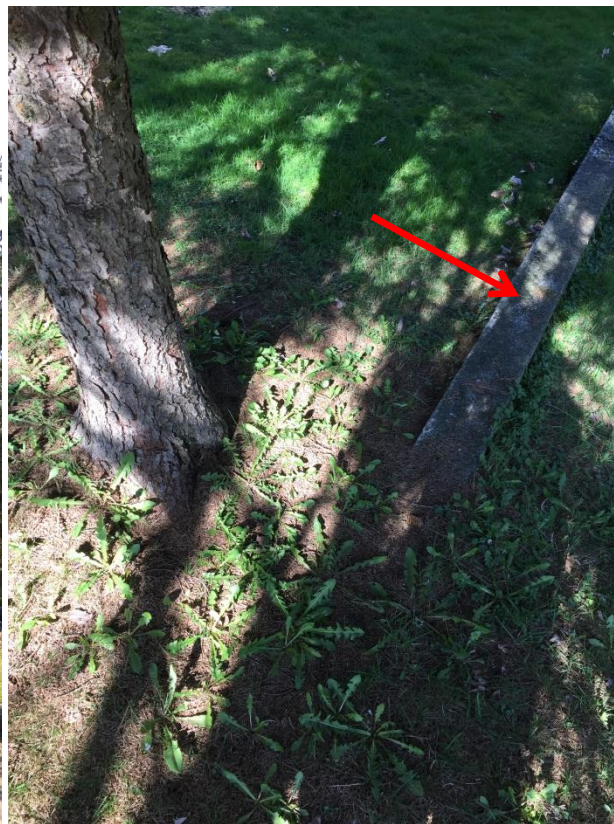
Photo 4. Looking at the retaining wall within CRZ of tree #3

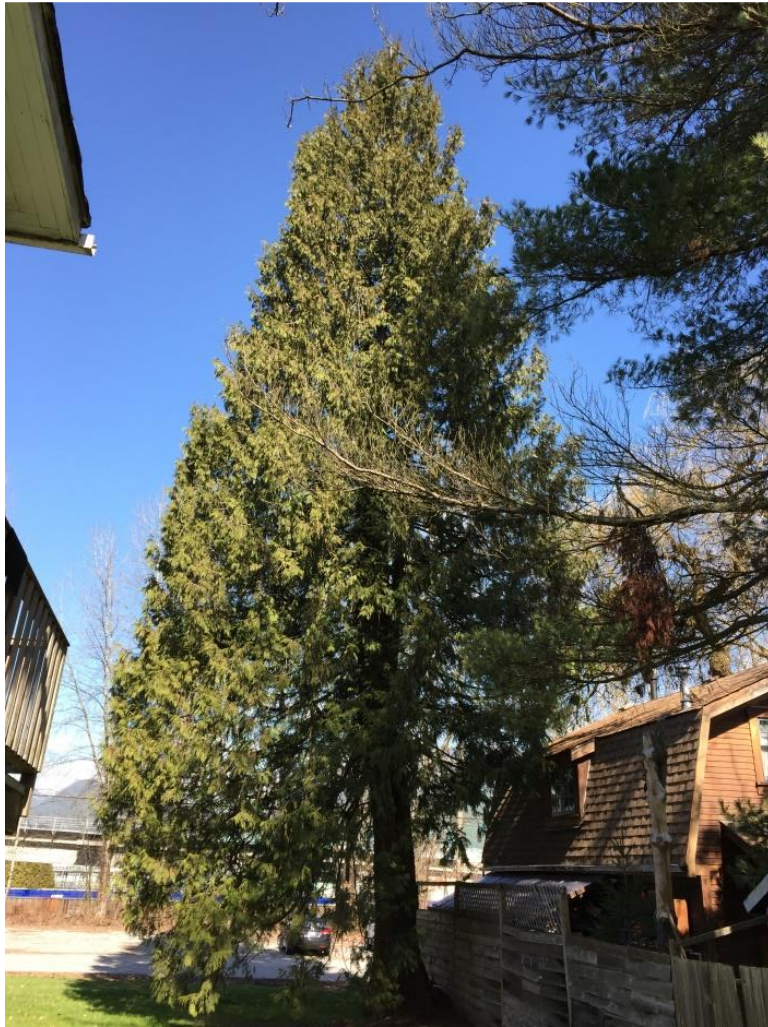
Photo 6. Facing towards tree #5

**Observations:** Tree #5 is a Western redcedar and is located to the back of the property and is situated to the north eastern side of the lot. The DBH measures 91cm at 1.4 meters high from the ground with an overall height of about 27m and a crown spread of about 9m.

- Observing the tree, a multi stem attachment near the top third can be examined that seem to be weakly attached with poor junctions. A large wound from a past large limb failure can be observed. Examining the wound, dead wood and what appears to be insect infestation can be examined. Low live crown ratio tree. Observing overall, subject tree is in fair to poor condition.

**Recommendations:** Tree #5 will be in conflict with the proposed development, and falls just outside the proposed building footprint of the laneway house & within zone of heaviest construction & excavation activity. Removal is recommended.
