## CERTIFIED ARBORIST REPORT

1008 Tuxedo Dr, Port Moody

September 27, 2021

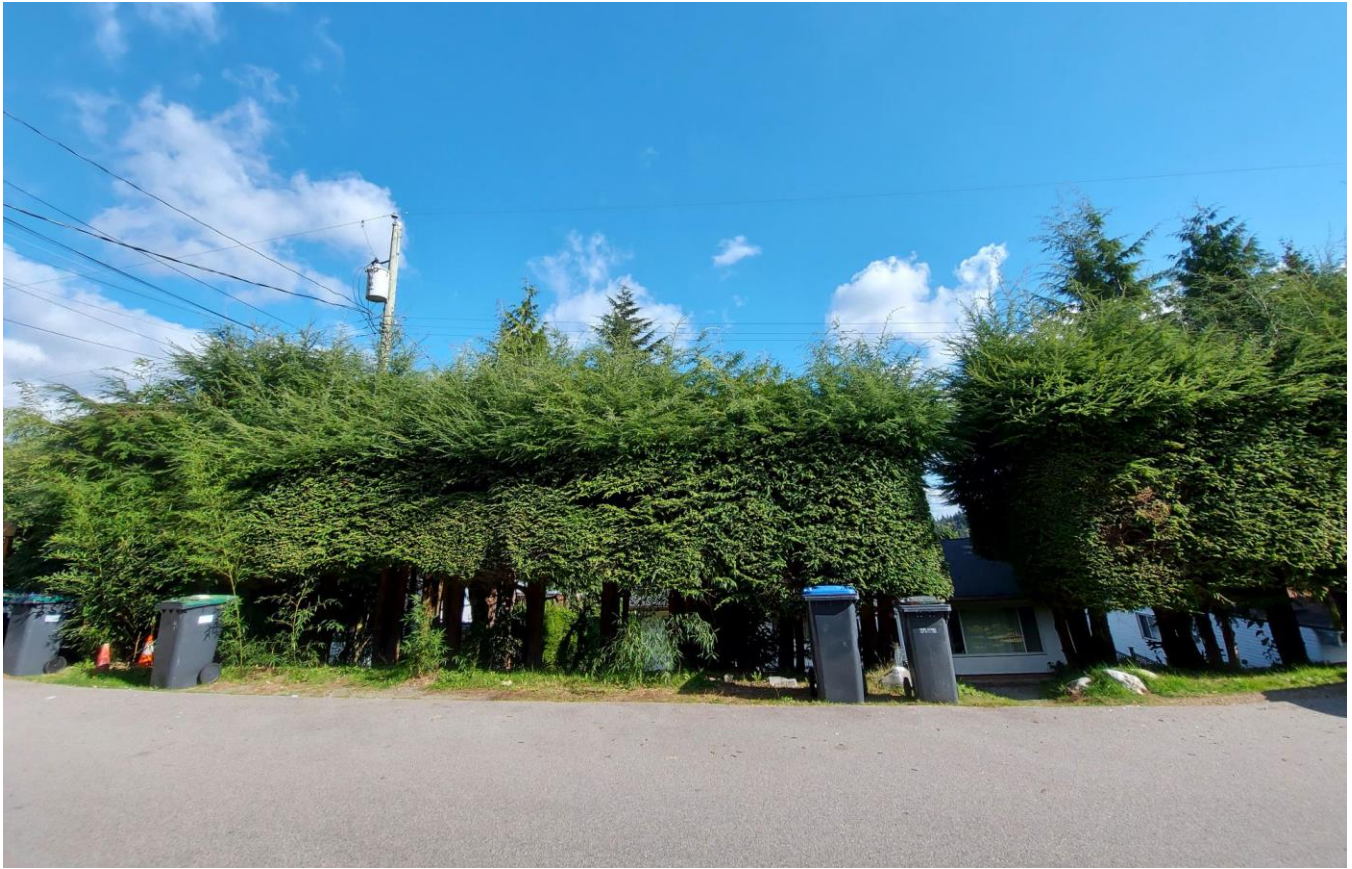
**City trees #C1, #C2, #C3, #C4, #C5, #C6, #C7, #C8, #C9, #C10, #C11, #C12, #C13, #C14, #C15, #C16, #C17, #C18, #C19, #C20, #C21, #C22, and on-site tree #001** were observed to be unsuitable candidates for long term retention as determined by their poor overall structures & health. The repetitive clearing of their overall crowns in order to conform to the desired sized and clear the overhead utility lines had resulted in the trees to become potentially weakened and have mutilated their overall development.

Photo 1 - Facing towards the frontage of the lot and of city trees #C1 - #C22

- ❖ ***As trees #C1, #C2, #C3, #C4, #C5, #C6, #C7, #C8, #C9, #C10, #C11, #C12, #C13, #C14, #C15, #C16, #C17, #C18, #C19, #C20, #C21, and #C22, were examined to be situated within the limits of the city’s property, the City of Port Moody’s (Parks) authorization would be required for their removal.***

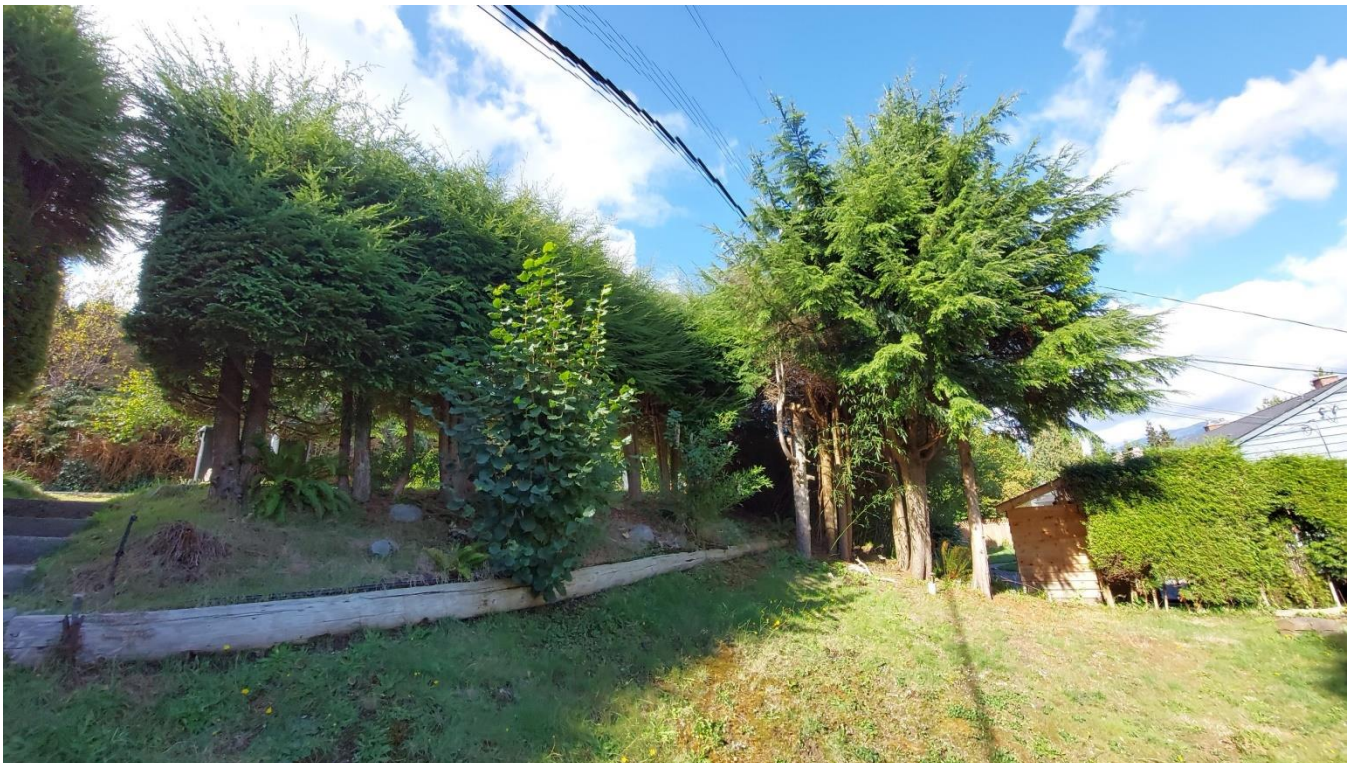
Photo 2 - Facing towards the frontage of the lot and of city trees #C1 - #C22

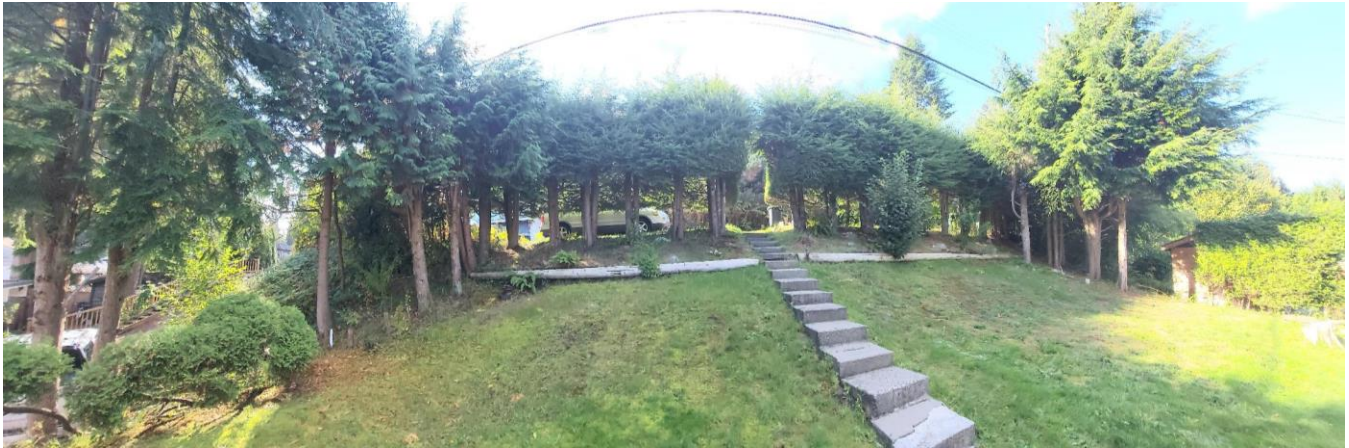
**City Trees #C1 - #C22 - Photos**

**Photo 3 - Facing towards city trees #C1 - #C22**

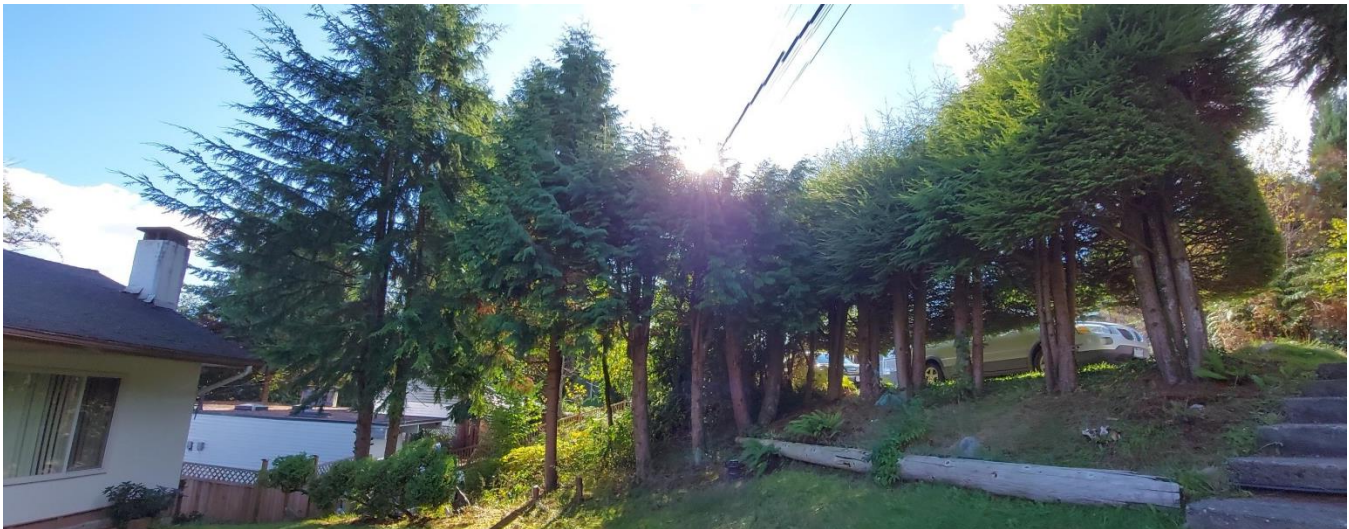
| <b>Table 2 - Off-site Tree Inventory</b> | | | | | | | | | | | | |
|--|---|--|---|---|---|---|---|---|--|---|---|---|
| OS3 | Yes | Off-site | Western hemlock | <i>Tsuga heterophylla</i> | 12/5 | 40 | 5 | Bifurcated stemmed, small, mature, co-dominant and topped coniferous tree. Enlarged base. Limb attachments at 2.2m in height. Crown development was observed to be shared with adjacent trees. No signs of decay. Subject tree is in fair condition. | Place Tree Protection barriers to protect its trunk, roots, and structure. Arborist supervision will be required during the site clearing work. | Marginal /<br>Unsuitable | Retain | 1.2 |
| OS4 | Yes | Off-site | Western redcedar | <i>Thuja plicata</i> | 23 | 40 | 4 | Single stemmed, medium, mature co-dominant and topped coniferous tree. Enlarged base. Limb attachments at 2m in height. Crown development has been pruned in order to clear utility lines. No signs of decay. Subject tree is in fair condition. | Place Tree Protection barriers to protect its trunk, roots, and structure. Arborist supervision will be required during the site clearing work and excavation & construction for the new dwelling. | Marginal | Retain | 1.4 |
| OS5 | Yes | Off-site | Western hemlock | <i>Tsuga heterophylla</i> | 30/23 | 40 | 5 | Single stemmed, medium, mature, co-dominant coniferous tree. Enlarged base. Limb attachments at 2.2m in height. Crown development was observed to be shared with adjacent trees. No signs of decay. Subject tree is in fair condition. | Place Tree Protection barriers to protect its trunk, roots, and structure. Arborist supervision will be required during the site clearing work and excavation & construction for the new dwelling. | Marginal | Retain | 3.2 |

**Photo 4 - Facing towards off-site trees #OS3, #OS4, #OS5, and city trees #C1 - #C8**

- **Demolition of the existing dwelling,**  
As part of the demolition process, the existing garage encompassing within the **TPZ of tree #OS5** as well as its foundations has been proposed to be removed. In order to limit the amount of disturbance occurring within the TPZ of the subject tree, the existing structure located within its protective areas would have to be removed under Arborist supervision and no excavation machinery will be allowed to encroach into its TPZ throughout the demolition process.

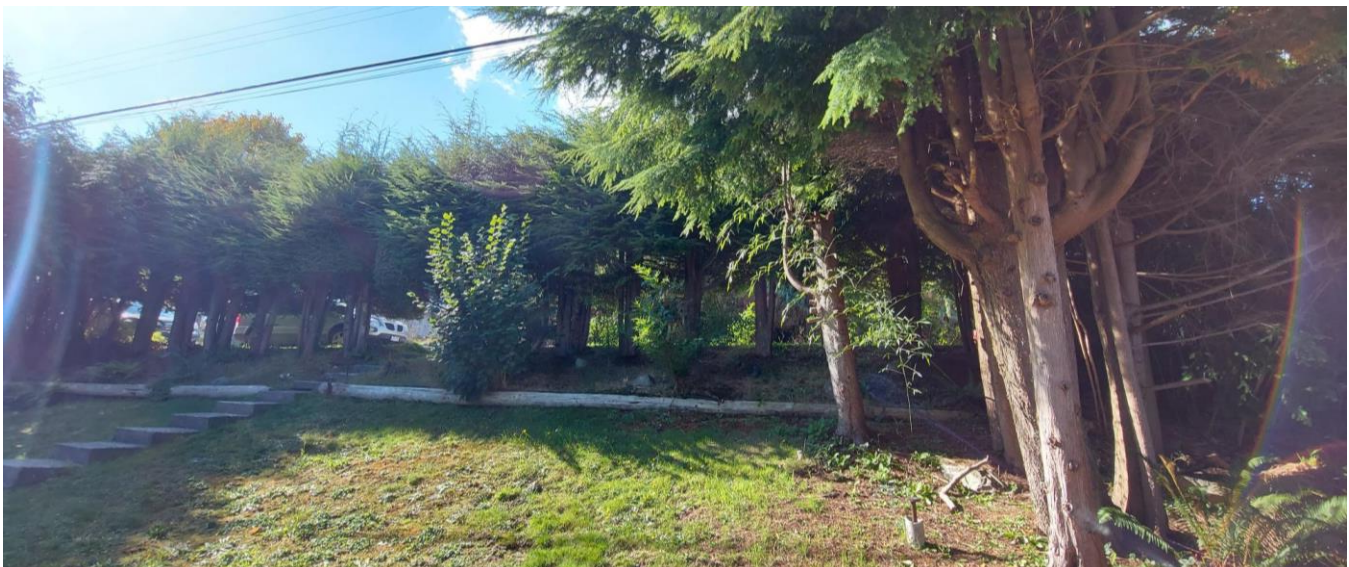
| <b>Table 1 - On-site Tree Inventory</b> | | | | | | | | | | | | |
|---|---|--|---|---|---|---|---|---|--|---|---|---|
| 001 | Yes | On-site | Western hemlock | <i>Tsuga heterophylla</i> | 21 | 15 | 5 | Single stemmed, medium, mature co-dominant and topped coniferous tree. Enlarged base. Limb attachments at 2m in height. Crown development has been pruned to clear utility lines. Subject tree is in fair to poor condition. | Subject tree will be in direct conflict with the proposed lot grading & site servicing requirements, and will be within the zone of the heaviest grading related requirements. | Marginal / Unsuitable | Remove | 1.3 |

**Photo 5 - Facing towards on-site trees #001 and of city trees #C9 - #C21**

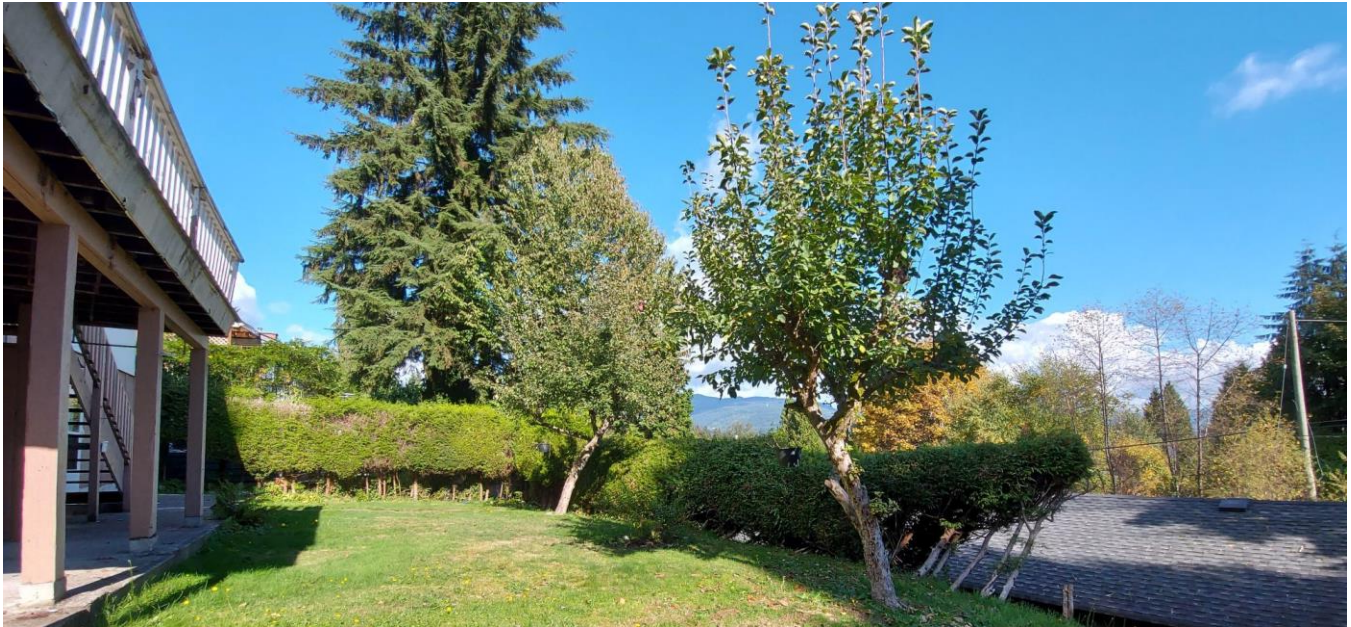
**On-site Trees #002, #003, #004 & Off-site Trees #OS1 & #OS2 - Photos**

| <b>Table 1 - On-site Tree Inventory</b> | | | | | | | | | | | | |
|---|---|--|---|---|---|---|---|---|--|---|---|---|
| 002 | No | On-site | Common apple | <i>Malus domestica</i> | 9/19 | 60 | 5 | Bifurcated stemmed, small, mature deciduous fruiting tree. Loss of leading growth. Former limbs pruning marks along the first quarter of its main trunk. Crown growth has been shaped for landscaping. No signs of decay. Subject tree is in fair condition. | Subject tree will be in direct conflict with the proposed lot grading & building footprint, and will be within the zone of the heaviest grading related requirements. | Marginal | Remove | 1.7 |
| 003 | No | On-site | Common apple | <i>Malus domestica</i> | 16/10 | 60 | 5 | Single stem med, small, mature deciduous tree. Loss of leading growth. Former limbs have been pruned along the first quarter of its main trunk. Crown growth has been shaped for landscaping. No signs of decay. Subject tree is in fair condition. | Subject tree will be in direct conflict with the proposed lot grading & building footprint, and will be within the zone of the heaviest grading related requirements. | Marginal | Remove | 1.6 |

| <b>Table 2 - Off-site Tree Inventory</b> | | | | | | | | | | | | |
|--|---|--|---|---|---|---|---|---|--|---|---|---|
| OS1 | Yes | Off-site | Western hemlock | <i>Tsuga heterophylla</i> | 60 | 40 | 5 | Single stemmed, medium, mature co-dominant coniferous tree. Enlarged base. Limb attachments at 2.2m in height. Crown development in contact with the neighboring tree. Ivy growth along the trunk. Subject tree is in fair condition. | Place Tree Protection barriers to protect its trunk, roots, and structure. Arborist supervision will be required during the site clearing work and excavation & construction for the new garage. | Marginal | Retain | 3.6 |
| OS2 | Yes | Off-site | Western hemlock | <i>Tsuga heterophylla</i> | 40 | 30 | 5 | Single stemmed, small, mature and suppressed deciduous tree. Enlarged base. Limb attachments at 1.50m in height. Crown development has been pruned for landscaping towards the south. Ivy growth along the trunk. No signs of decay. Subject tree is in fair condition. | Place Tree Protection barriers to protect its trunk, roots, and structure. Arborist supervision will be required during the site clearing work and excavation & construction for the new garage. | Marginal | Retain | 2.4 |

Photo 6 - Facing towards on-site trees #002, #003, and off-site trees #OS1 and #OS2 within the distant

Encroachment of the excavation & construction process for the garage is expected to encroach into the **TPZ(s) of trees #OS1 and #OS2**. Due to the encroachment, Arborist supervision will be required during the excavation process along with the installation of forms of the garage and of its eastern foundation line.

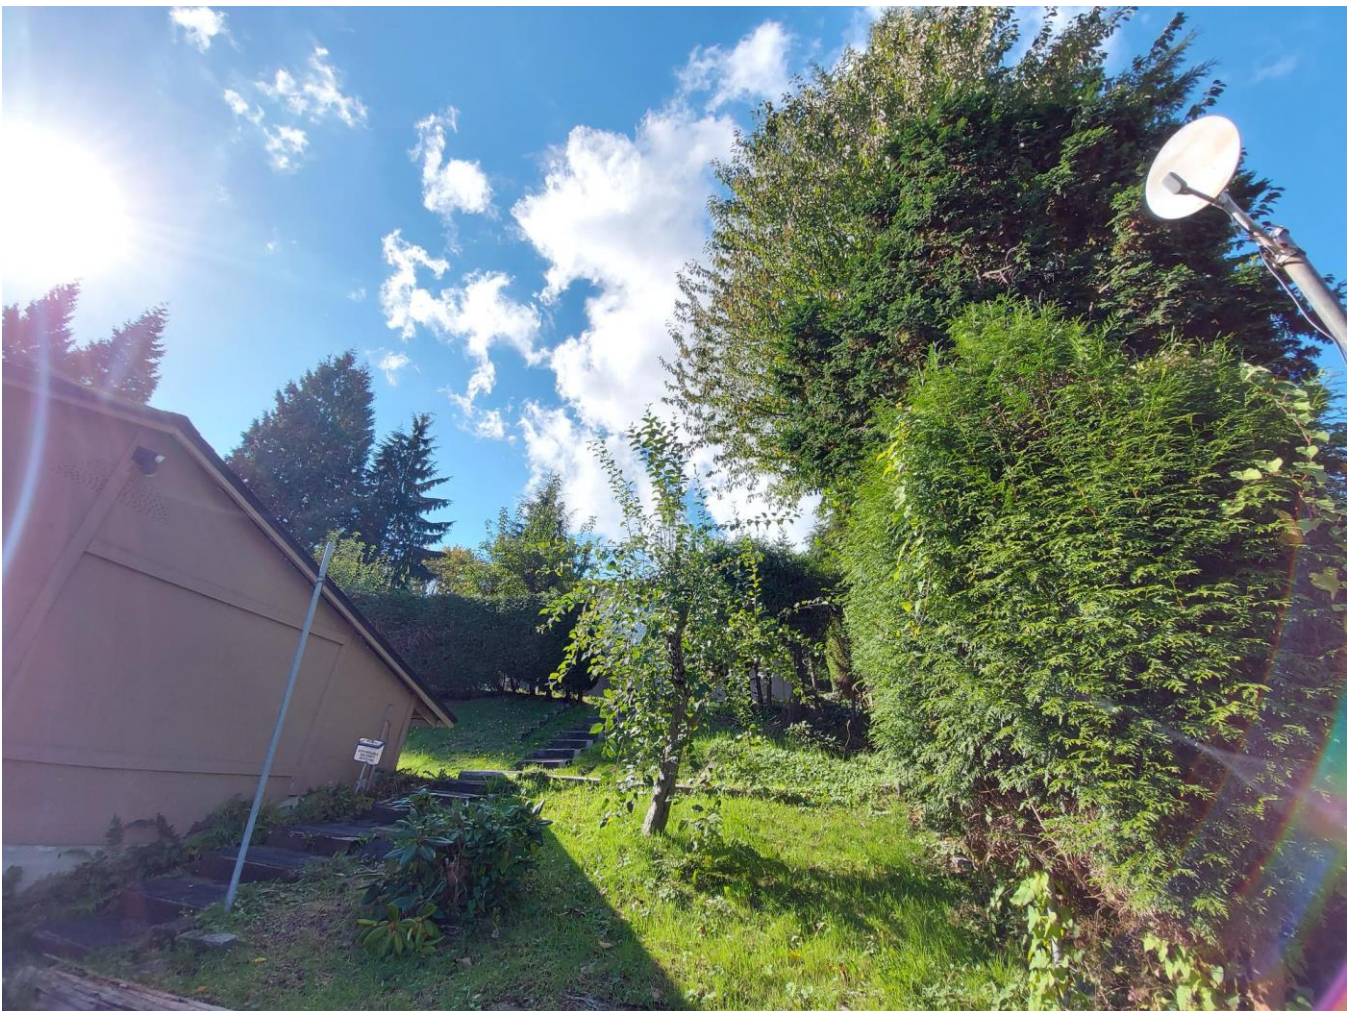
| <b>Table 1 - On-site Tree Inventory</b> | | | | | | | | | | | | |
|---|---|--|---|---|---|---|---|---|--|---|---|---|
| 004 | No | On-site | Common apple | <i>Malus domestica</i> | 11/13 | 70 | 5 | Single stemmed, small, mature deciduous tree. Loss of leading growth. Former limbs have been pruned along the first quarter of its main stems. Crown growth has been shaped for landscaping. Decay process along the structure was observed. Subject tree is in fair condition. | Subject tree will be in direct conflict with the proposed lot grading & building footprint, and will be within the zone of the heaviest grading related requirements. | Marginal | Remove | 1.5 |

Photo 7 - Facing towards on-site tree #004 and of the rear yard area
