Drawing Title: Tree Management Plan
Project Address: Moody Centre, 3006, 3008, 3010, 3020, 3022 Spring Street, Port Moody, BC
Client: PCI Developments

Arboricultural Inventory and Report

Site Location:
Moody Centre, 3020 Spring Street
Port Moody, BC

Dated: June 6, 2023
Previously Dated: May 17, 2023; June 9, 2020

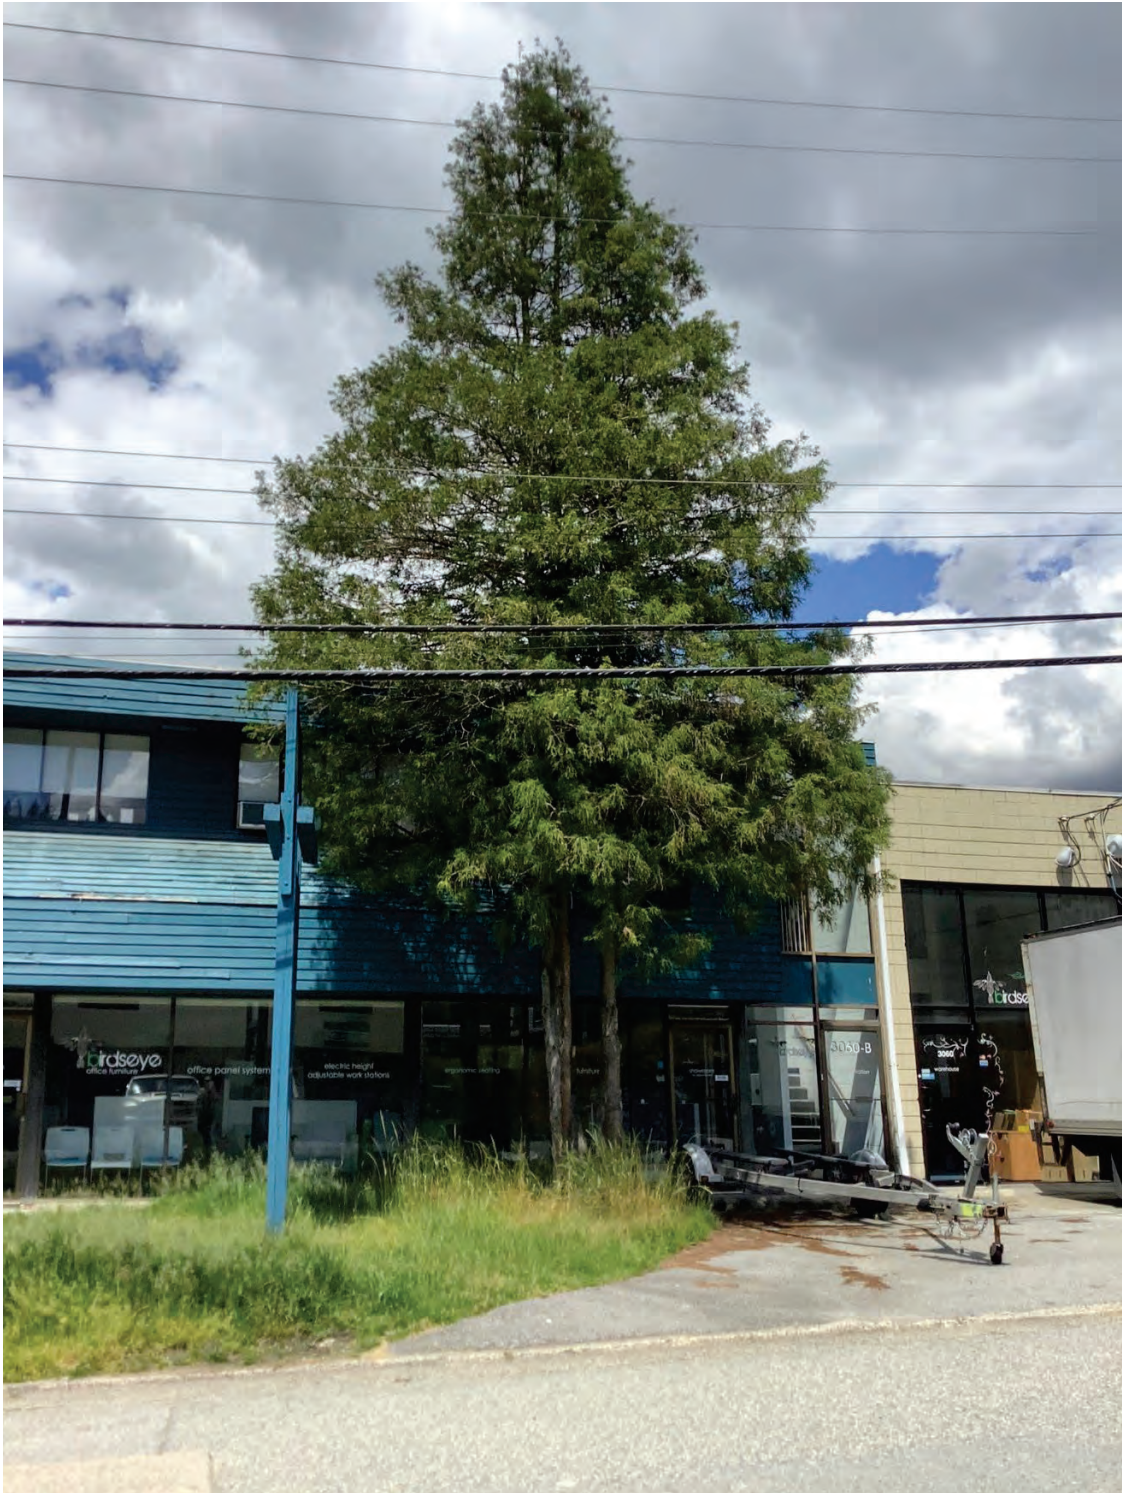
Photo 1. Showing tree # 2953, growing along Spring Street.

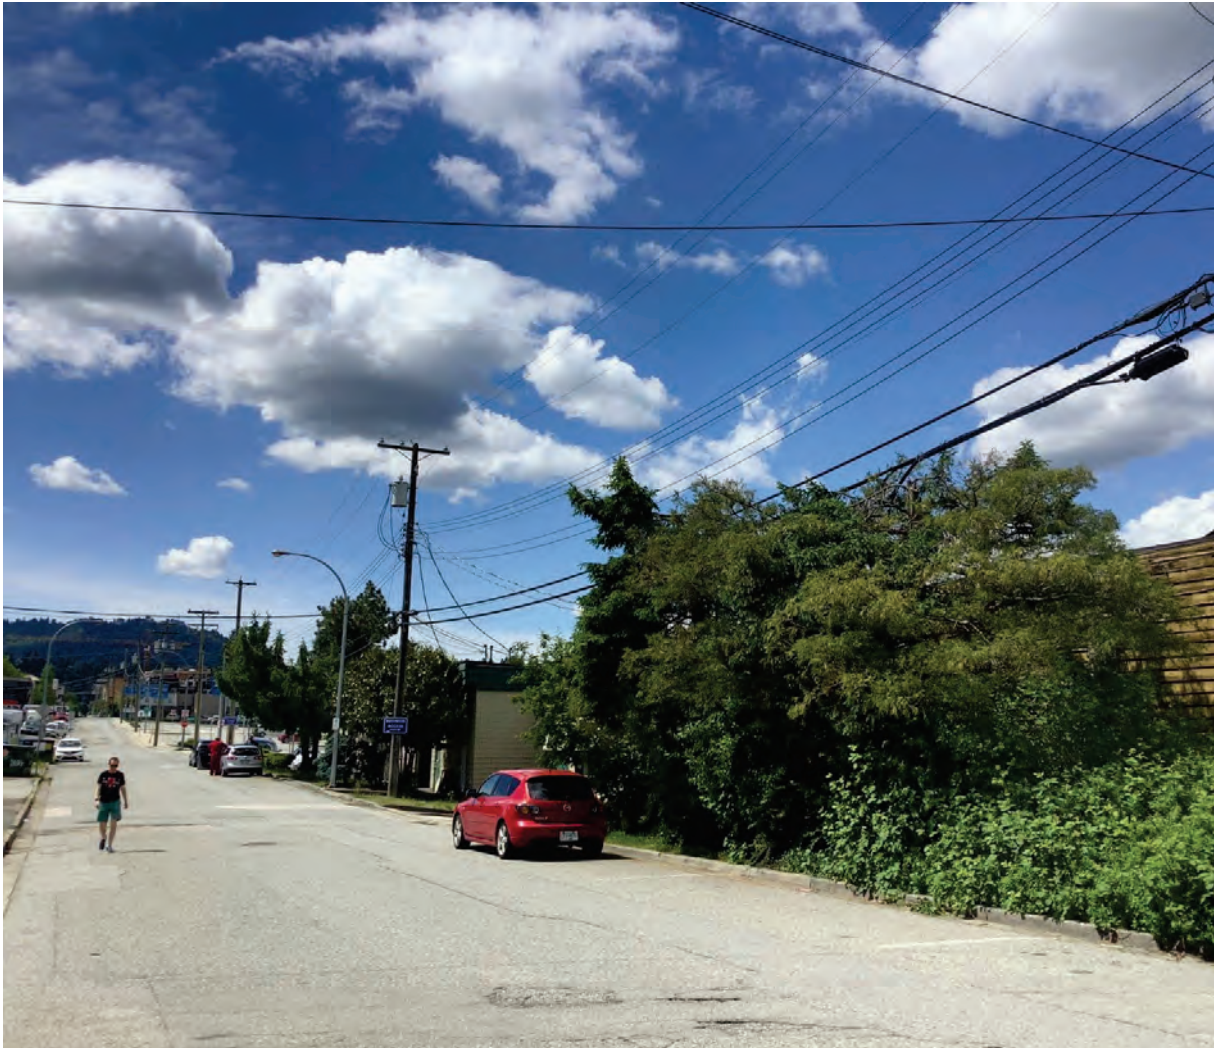
There were seven (7) City owned trees. All City trees are recommended for removal as part of this development proposal (See Appendix 1 for individual tree inventory information).

Photo 2. Showing trees City-15 to 19 and tree #2954, growing along Spring Street.

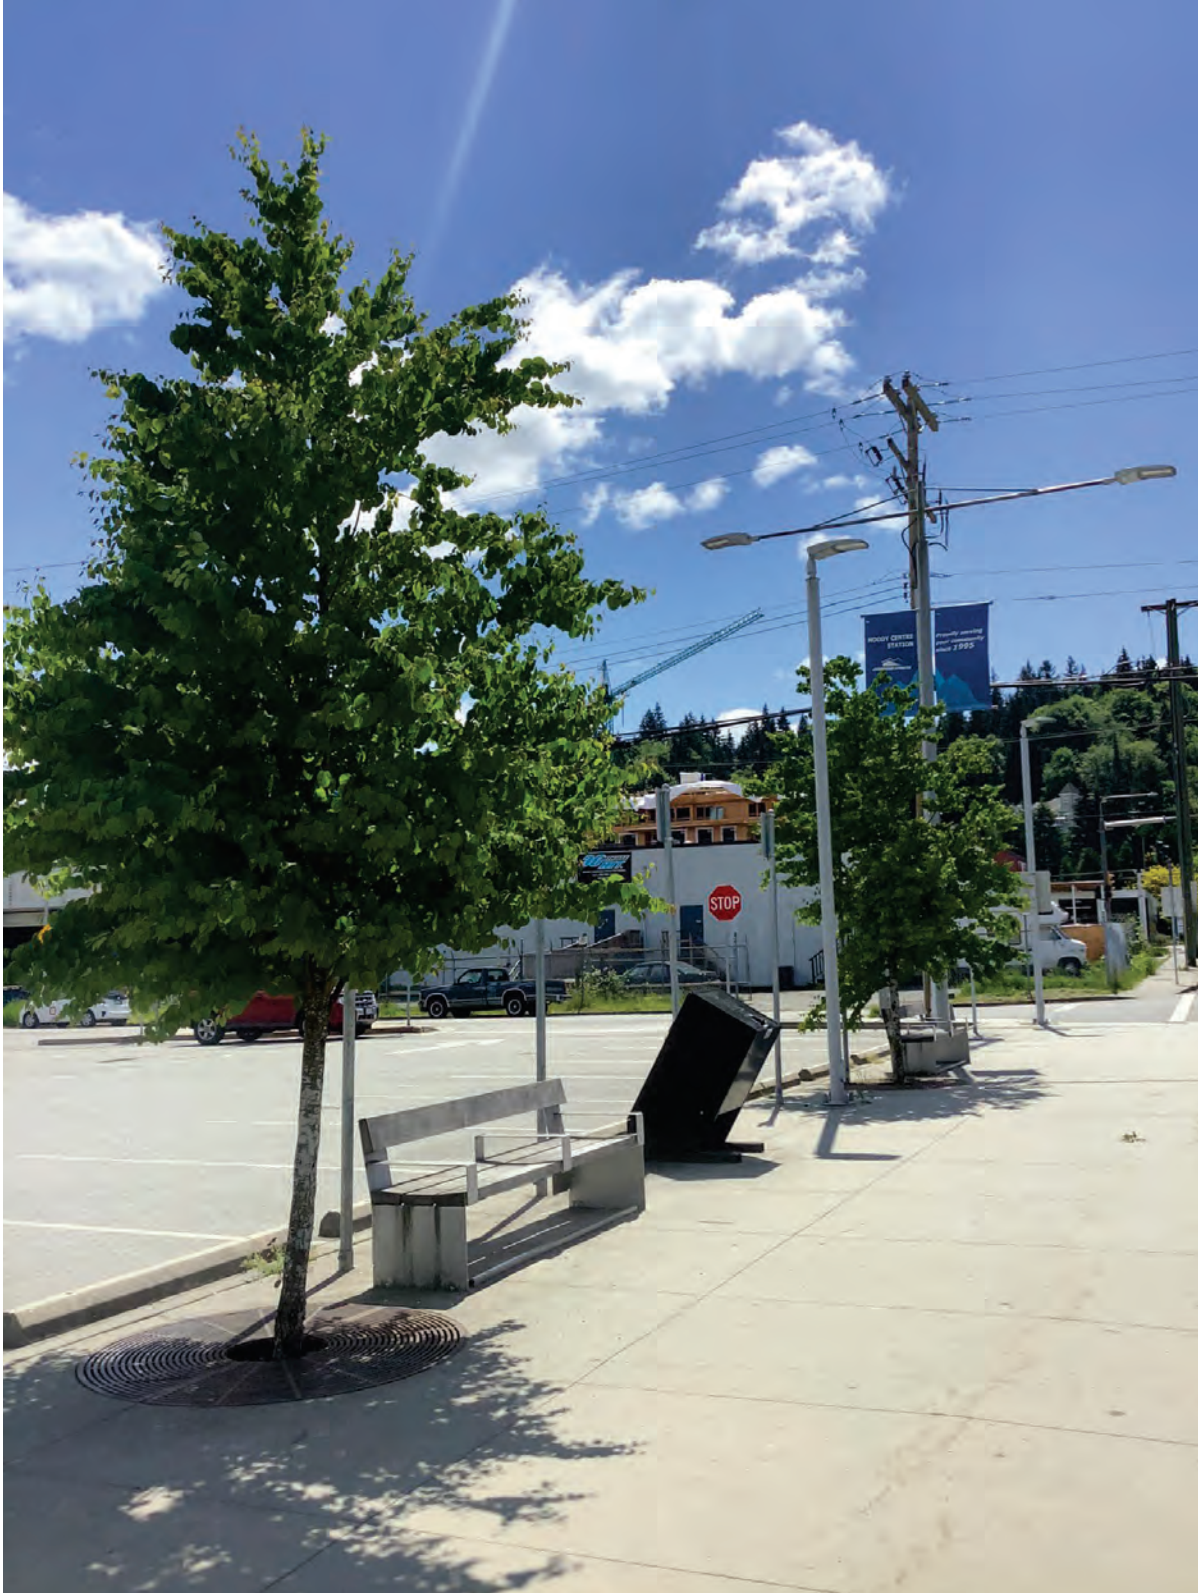
There were four (4) protected trees within the subject site. All on-site trees are recommended for removal as part of this development proposal (See Appendix 1 for individual tree inventory information). Trees 2943, 2944, 2945, and 2946 are suitable for retention if accommodated in the proposed Transit Plaza design.

Photo 3. Showing trees 2944 to 2946, surrounded by concrete.

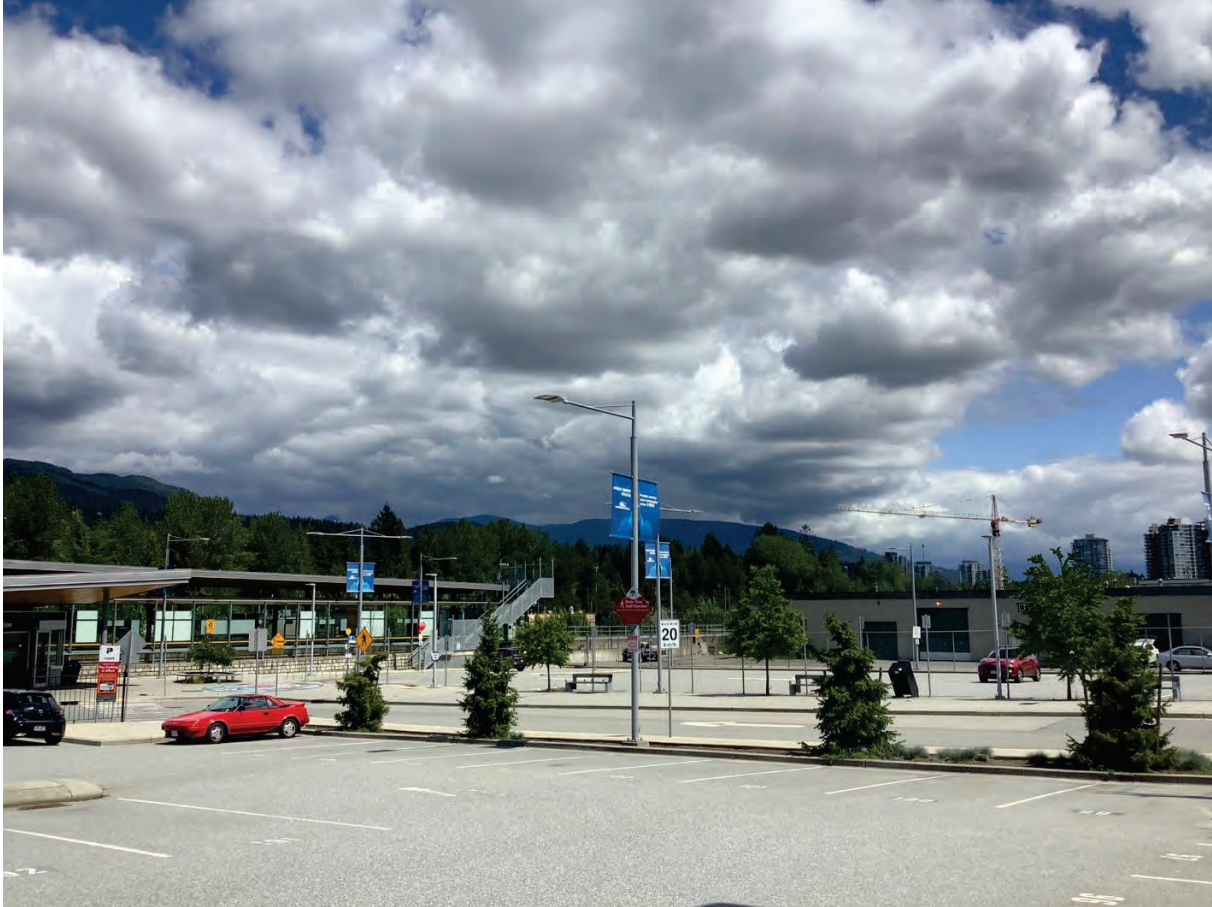
Photo 4. Showing trees 2947 to 2950, surrounded by the parking lot.
