| Project Title: | Mount Royal Drive Walkway | File No.: | 22-0497 |
| Re: | Headwall Tree Impacts | | |

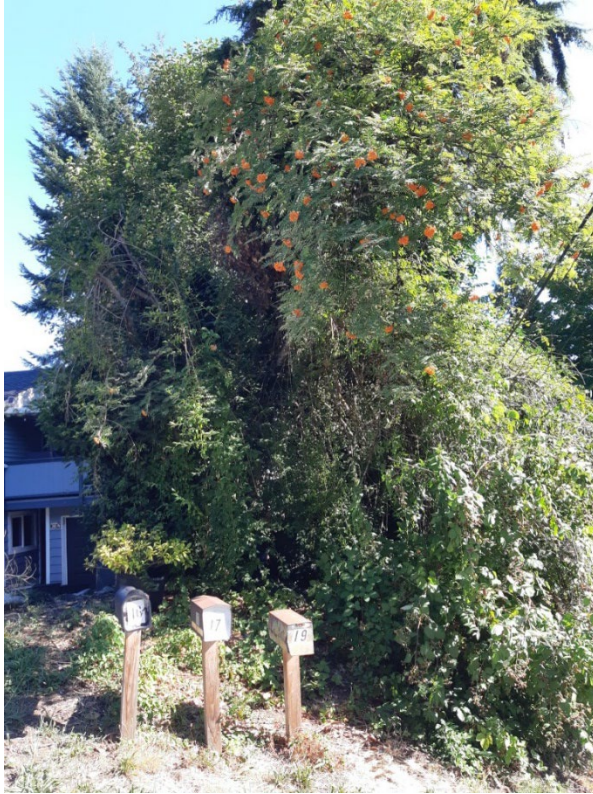
| Tree # | Botanical Name | Common Name | DBH cm | Canopy Radius (m) | Comments | Remove/Retain |
|---|---|---|---|---|--|--|
| 1 | <i>Sorbus sp.</i> | Mountain Ash | Multi-stem | 5 | Fair condition -Covered in ivy | Could be impacted by excavation for the retaining wall. Removal is recommended. |

Photo 1: Tree #1- Mountain Ash

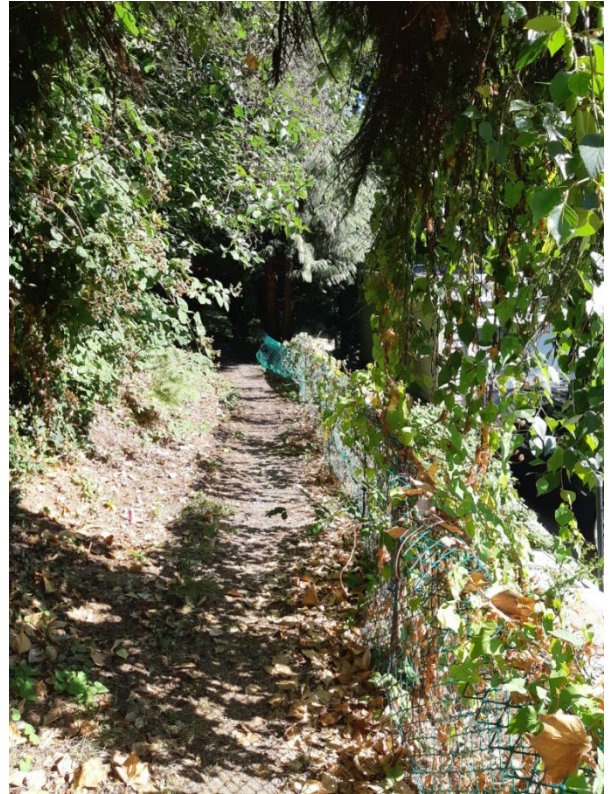
Photo 2: Existing path

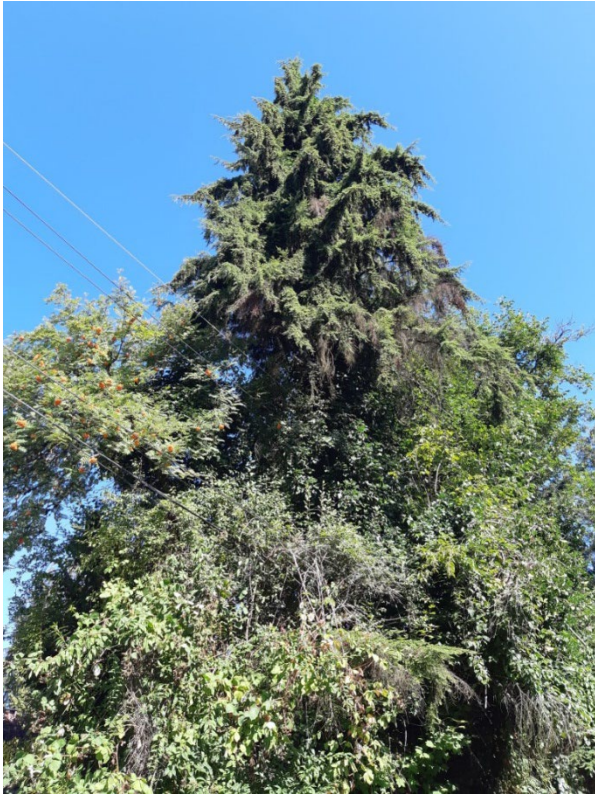
| Tree # | Botanical Name | Common Name | DBH cm | Canopy Radius (m) | Comments | Remove/Retain |
|---|---|---|---|---|--|--|
| 2 | <i>Tsuga heterophylla</i> | Western Hemlock | Approx. 60 | 4 | Moderate condition -Covered in ivy -Live Crown ratio 50% due to base covered in ivy -Base of tree 2 feet above the path grade | -Excavation for retaining wall footing is up against the trunk (1m from the proposed retaining wall). Removal is recommended. |

Photo 3: Tree #2- Hemlock

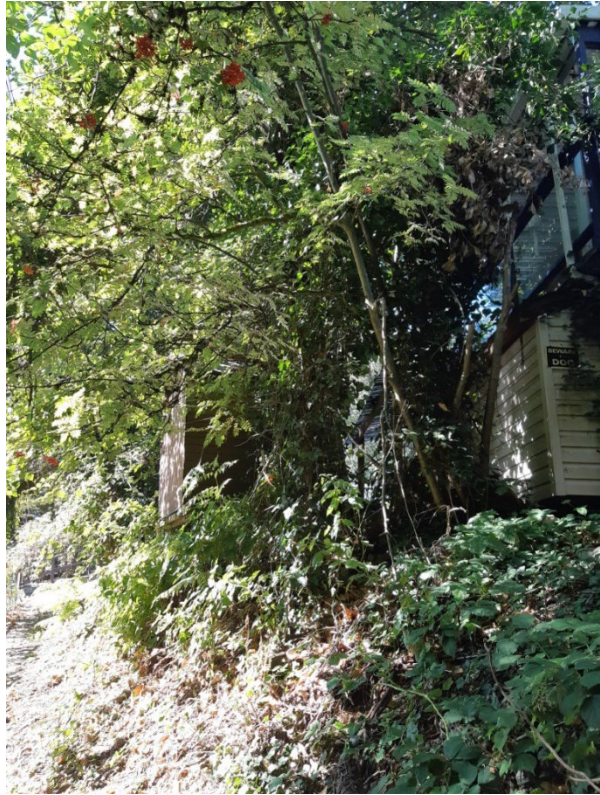
| Tree # | Botanical Name | Common Name | DBH cm | Canopy Radius (m) | Comments | Remove/Retain |
|---|---|---|---|---|--|--|
| 3 | <i>Alnus rubra</i> | Red Alder | Approx. 76 | 5 | Moderate condition -Covered in ivy -Approximately 2m higher than existing path | -Excavation for retaining wall footing is right up to the trunk. Removal is recommended. |

Photo 4: Tree #3- Red Alder
(branches near overhead wires)

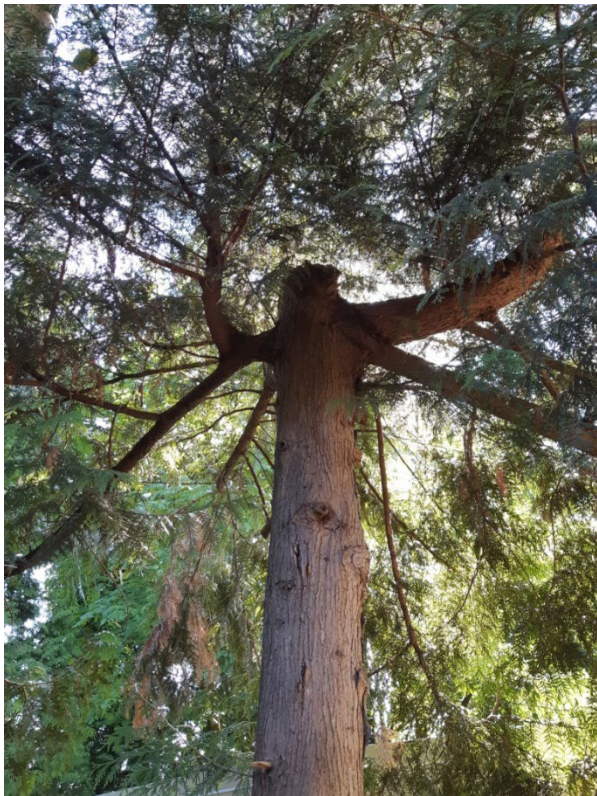
| Tree # | Botanical Name | Common Name | DBH cm | Canopy Radius (m) | Comments | Remove/Retain |
|---|---|---|---|---|--|--|
| 4 | <i>Thuja sp.</i> | Cedar | 25 | 1 | Poor -Previously topped -Overhead wires directly above | Retain with possible removal |

Photo 5: Tree #4- Cedar

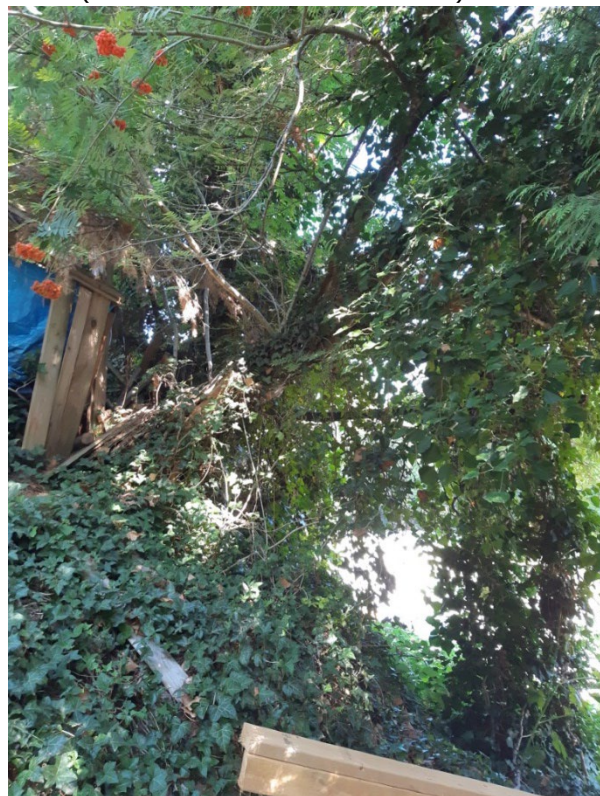
| Tree # | Botanical Name | Common Name | DBH cm | Canopy Radius (m) | Comments | Remove/Retain |
|---|---|---|---|---|--|--|
| 5 | <i>Sorbus sp.</i> | Mountain Ash | Unknown | 4 | Poor -45 degree lean, hazard tree | Remove |

Photo 6: Tree #5- Mountain Ash

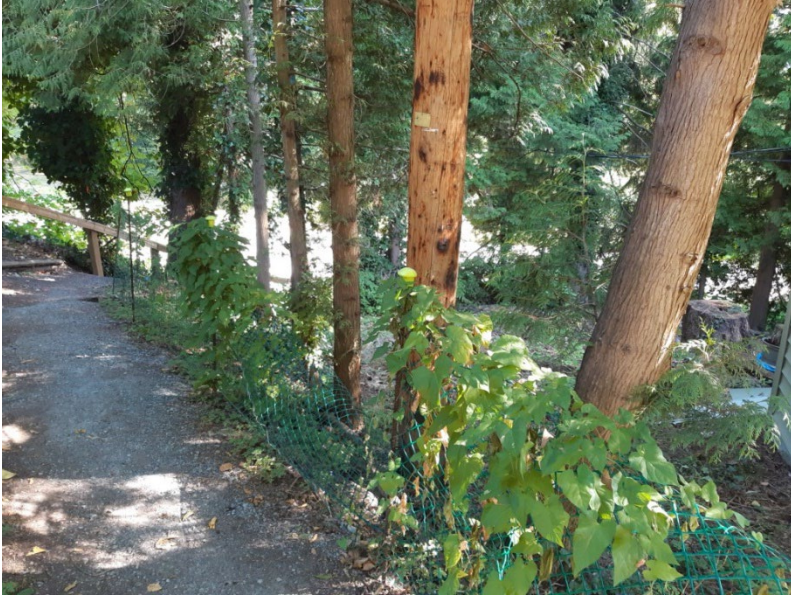
Photo 7: Row of young cedars

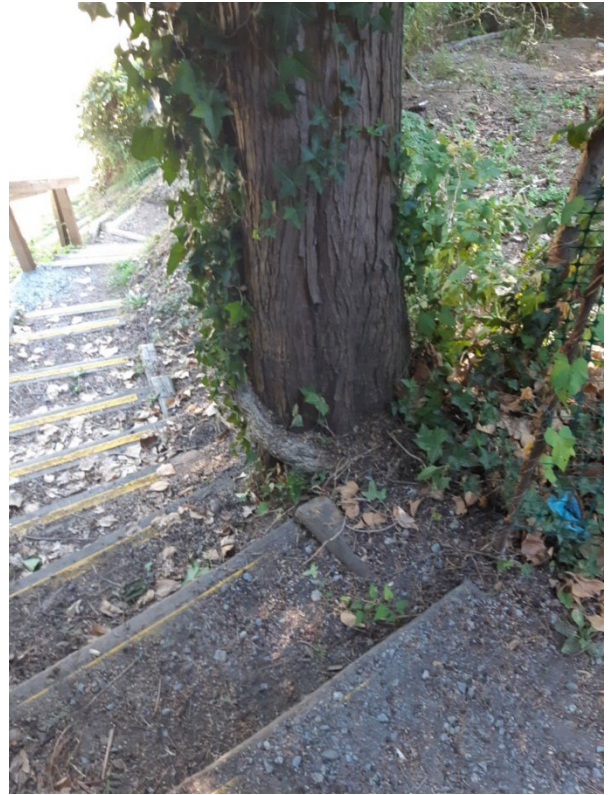
| 6 | <i>Thuja sp.</i> | Cedar | 50 | 4 | Moderate -Covered in ivy -1.6m from proposed path | Retain –do not cut tree roots |

Photo 8: Tree #6 - Cedar
