Froggers Creek Tree Consultants Ltd.

RE: 2804 and 2808 St George Street, Port Moody

Tree Management Report

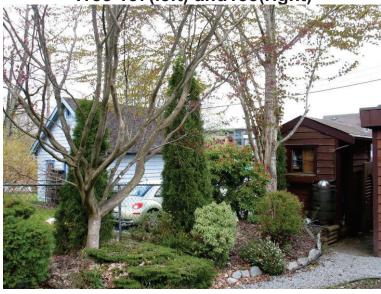
Tree 187(left) and 188(right)

#	Type	Action	Reason	VAL	DBH	MPZ	НТ	CR	Health	Structural Condition
179	Apple	Remove	Inside building	Low	22cm	1.3m	5m	2m	Declining	Tree is topped, decay in trunk
180	Pear	Remove	Inside road	Low	27cm	1.6m	4m	2m	Declining	Tree is topped, decay in trunk
181	Douglas Fir	Remove	Inside path, too close	Mod	21cm	1.3m	5m	2m	Fair	Tree is topped
182	English Holly	Remove	inside patio, too close	Low	26cm	1.6m	5m	2m	Fair	Tree is topped
183	Black Pine	Remove	Inside path	Mod	36cm	2.2m	12m	4m	Fair	Tree is topped, co doms at 15'
184	Flowering Dogwood	Retain		Mod	10/10/6cm	1.5m	4m	3m	Fair	No apparent defects
185	Pyramid Cedar	Remove	Inside building	Low	14/10cm	1.3m	3m	1m	Fair	Topped, 2' from foundation
186	Saucer Magnolia	Remove	Too close	Mod	12/9/9cm	1.8m	5m	3m	Fair	No apparent defects
187	Japanese Maple	Retain		Mod	13/12/12cm	2.0m	6m	4m	Fair	No apparent defects
			Too close to amenity							
188	Katsura	Remove	space	Mod	35cm	2.1m	10m	4m	Fair	Grade high at base of tree
