# IOCO TOWNSITE

HERITAGE CONSERVATION AREA  
PORT MOODY, B.C.

## PRESERVATION AND PREVENTATIVE MAINTENANCE PLAN

NOVEMBER 2015

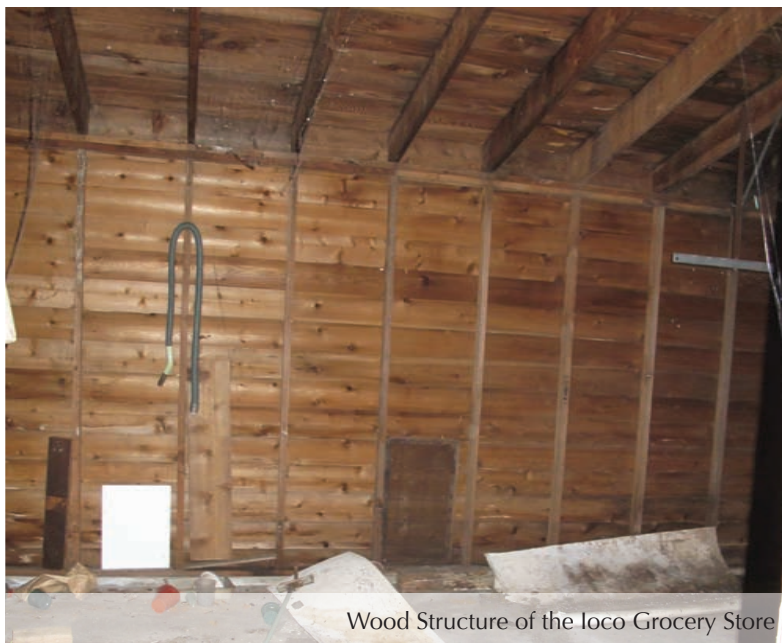
Wood Structure of the Ioco Grocery Store

The Ioco Grocery Store is built in traditional wood-frame construction with dimensional lumber. Wood-frame construction is one of the most affordable housing construction methods that utilized old growth lumber in the past. The framing type could not be determined during the site visit. The structural report by Siefken Engineering from June 2012 indicates that several of the structural members have deteriorated, and some members have suffered fire damage.

- The structure should be inspected by a qualified structural engineer, and reinforced as required to ensure that the building can survive until further work is undertaken.
- Structural stabilization should take place from the interior, so that the historic exterior appearance is not disturbed.
- Where possible, the historic structural members should be preserved. New structural members should not impact the historic exterior appearance of the building.

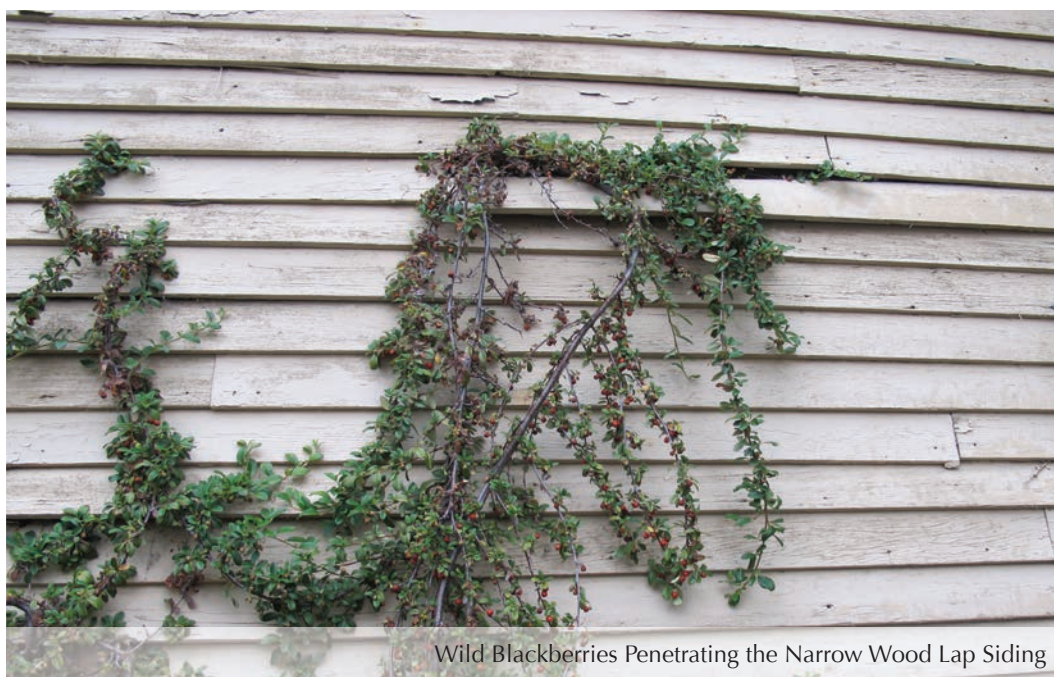
Wild Blackberries Penetrating the Narrow Wood Lap Siding

- The exterior wood cladding should be regularly monitored once the vegetation has been removed from the site, to ensure that no new vegetation is damaging the historic materials.
- All holes or openings in the cladding should be covered so that water and/or rodents cannot enter.
- Narrow wood lap siding that has been lifted from the surface of the building due to plant infiltration should be re-affixed.
- If further repairs to the exterior wood cladding are undertaken at this time, the repairs should be done in-kind using wood. Combed and/or textured lumber, as well as vinyl or fibre cementitious cladding are not acceptable materials for use on the historic building.

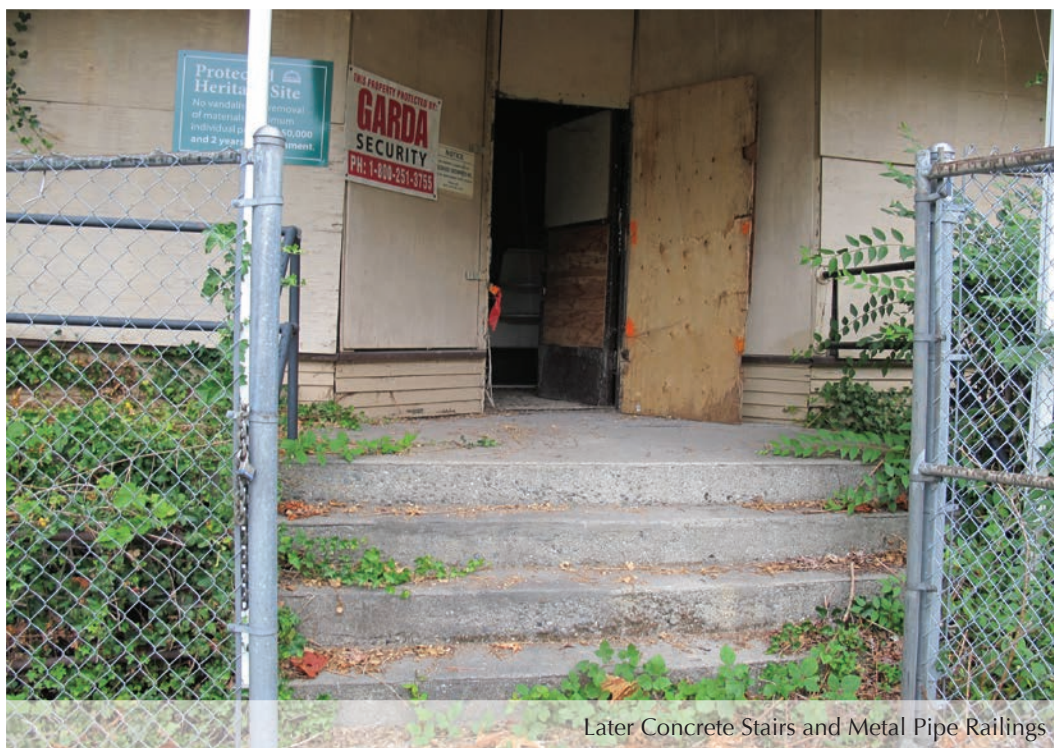
Later Concrete Stairs and Metal Pipe Railings

The loco Grocery Store is accessed by a set of later concrete stairs with metal pipe railings. Concrete is a durable material, and these stairs have survived in better condition than many of the exterior wood stairs on other buildings within the loco Townsite.

- Ensure that the later concrete stairs with metal pipe railings are maintained, clear of plants and garbage, and that the handrails are securely fastened.

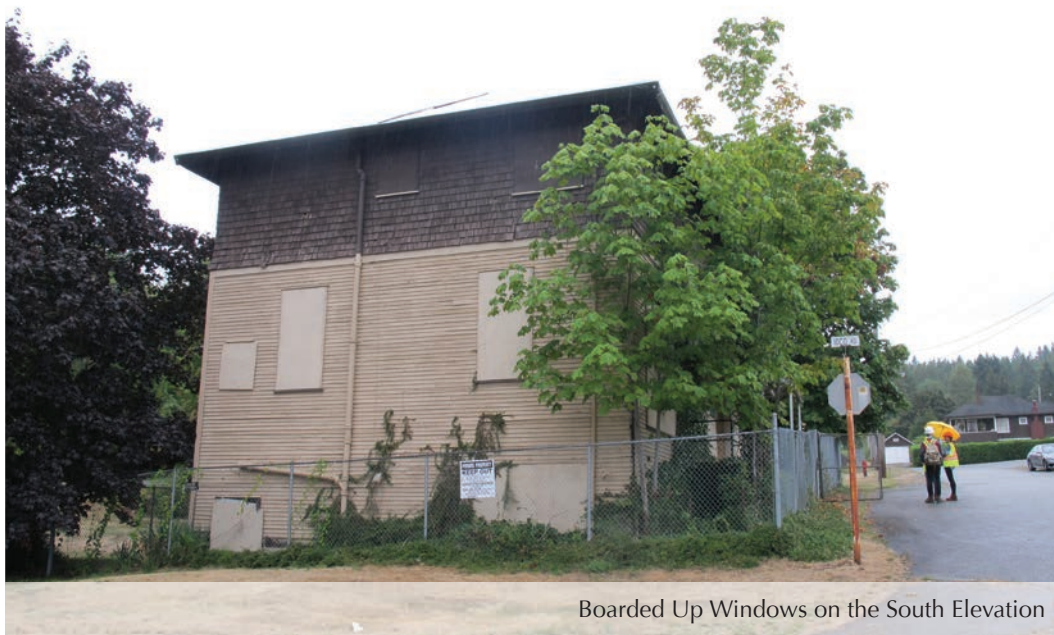
Boarded Up Windows on the South Elevation

The window and door openings on the historic building have been covered in plywood sheets to protect the glazing from damage and to discourage break-ins. The plywood sheets have been painted to match the surrounding cladding, which can indicate to passers-by that the building is valued. Several of the panels were reviewed and found to be fixed using screws, which is the preferred system. The use of nails or staples should be avoided, as these systems require the boards to be pried off, which can cause damage to the materials that the plywood is attached to. The window function and condition were not reviewed during the site visit.

- Vented louvres should be placed in window openings to assist with the ventilation of the building. Secure vented louvres should be placed into the plywood covering the windows, and should not allow for rodents or water to enter the opening. The amount of vented louvreing is typically five to ten percent of the area of each floor in the building, but may be greater in damp climates. Louvres should be placed to encourage cross-ventilation. In situations where double or single-hung windows exist, one of the sashes can be left open and the vented louvre aligned with the opening. In situations where fixed, casement, awning or hopper windows exist, the sash should be carefully removed, labelled, and stored safely in the building, and the plywood panel with vented louvres placed over the opening.

- Exterior doors should be closed, locked, and covered with plywood panels, and the keys stored in a secure but accessible place.

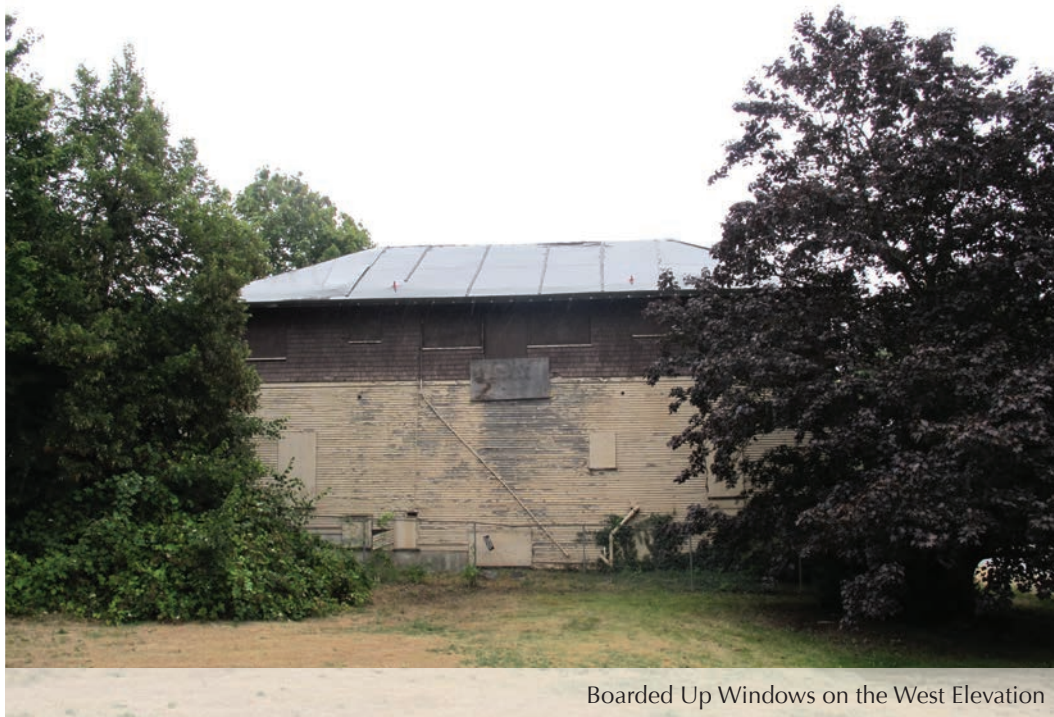
Boarded Up Windows on the West Elevation

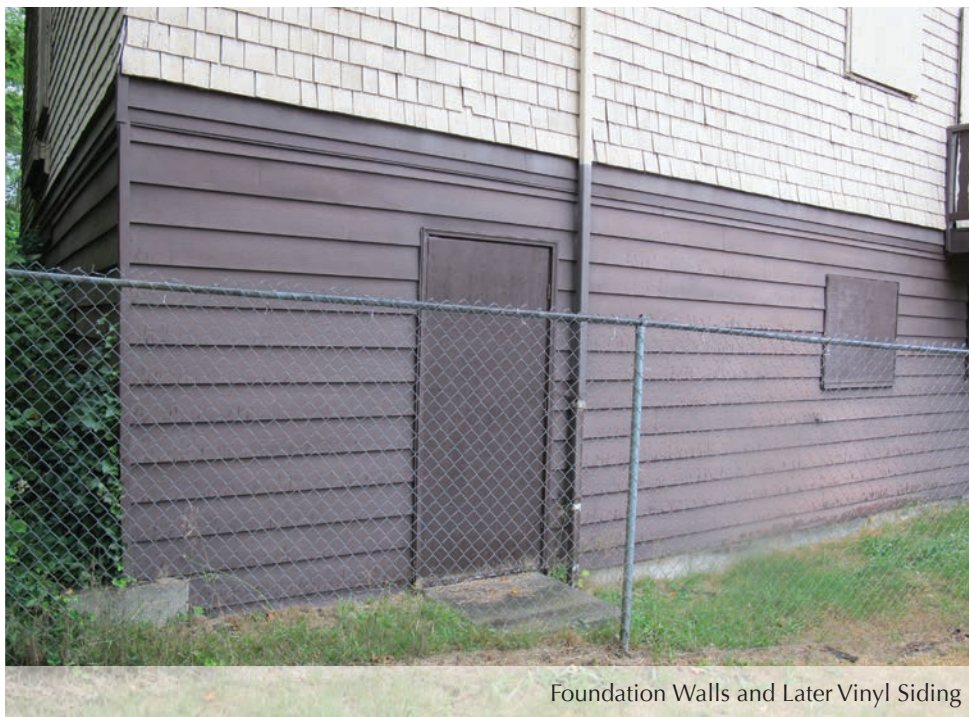
Foundation Walls and Later Vinyl Siding

The existing foundation was not reviewed during the site visit, but consists of poured-in-place concrete foundation walls and slab. Parts of the foundation are covered with overgrown vegetation on the exterior.

- The foundations should be inspected by a qualified structural engineer to ensure that they can hold the building up until further work is undertaken. If the foundations require upgrading, the work should not impact the historic exterior appearance of the building, if possible.
- Areas of heavy organic buildup on the foundation walls should be cleaned once the grounds have been cleared of excess vegetation. Cleaning should be undertaken using the gentlest means possible, which involves a soft, natural bristle brush, without water. For more intensive cleaning, mild detergent and warm water wash may be required. Power washing is not permitted.

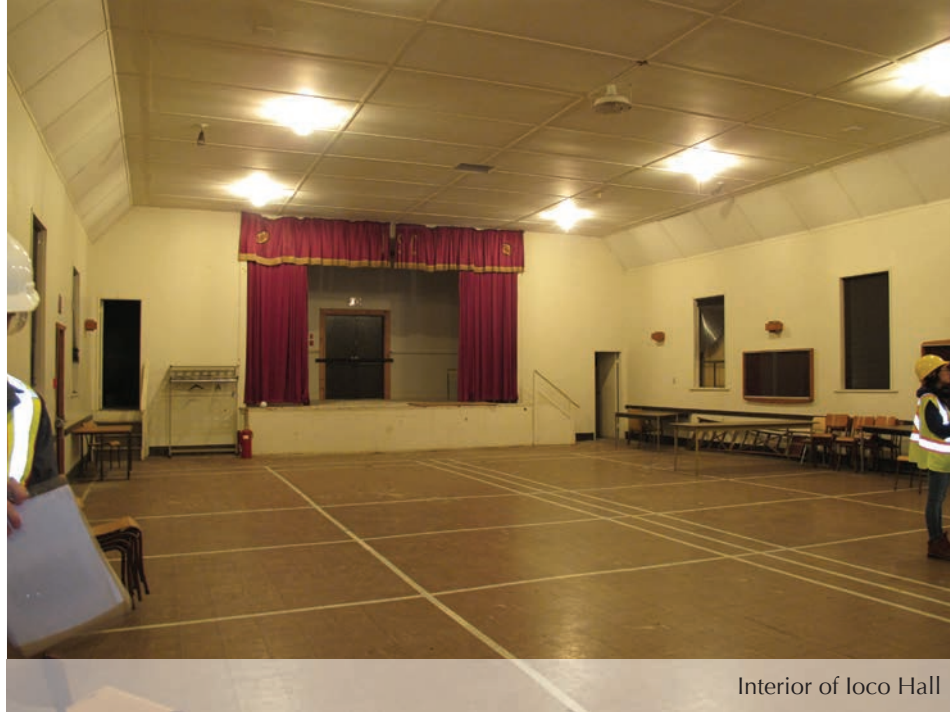
Interior of loco Hall

The main interior hall has minor signs of water damage, and is broom-clean. The other areas of the interior were not reviewed and require further investigation

- Minimal heating should occur during cold weather to ensure that the interior can dry out. A mechanical engineer should advise on the required temperature. Mothballed buildings are typically heated to seven degrees celsius during the winter.

- The interior moisture levels and temperature should remain as stable as possible. Frequent fluctuations in moisture and temperature cause some of the most damaging effects to historic materials.

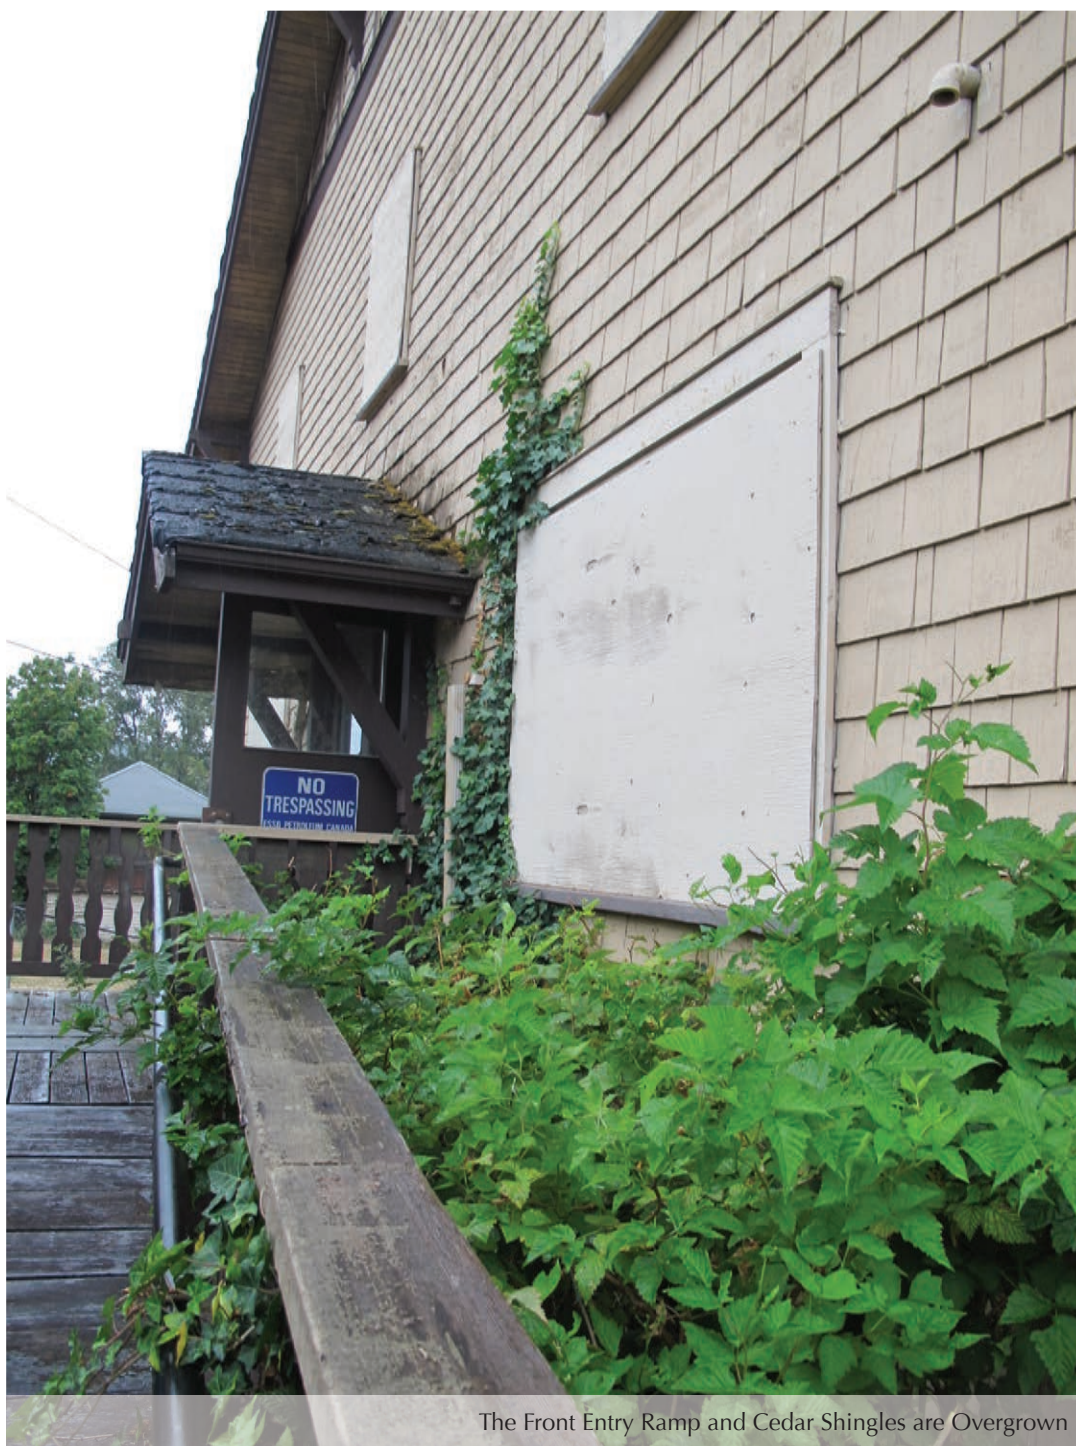
The Front Entry Ramp and Cedar Shingles are Overgrown

- Ensure that the later wood stairs and ramp with decorative wood balustrades and metal pipe railings are maintained, clear of plants and garbage, and that the handrails are securely fastened.

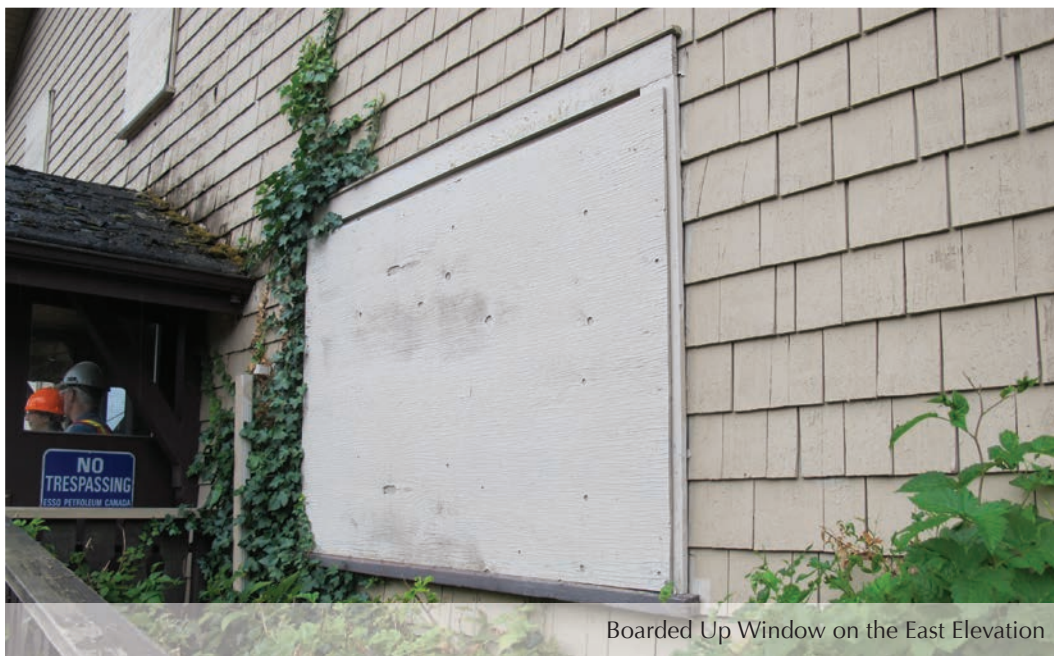
Boarded Up Window on the East Elevation

- Vented louvres should be placed in window openings to assist with the ventilation of the building. Secure vented louvres should be placed into the plywood covering the windows, and should not allow for rodents or water to enter the opening. The amount of vented louvreing is typically five to ten percent of the area of each floor in the building, but may be greater in damp climates. Louvres should be placed to encourage cross-ventilation. In situations where double or single-hung windows exist, one of the sashes can be left open and the vented louvre aligned with the opening. In situations where fixed, casement, awning or hopper windows exist, the sash should be carefully removed, labelled, and stored safely in the building, and the plywood panel with vented louvres placed over the opening.

- Exterior doors should be closed, locked, and covered with plywood panels, and the keys stored in a secure but accessible place.

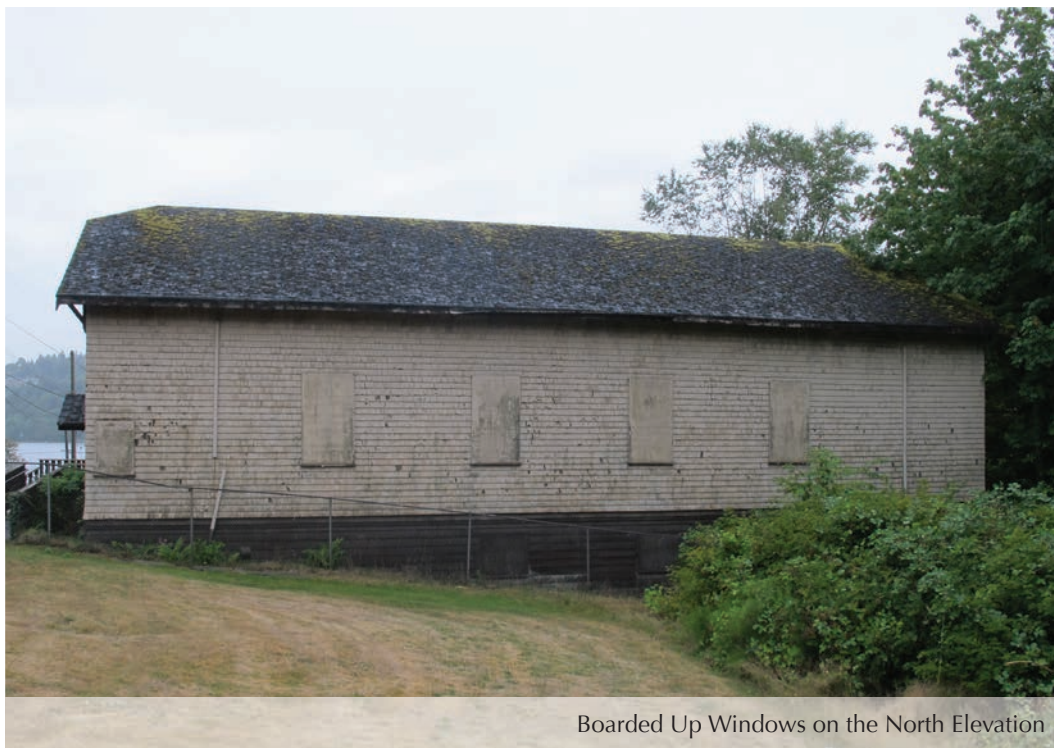
Boarded Up Windows on the North Elevation

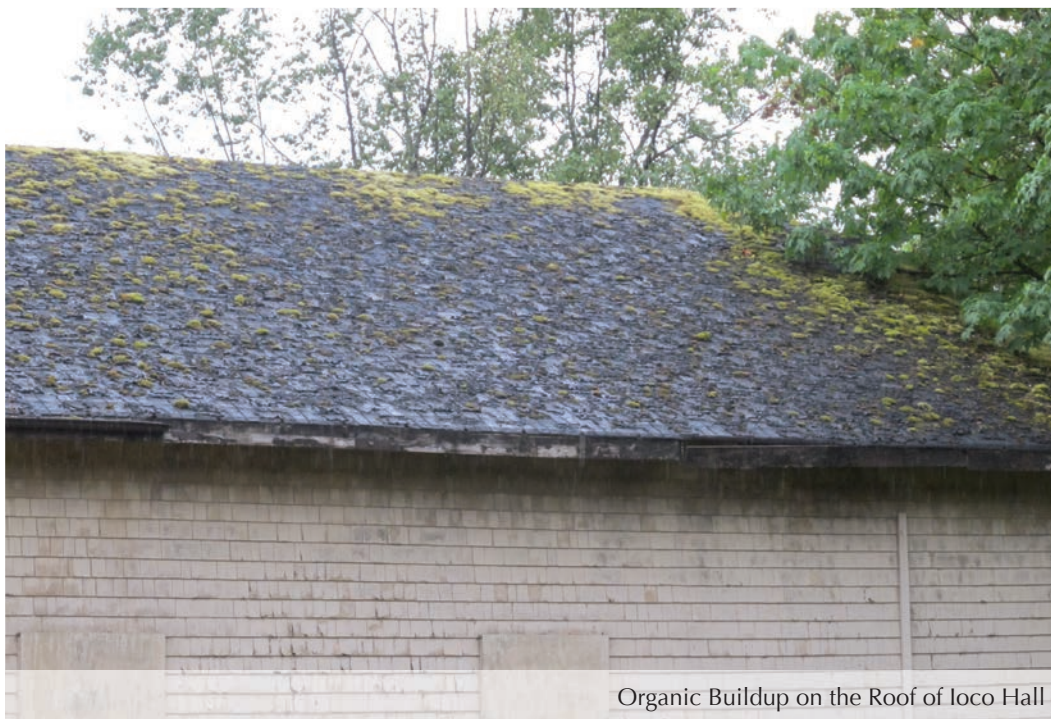
Organic Buildup on the Roof of Ioco Hall

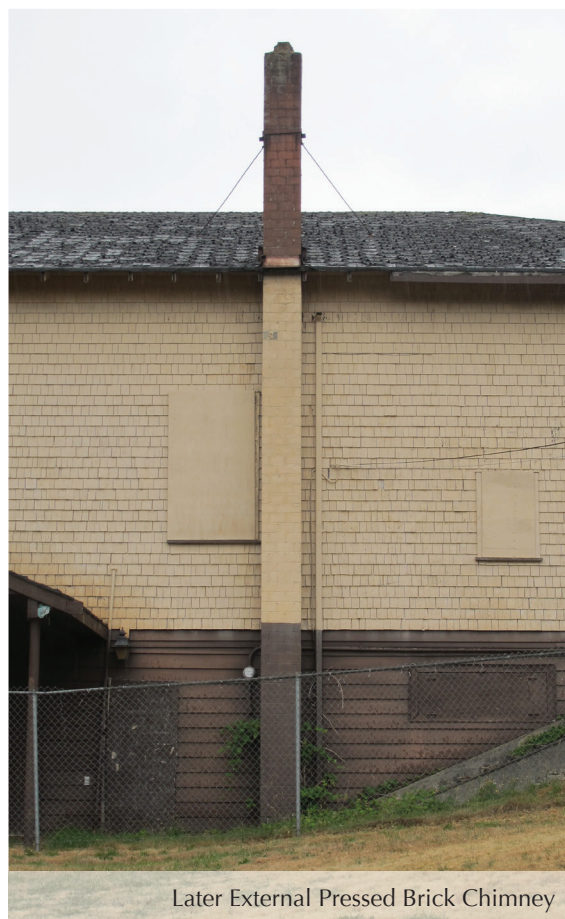
Later External Pressed Brick Chimney

- The chimney should be preserved in situ, if possible. Review and replace the restraints as needed.
- If removed, the bricks from the chimney should be salvaged, labelled and carefully stored within loco Hall, along with documentation (e.g. photographs in a plastic sleeve) depicting the exterior portions of the chimney prior to disassembly.

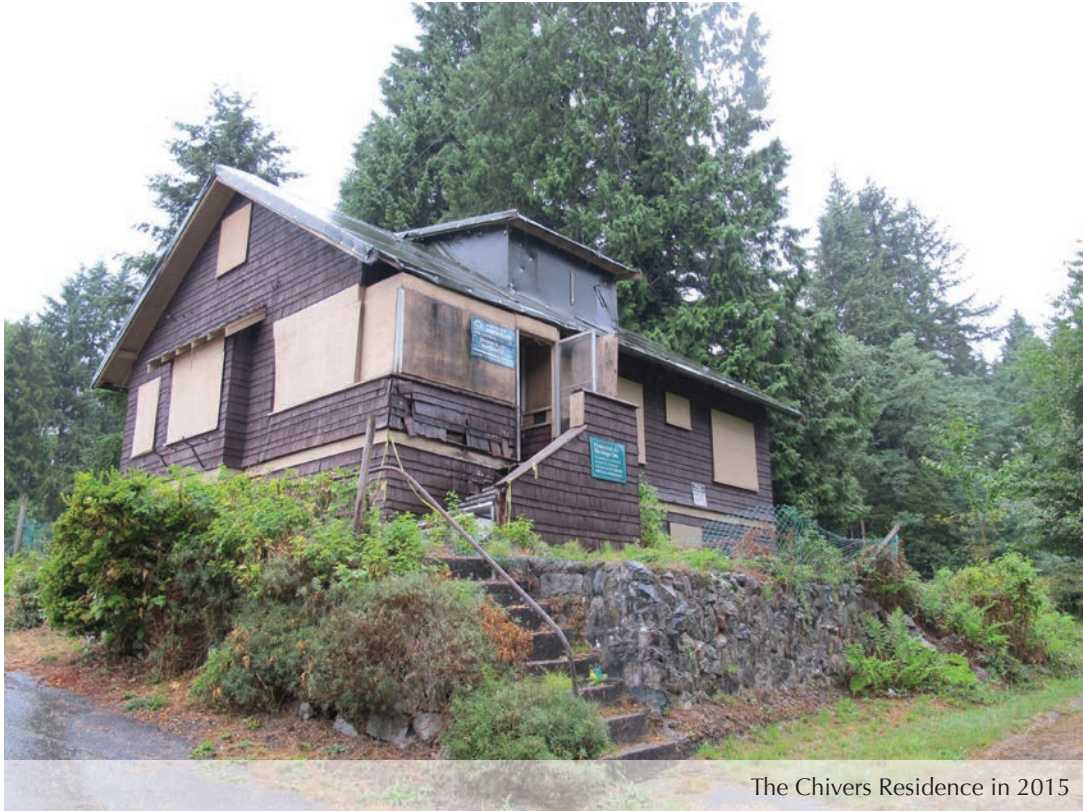
## CHIVERS RESIDENCE 306 FIRST AVENUE

The Chivers Residence in 2015

- The stone retaining wall should be inspected for loose or failing stones. The overgrown plantings should be removed from the wall to ensure that they are not growing into the mortar joints between the stones. If mortar joints have been damaged by plants, they should be repaired using mortar with the same colour, consistency, strength, and profile of the original.
- Both sets of concrete steps should be clear of garbage and vegetation.
- Ensure that the metal pipe railing is secure.
- Areas where the garage/carport used to attach to should be covered, but not patched with shingles.

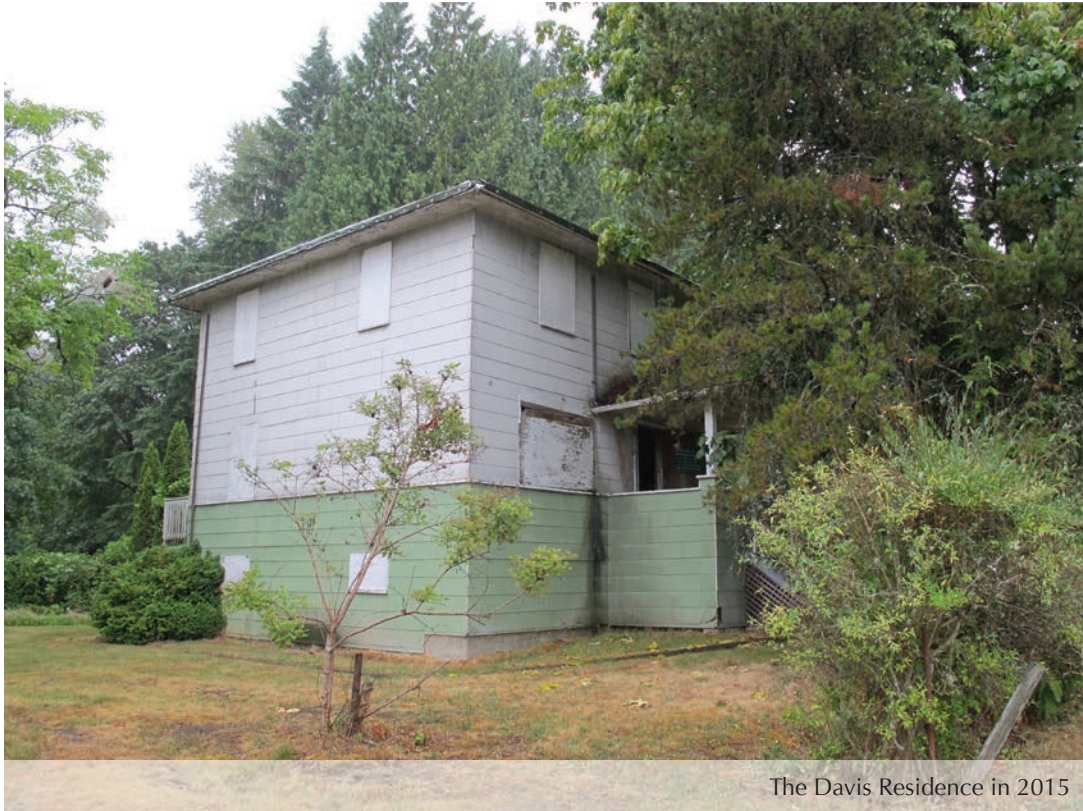
## DAVIS RESIDENCE 306 SECOND AVENUE

The Davis Residence in 2015

- Extra precaution should be taken when undertaking any work, including cleaning, on or around this house due to the possible presence of asbestos cement siding. Activities such as drilling into the siding, or breaking pieces of siding can release asbestos into the air. It is recommended at this stage to have testing done to determine if asbestos is present. All work on or around this house should conform with any relevant WorkSafe BC and Occupational Health and Safety regulations.

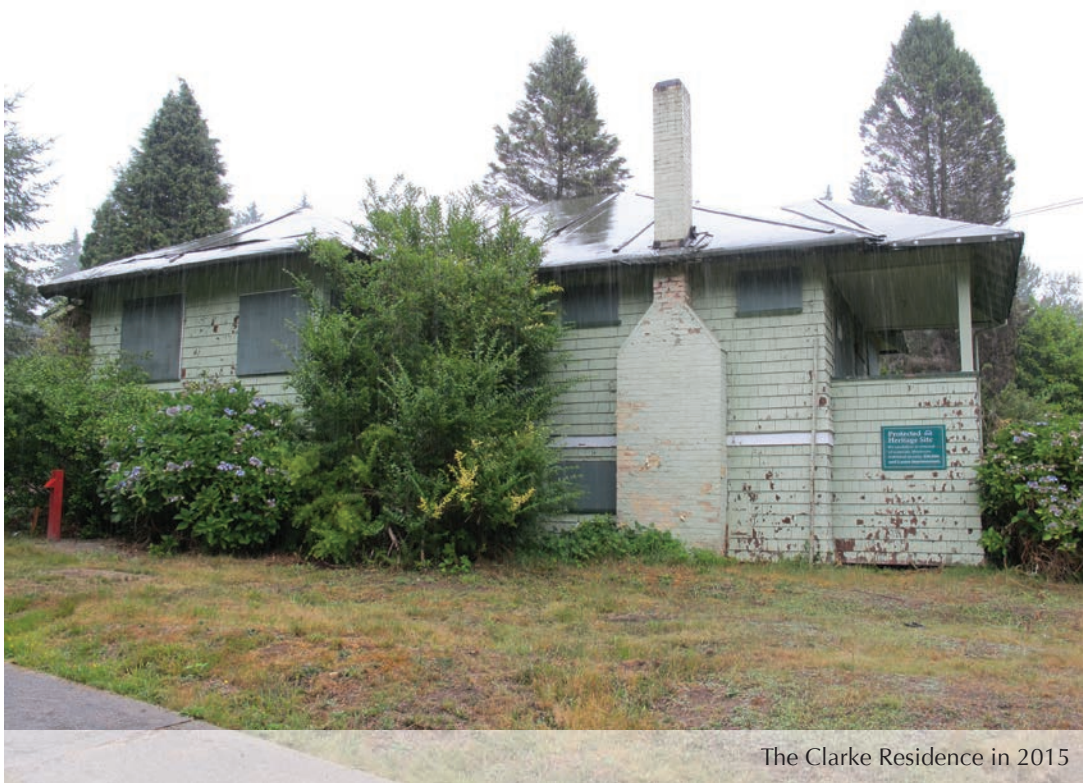
## CLARKE RESIDENCE 207 SECOND STREET

The Clarke Residence in 2015

- Organic buildup should be removed prior to installing the new temporary roof.
- The English-inspired plantings should be maintained rather than removed. Plants should not touch the historic house, and should not become overgrown.

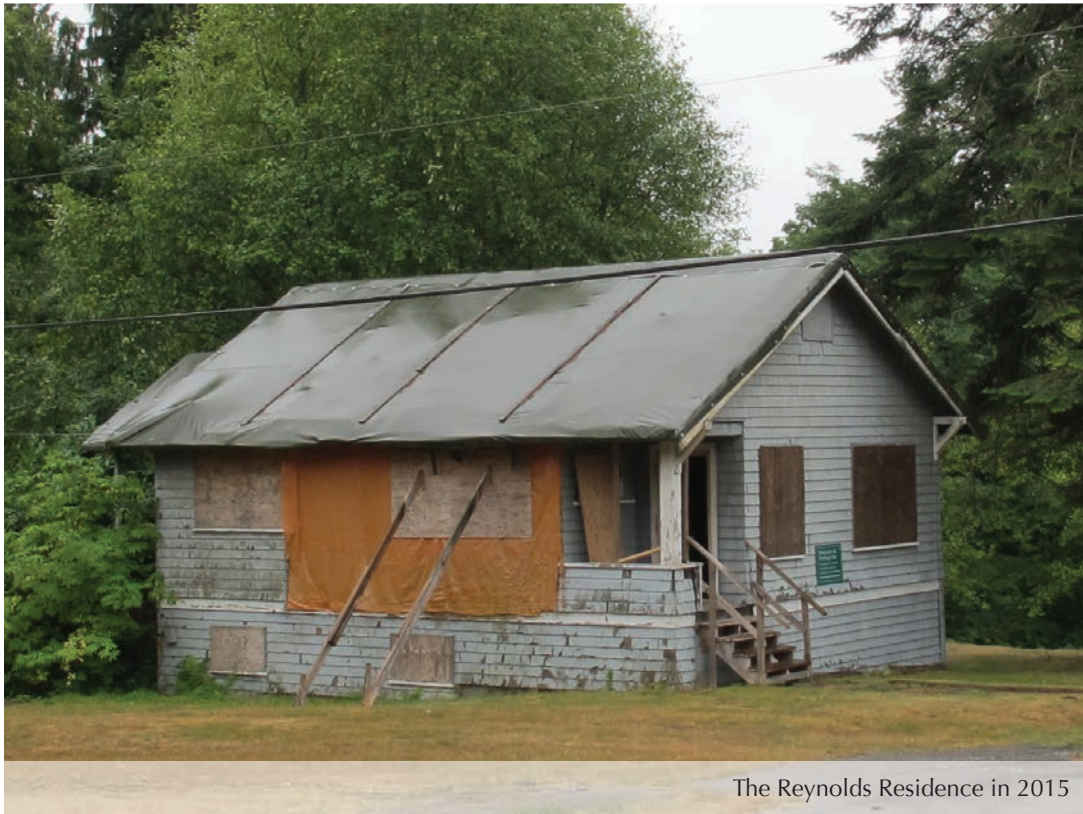
## REYNOLDS RESIDENCE 207 THIRD AVENUE

The Reynolds Residence in 2015

- Any gaps or holes in the tarping on the north wall should be covered so that moisture and/or rodents cannot enter.
- The shoring should be periodically inspected to ensure that it is secure and performing properly.
