MEMORANDUM

Date: May 22, 2020

File: 28256

**SLOPE STABILITY ASSESSMENT NEAR WASHINGTON DRIVE
AND PRINCETON AVENUE
PORT MOODY, BC
DRAFT**

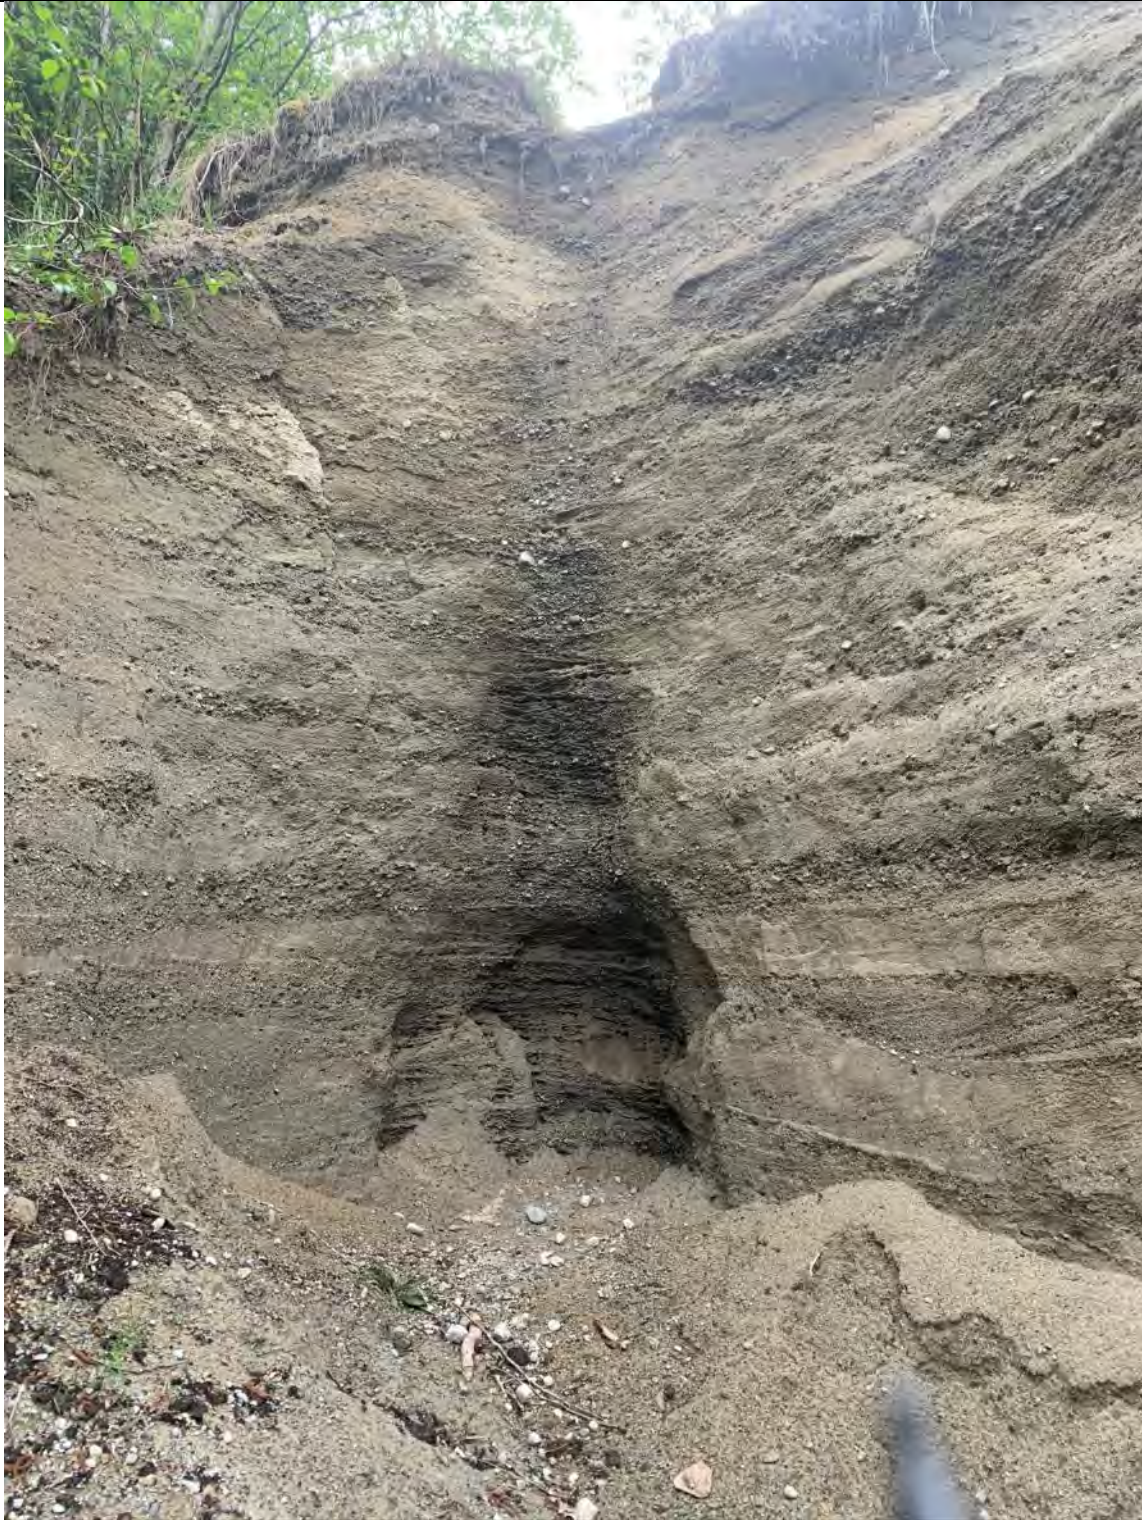
A gravel path bounds the Site to the east (above) and west (below) as shown on Sketch 1. The Site is sparsely vegetated. The Site comprises beds of dense to very dense gray sand with a trace to some gravel and cobbles that are typically between 100 mm and 400 mm thick (Photos 1 to 3). The Site's predominate feature is a section of the slope that has eroded, resulting in an exposed, near vertical soil face that is between 4 m and 5 m high and about 4 m wide (Photo 2). The slopes to the north and south of this eroded section are sloped at 30° to 35° and show only minor signs of erosion and undercutting of the topsoil. Groundwater seepage was not observed.

Photo 1: Looking east from the base of the eroded slope.

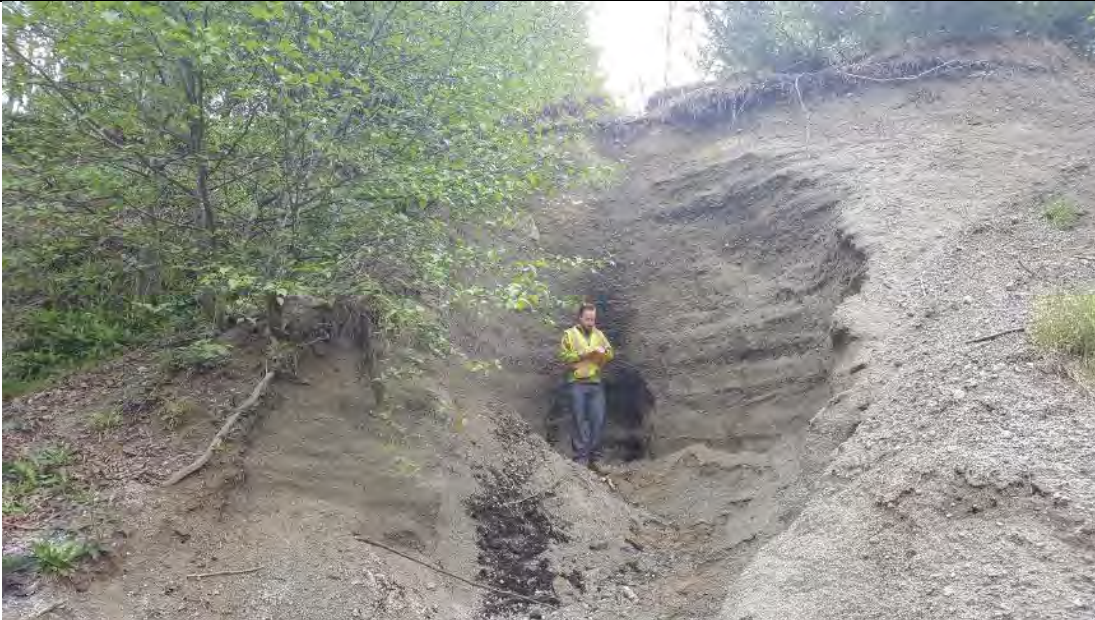
Photo 2: Looking at eroded slope with person for scale.

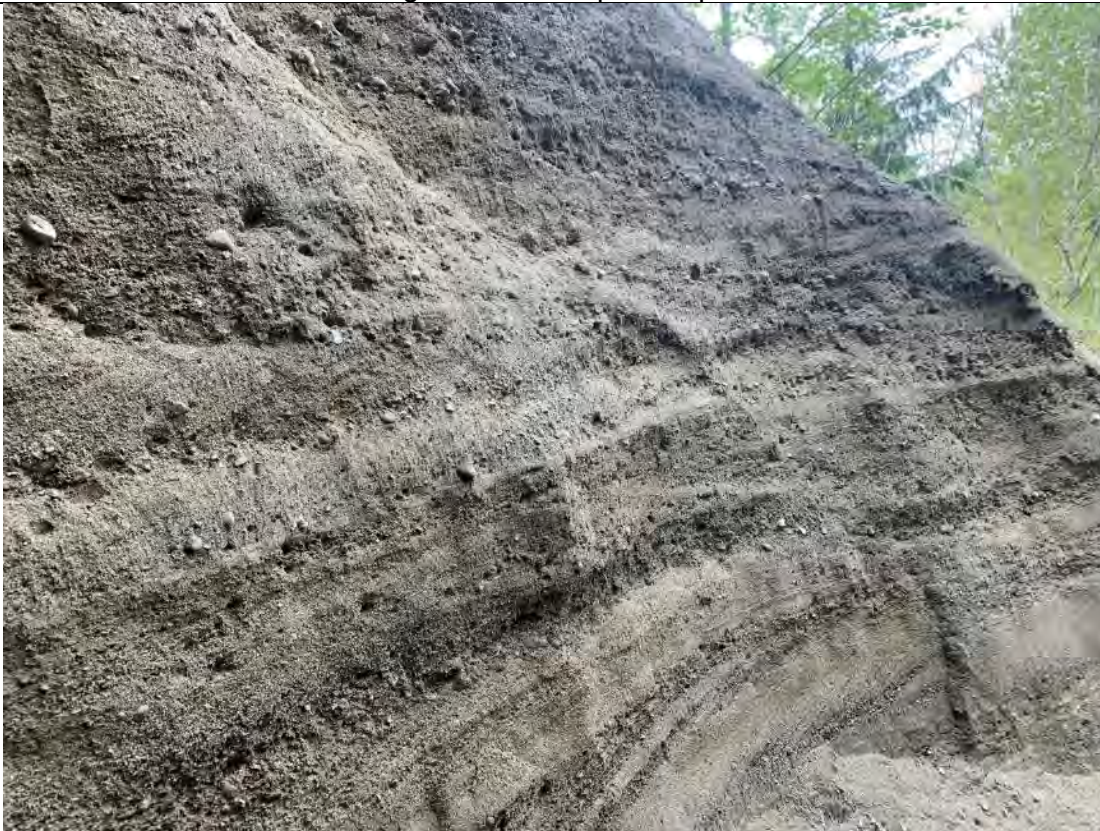
Photo 3: Bedding and crossbeds of sand.

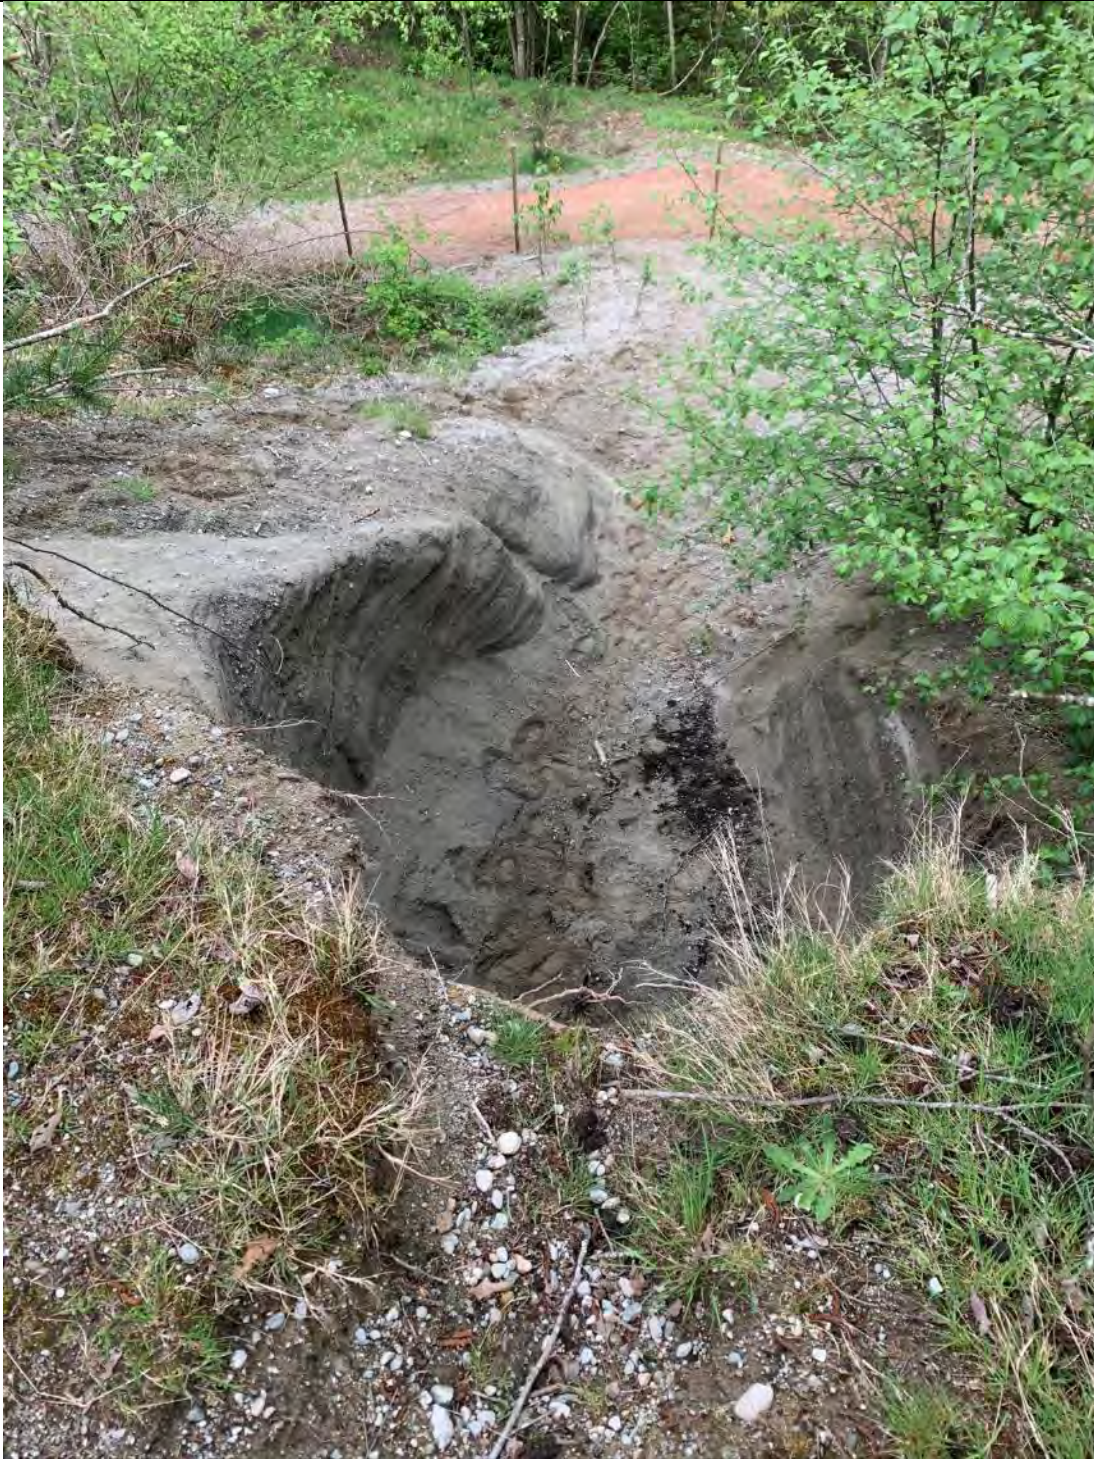
The primary erosion is occurring directly beneath a local low point in the path above the Site. There is evidence that water has flowed from the path, which is consistent with observations made from the City. The eroded sand has outwashed to the west of the erosion above the lower path (Photo 4).

Photo 4: Looking down from the top of the eroded slope.

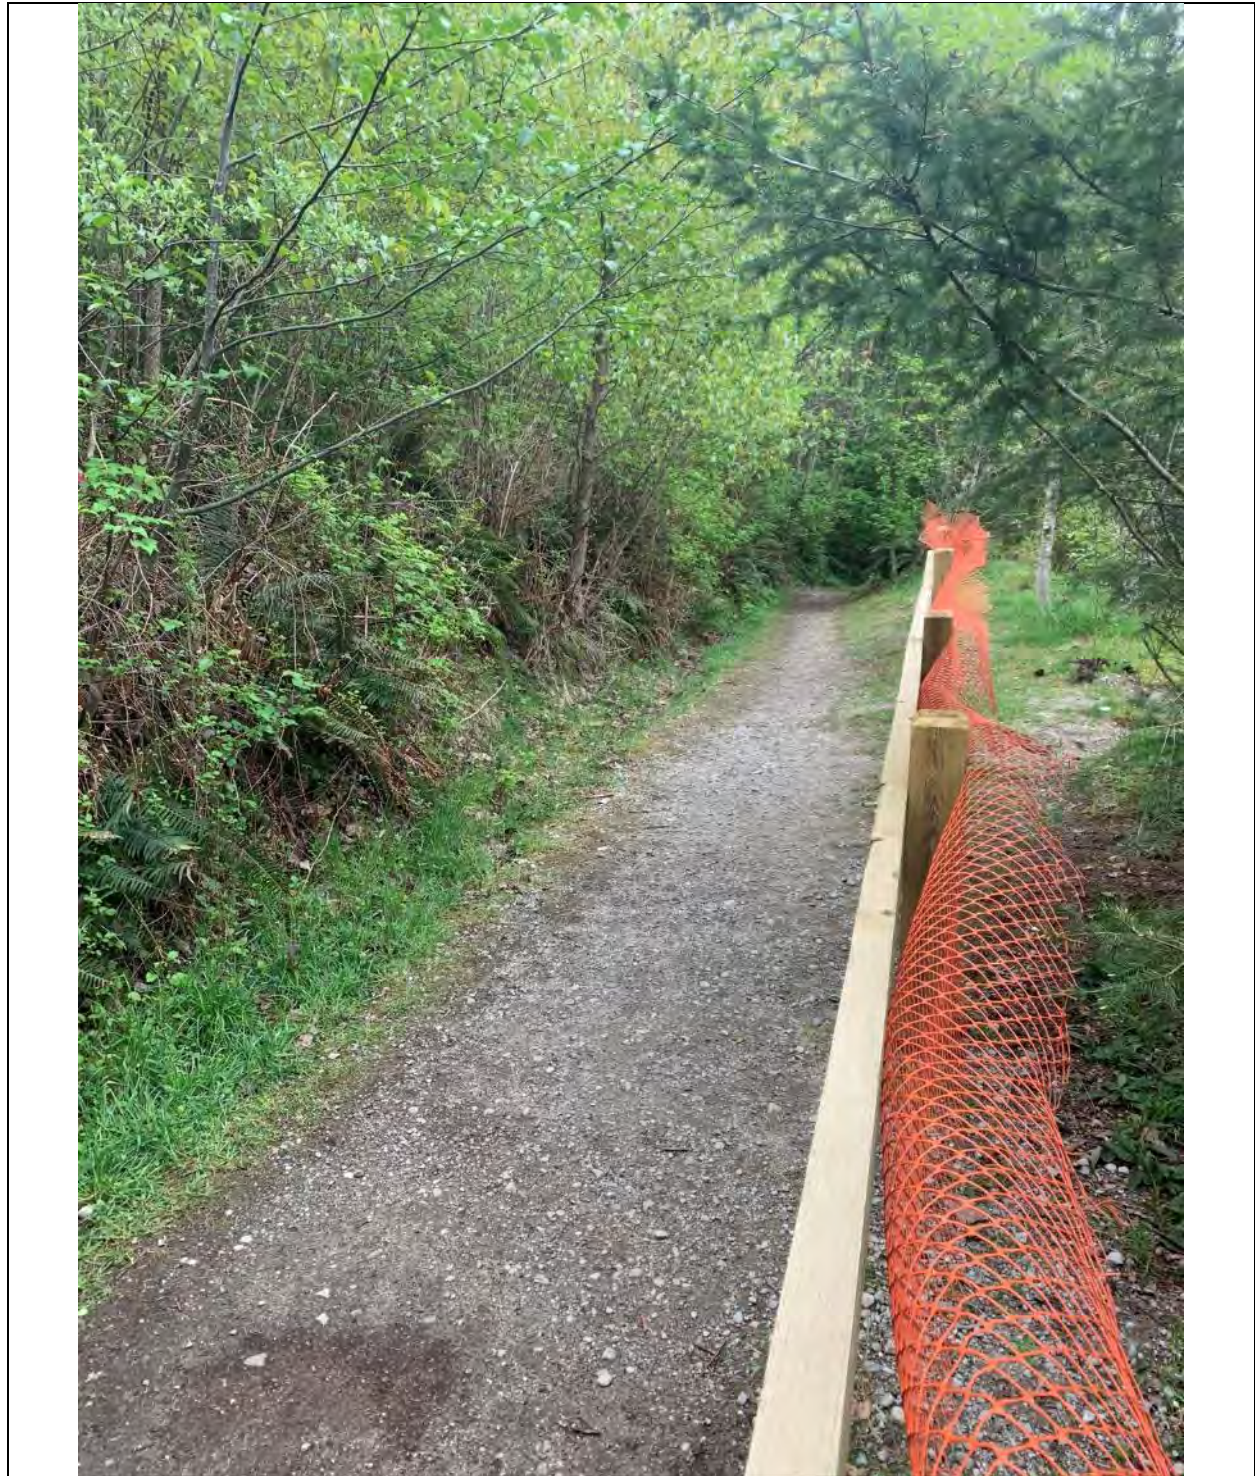
The dense to very dense sands on Site are strong but easily eroded by flowing water. The existing path configuration above the Site has a low point directly above the primary area of erosion (Photo 5). The surface water from the path accumulates at this low point and runs off the path towards the slope erosion. This surface water runoff would have originally caused erosion of the sloped ground. The erosion would eventually form a small over-steepened, near vertical slope. This near-vertical slope would cause the surface runoff to waterfall, resulting in further erosion and causing the near-vertical slope to become larger and to retrogress over time.

Photo 5: Looking south along pathway at top of eroded slope.

The path above the Site generally slopes downhill from north to south (Photos 5 and 6), with the exception of the local low point that accumulates water. Redirecting surface runoff from the erosion site will greatly reduce the amount of erosion. We believe that this is feasible by re-grading the section of pathway that is east (above) and south of the erosion Site. The re-grading would require lowering the elevation of the path. Further, as shown on Sketch 2, reinstating the ditch on the east (uphill) side of the pathway would help collect runoff and direct it downhill alongside the path. The path should have a slight crossfall to promote water to run off into the ditch on the east rather than down the hillside to the west as the lower exposed soil slopes would be subject to similar erosion if water was directed over down the slope (Photo 7).

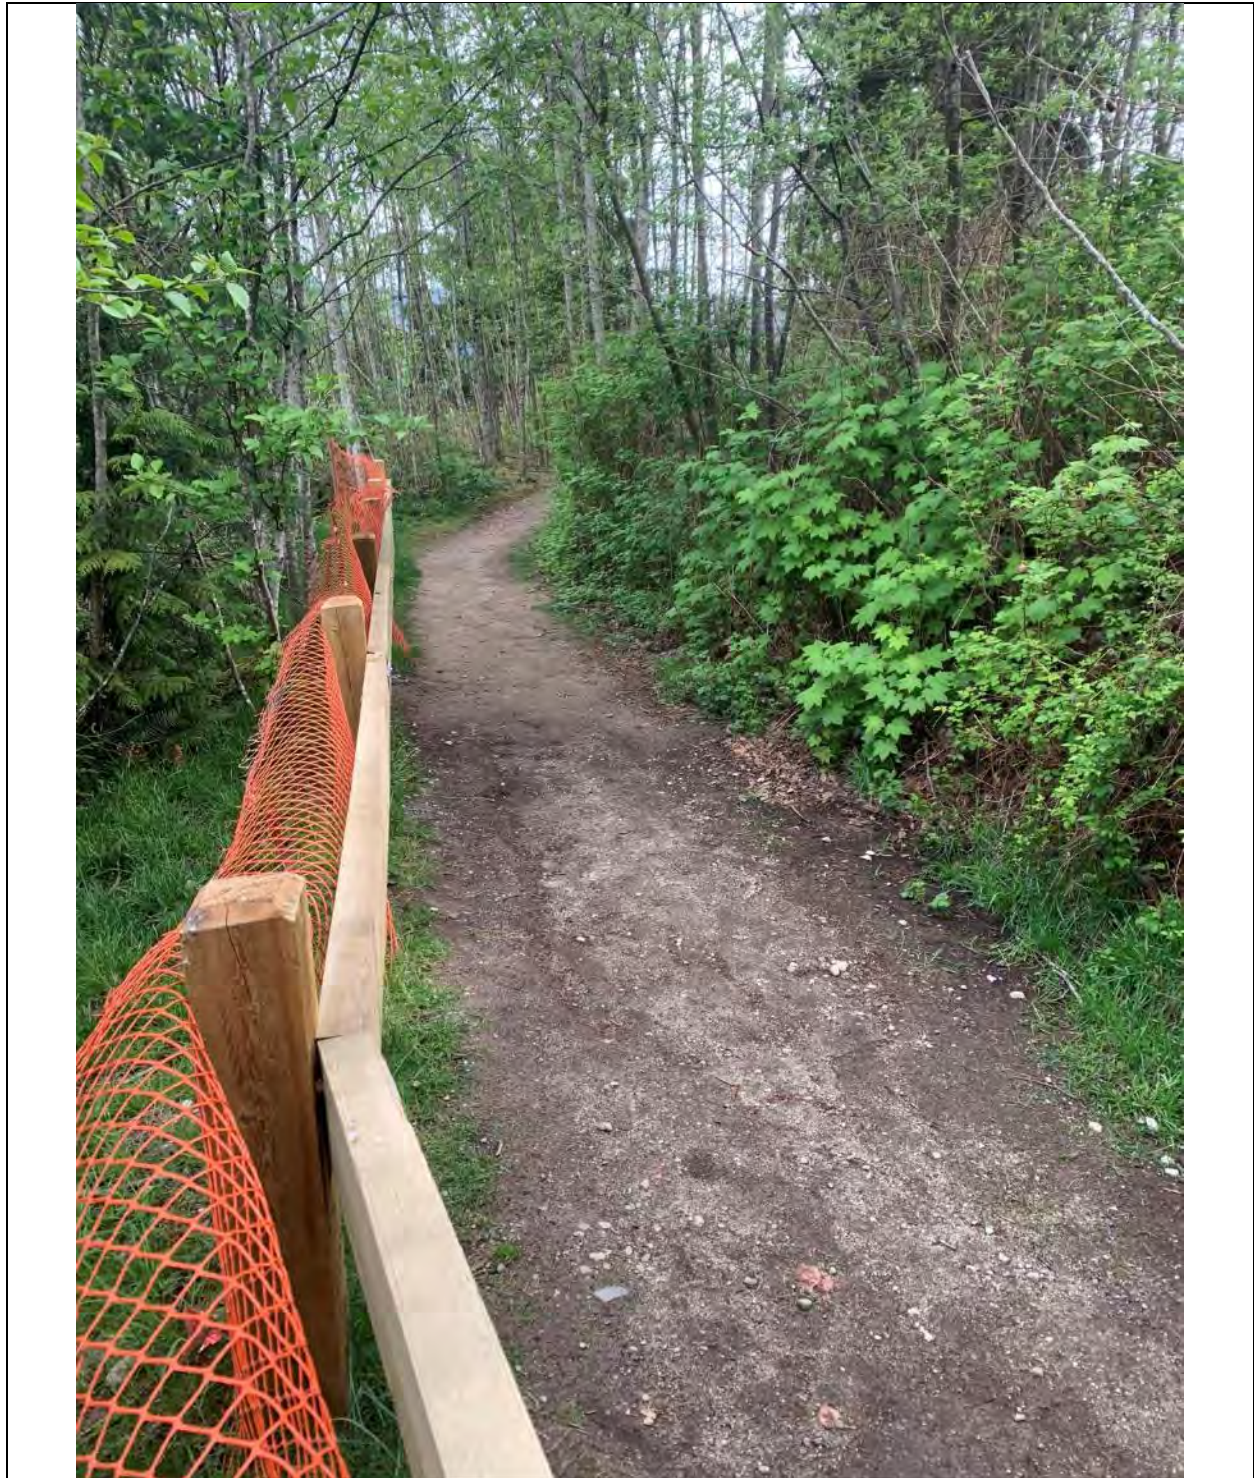
Photo 6: Looking north along pathway at top of eroded slope.

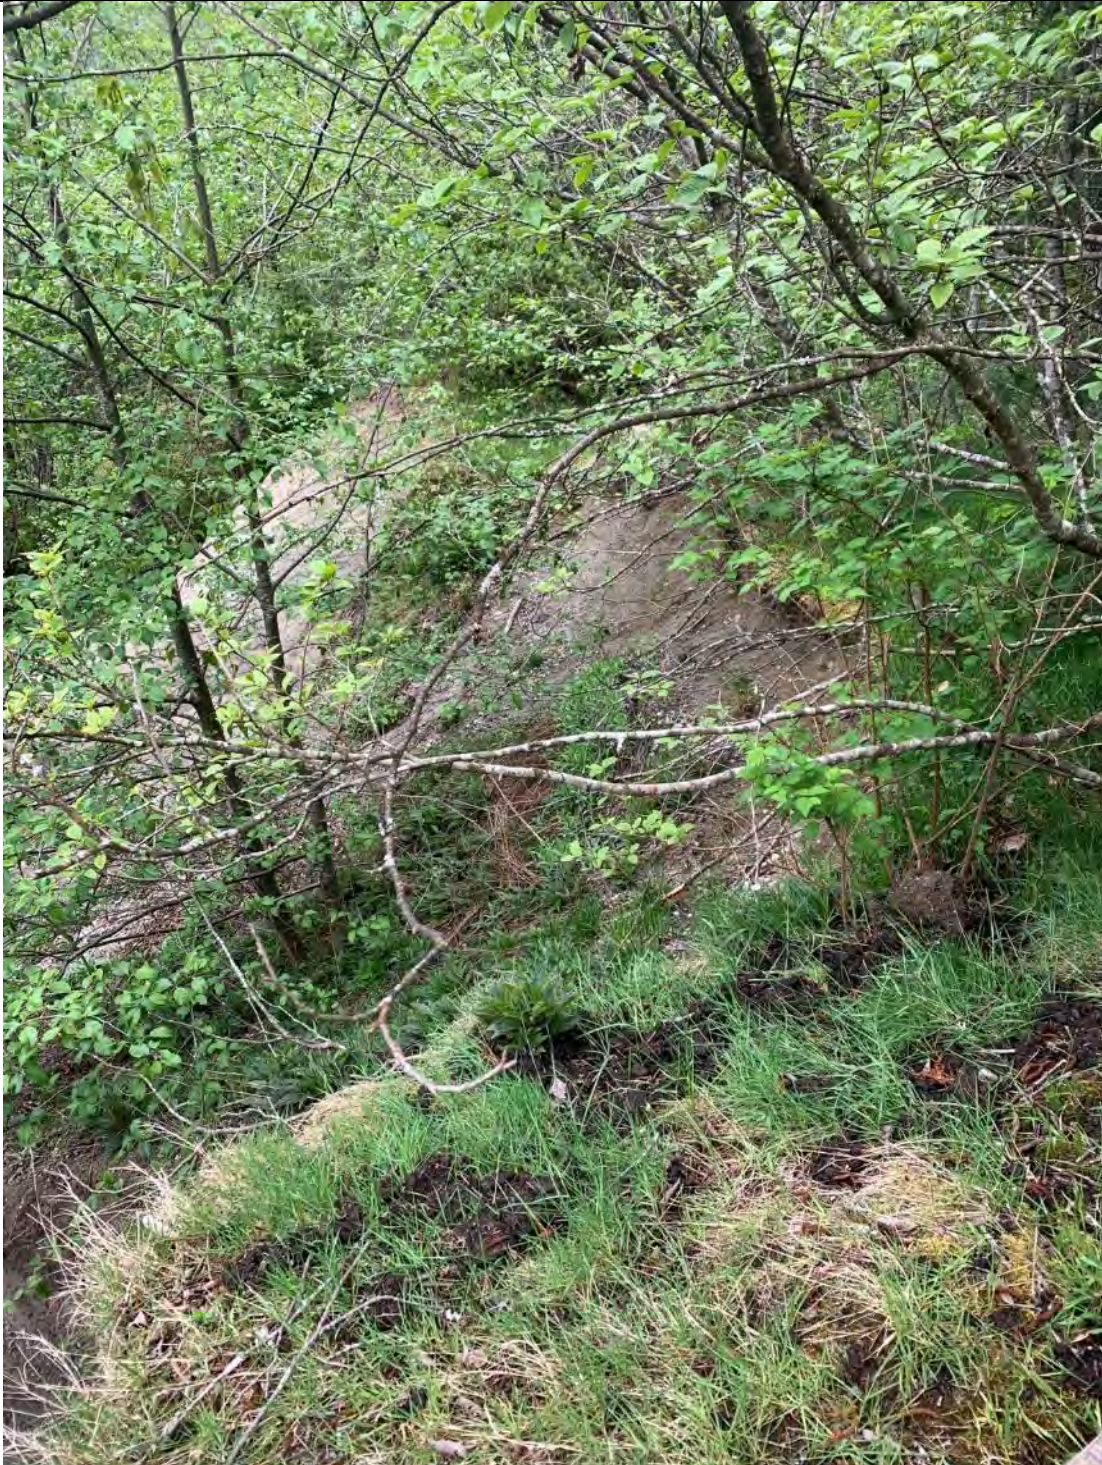
Photo 7: Exposed soil slopes adjacent to primary erosion area. These would be susceptible to similar erosion if surface water is directed over the slopes.

Portions of the hillside adjacent to the eroded sections will be susceptible to surface erosion if water is directed over the slope, particularly where vegetation is thin. It will be critical for re-grading of the path to not cause water to flow down slope of the path where it could erode new sections. Re-vegetating the slopes would also help reduce the erosion risk, although the sandy soil may make re-vegetating the slope challenging.

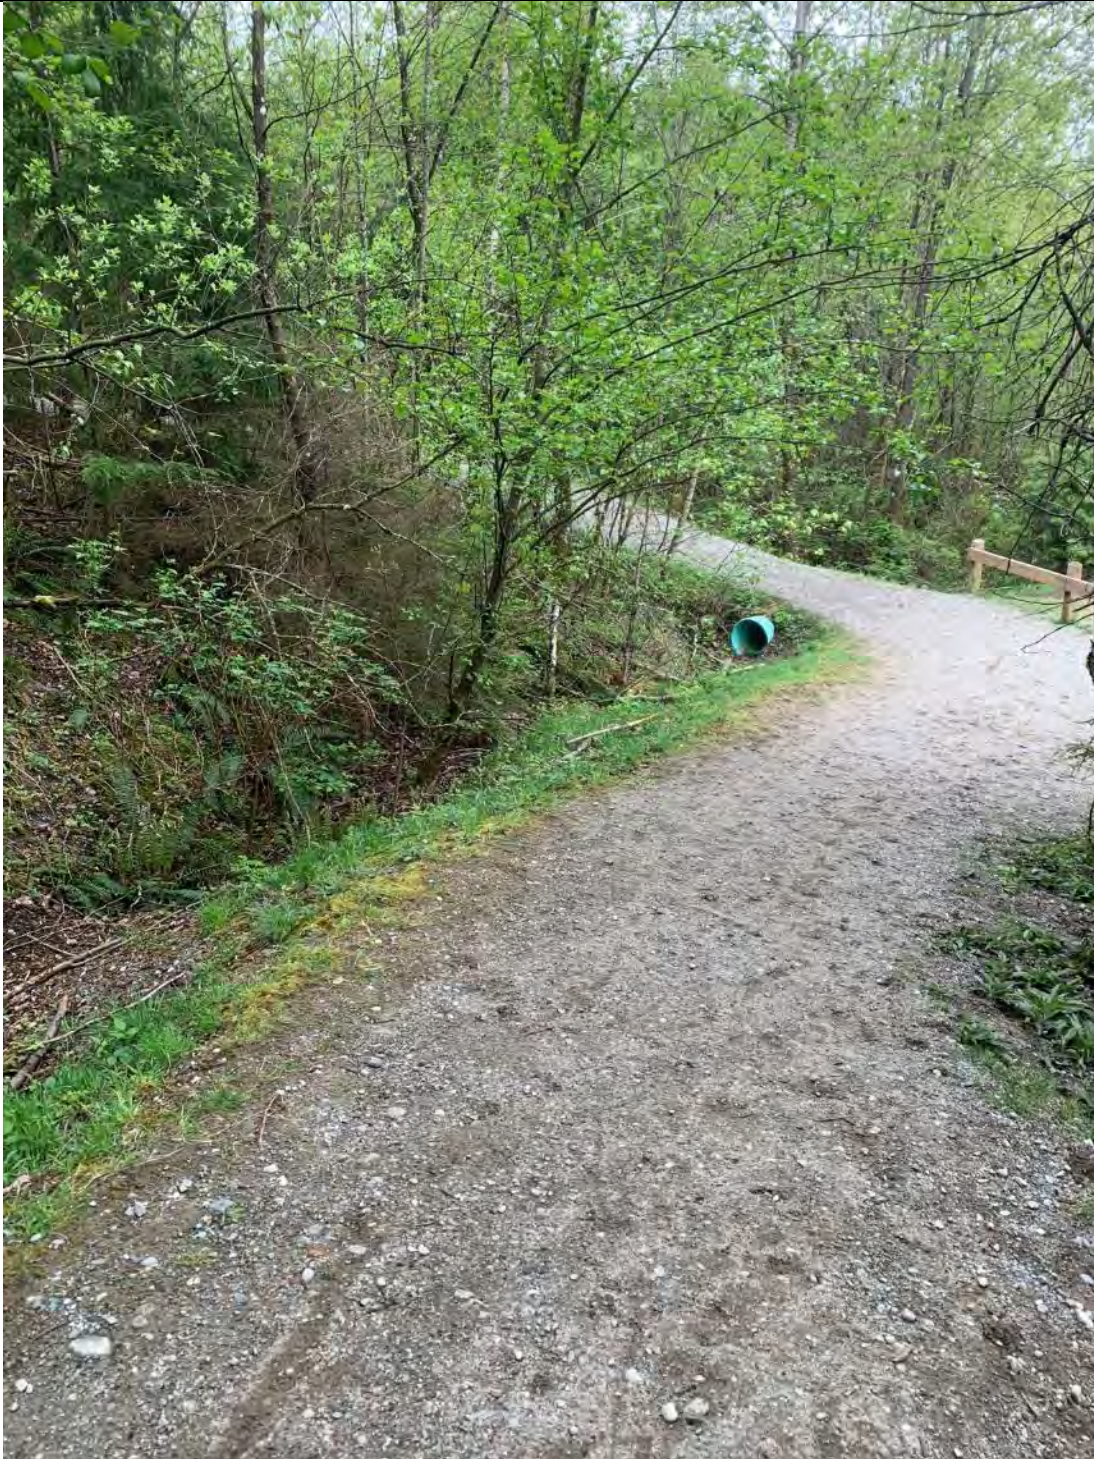
There is a poorly developed ditch on the east side of the path, approximately 15 m to 20 m south of the Site. This ditch parallels the path until it crosses beneath a second path in a PVC culvert, south of the Site (Photo 8). After crossing beneath the second path, the water would travel in another broad ditch towards the west. The ditch ends above a steep slope. There is a PVC pipe that appears to collect water from this ditch and transport it somewhere down the slope. The PVC pipe was infilled with material and it was not obvious where it discharged.

Photo 8: Ditch on the uphill side of the pathway that is above the erosion site. Note the PVC culvert crossing the other trail in an east-west direction.

We recommend that the reinstated ditch above the Site be connected to the existing ditch described above. Further, we recommend that the existing, poorly developed ditch be deepened and cleared of some of the vegetation. We recommend that the City maintain the ditch regularly

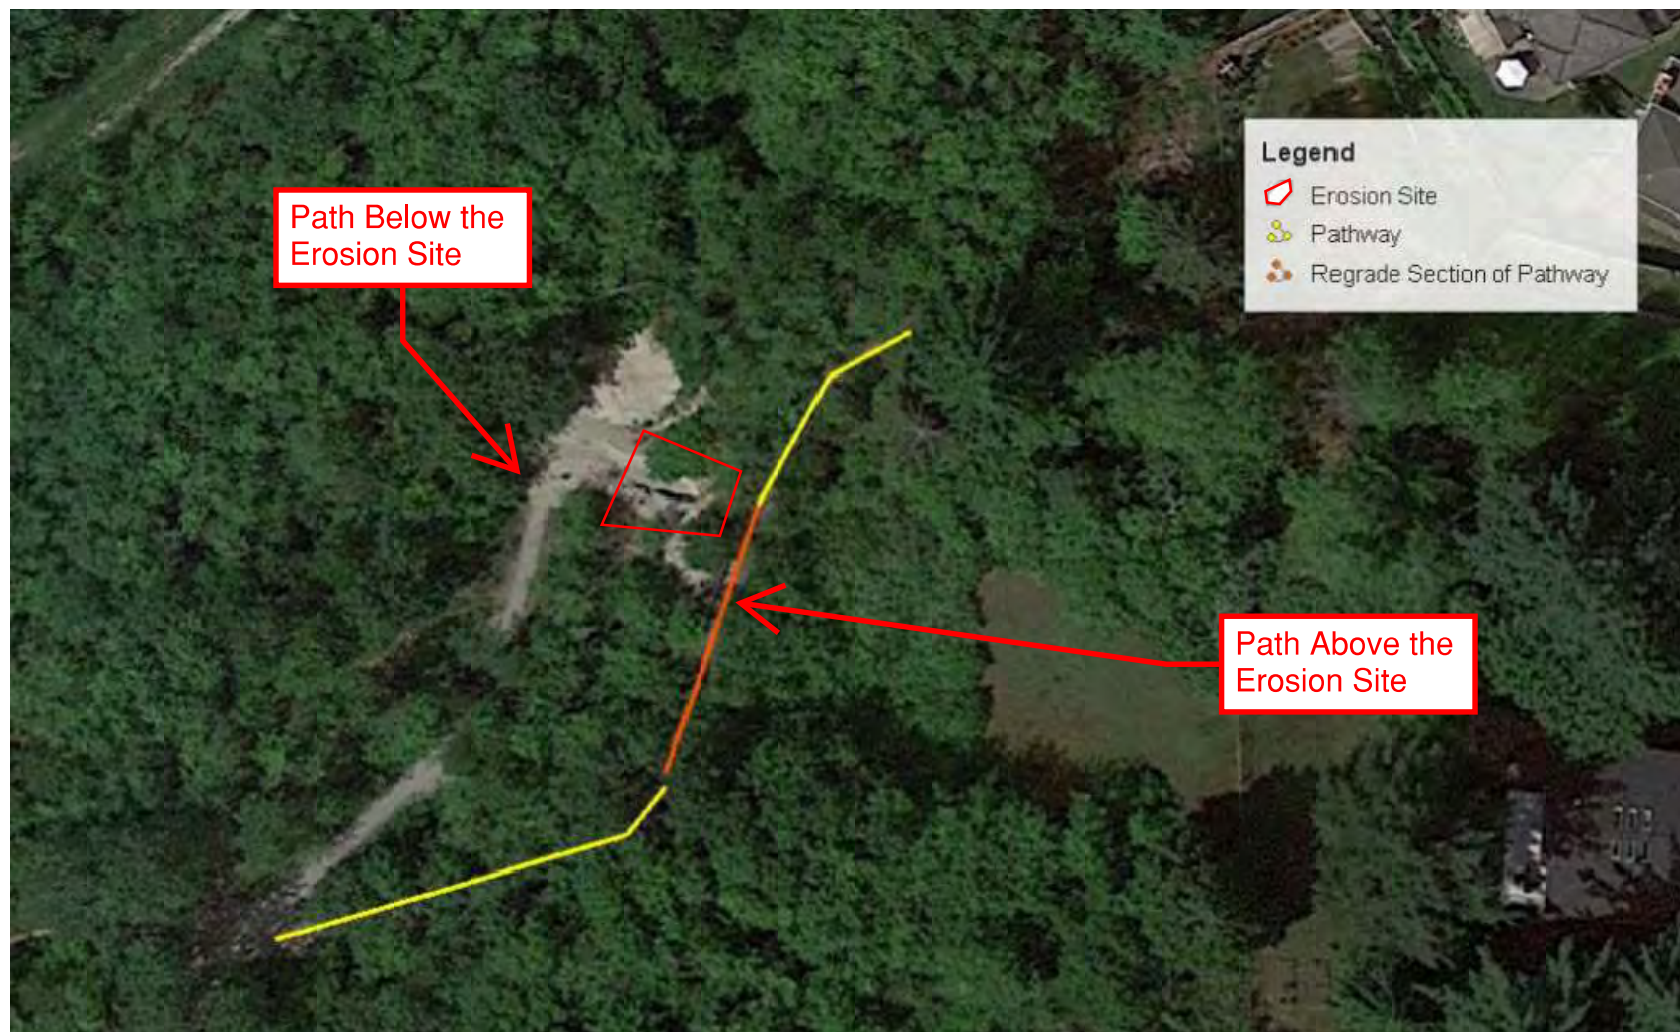
Sketch 1

Current local low point along pathway which collects water that flows across the path causing further erosion

Reinstate ditch which is overgrown or filled in.
