# IOCO TOWNSITE

HERITAGE CONSERVATION AREA, PORT MOODY, BC

## HERITAGE CONDITION ASSESSMENT REPORT

JULY 2020

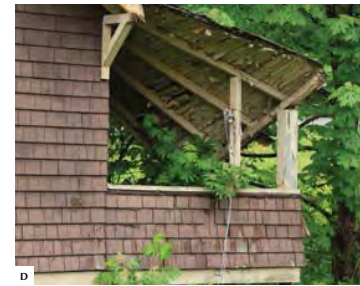
Collapsed shed roof of secondary porch at northeast corner of the house.

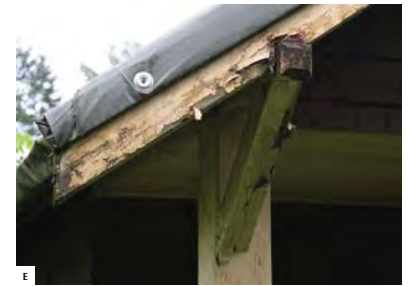
Typical deteriorated condition of wood trims (bargeboard supported by knee brackets on square post).

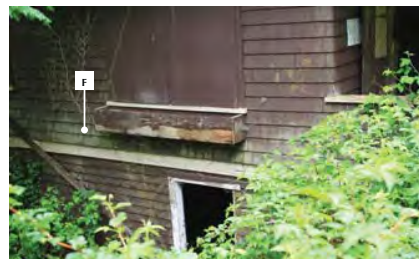
North elevation: detail photo showing door missing at opening to basement.

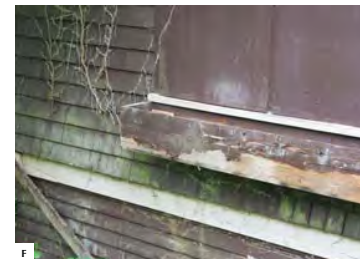
North Elevation: typical deteriorated condition of existing exterior cladding (shingles and siding) and trims.

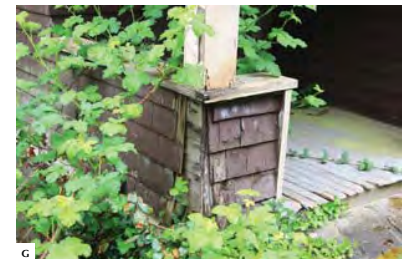
Typical deteriorated condition of entry porch elements (e.g. missing wood shingles, warped and loose decking, overgrown vegetation).

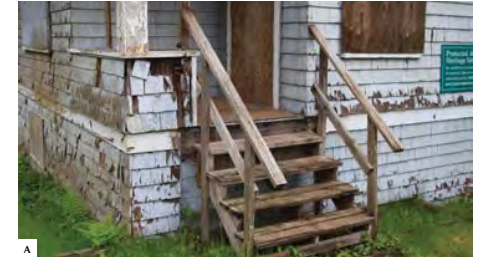
Typical deteriorated condition of wood shingle cladding, temporary porch entry staircase.

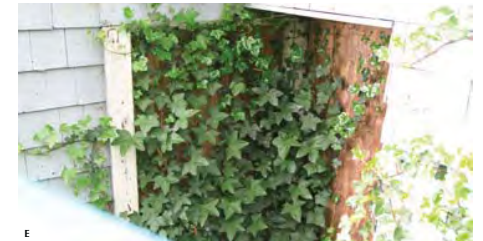
Door openings to basement at corner of southwest return, obscured by crawling vines.

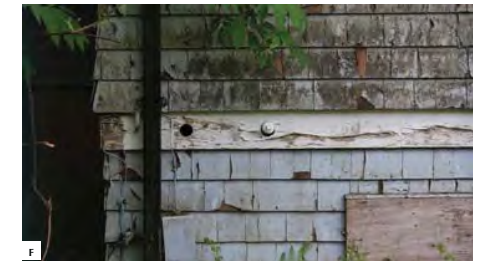
North elevation: detail photo showing typical deteriorated condition of wood cladding and trims.

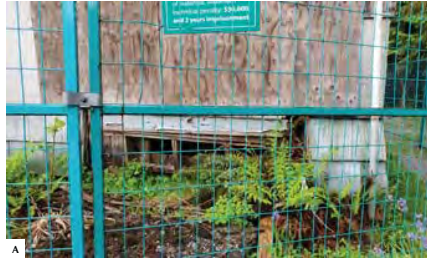
Missing front-entry steps, with exposed wall studs beyond missing exterior wall shingle cladding.

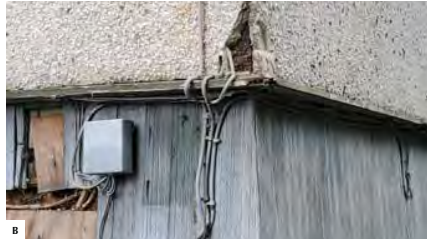
Detail photo showing existing deteriorated condition of existing later wall cladding. Note surviving original wood cladding underneath.

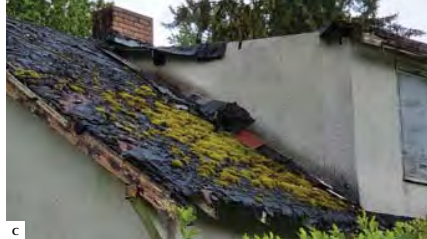
| NAME OF HISTORIC STRUCTURE | SITE | FORM, SCALE & MASSING | FOUNDATION | EXTERIOR WOOD-FRAME WALLS | PORCH & STOREFRONT | WINDOWS & TRIMS | DOORS & TRIMS | ROOF ELEMENTS | MAJOR DETERIORATION NOTED DURING REVIEW |
|---|---|---|---|---|---|---|---|---|---|
| <b>F RUNNELS RESIDENCE</b><br>(303 3rd Avenue) | ● | ● | ○ | ● | ● | ○ | ○ | ● | <ul style="list-style-type: none"> <li>• Dormer shed roof collapsed.</li> <li>• Temporary roof cladding is missing.</li> <li>• Missing front entry staircase, wall studs exposed, showing interior walls and floors beyond appear to be compromised.</li> <li>• Existing exterior stucco wall cladding is not original.</li> </ul> |

Detail photo showing existing deteriorated condition of roof elements. Note shed roof of dormer has collapsed, and existing brick chimney with no metal or cement cap.

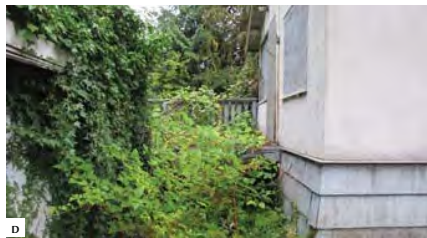
Rear deck was inaccessible due to overgrown vegetation.

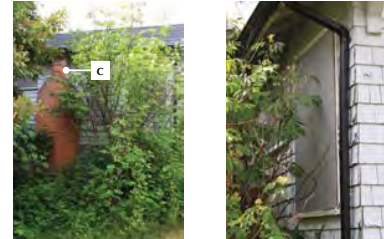
South elevation beyond vegetation: existing exterior brick chimney with missing stack above roofline. elevation (left). Original window openings and later rainwater systems (right).

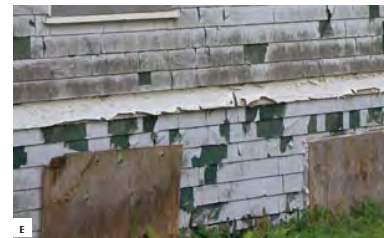
Detail photo showing existing deteriorated condition of wall cladding and trims.

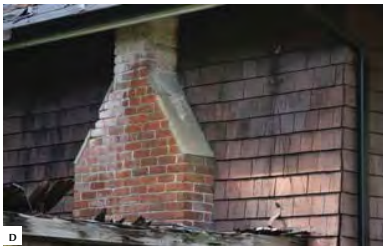
Detail photo showing typical deteriorated condition of exterior brick chimney, with missing section above roofline.

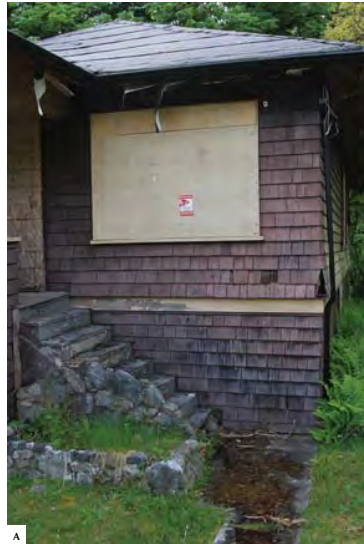
Detail photo showing deteriorated condition of existing side entry stairs with later rubble side wall in the foreground.

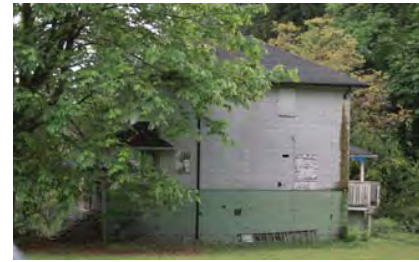
North elevation. Note missing rainwater leader at northwest corner.

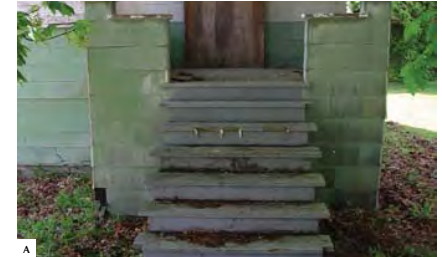
Detail photo showing existing condition of later front entry stairs and porch decking beyond.

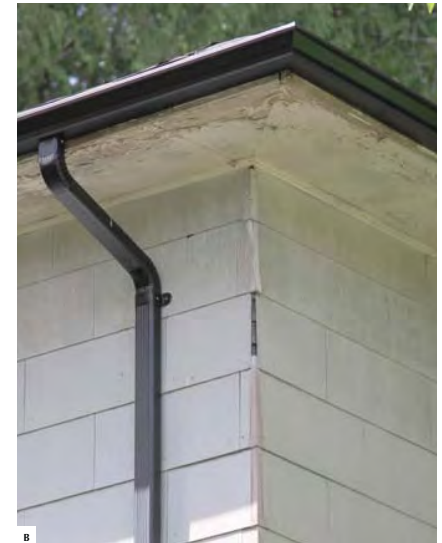
| NAME OF HISTORIC STRUCTURE | SITE | FORM, SCALE & MASSING | FOUNDATION | EXTERIOR WOOD-FRAME WALLS | PORCH & STOREFRONT | WINDOWS & TRIMS | DOORS & TRIMS | ROOF ELEMENTS | MAJOR DETERIORATION NOTED DURING REVIEW |
|---|---|---|---|---|---|---|---|---|---|
| <b>I DAVIS RESIDENCE*</b><br>(306 2nd Avenue) | ● | ● | ○ | ○ | ● | ○ | ○ | ● | <ul style="list-style-type: none"> <li>Existing asbestos cement siding is not original; original exterior wood cladding appears to be intact underneath (condition unknown).</li> </ul> |

Detail photo showing wall-to-soffit interface, with later asbestos cement siding, ply soffit, and rainwater system. Note surviving, original narrow lapped siding exposed underneath where later corner cap is missing.

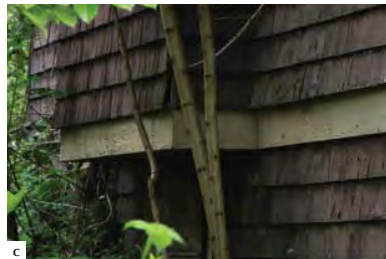
South elevation: detail photo showing typical deteriorated condition of wood cladding and trims at base of projecting bay window. Note crawling vegetation along the wood cladding beyond.

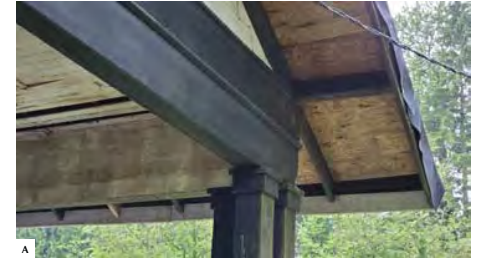
Detail photo of verandah columns, beams, and roof overhang. Note temporary ply soffit.

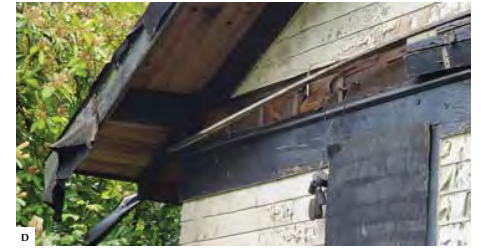
Missing materials on frieze band detailing. Note temporary ply soffit.

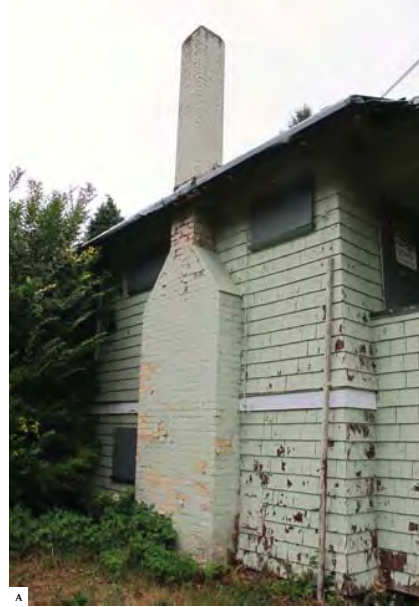
A  
East elevation: exterior brick chimney with unsympathetic paint finish.
