# ABC TREE MEN

## CERTIFIED ARBORIST REPORT

2222 Clarke St, Port Moody

April 27, 2018

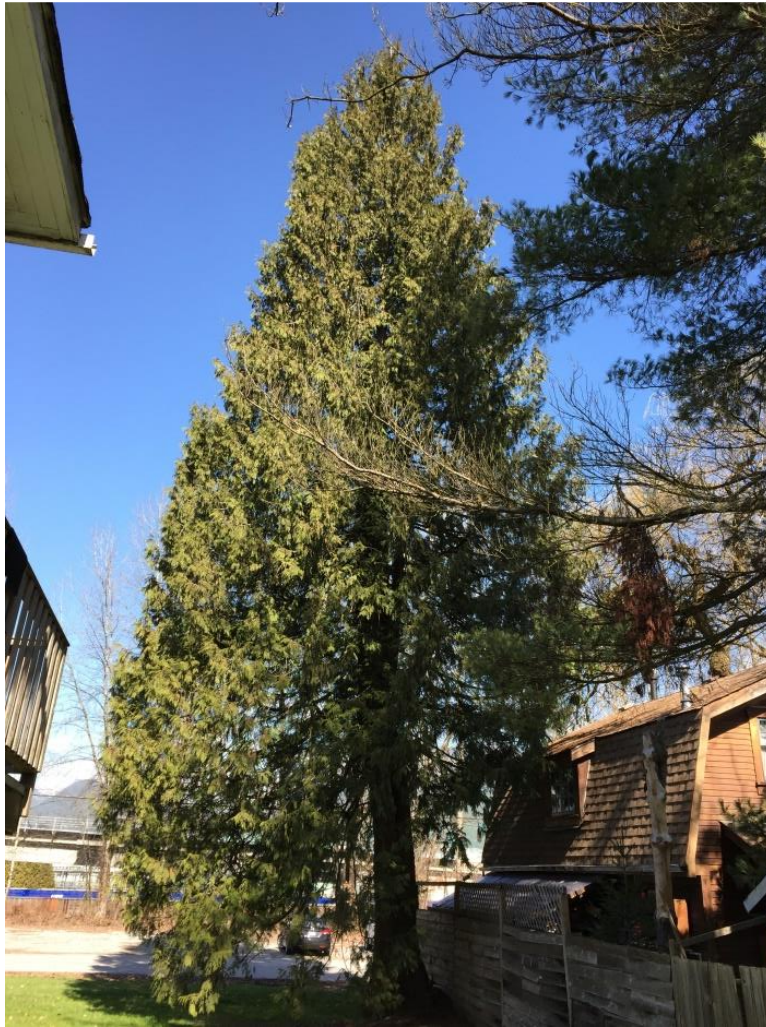
Photo 6. Facing towards tree #5

| Table 1 | | | | | | | | |
|---|---|---|---|---|---|---|---|---|
| 5 | Western redcedar | <i>Thuja plicata</i> | 91 | 27 | Onsite tree, located to the north eastern side of the lot. Large dominant tree with a multi stemmed top. Large past limb failure with an open wound and dead wood within. Overall, subject tree is in fair to poor condition. (3) | Remove | Removal is recommended due to conflicts with the proposed development | 5.5 |

**Observations:** Tree #5 is a Western redcedar and is located to the back of the property and is situated to the north eastern side of the lot. The DBH measures 91cm at 1.4 meters high from the ground with an overall height of about 27m and a crown spread of about 9m.

- Observing the tree, a multi stem attachment near the top third can be examined that seem to be weakly attached with poor junctions. A large wound from a past large limb failure can be observed. Examining the wound, dead wood and what appears to be insect infestation can be examined. Low live crown ratio tree. Observing overall, subject tree is in fair to poor condition.

**Recommendations:** Tree #5 will be in conflict with the proposed development, and falls just outside the proposed building footprint of the laneway house & within zone of heaviest construction & excavation activity. Removal is recommended.
