ENVIRONMENTAL ASSESSMENT MEMORANDUM

SUBJECT: 2122 St. George Street – Environmental Assessment Memorandum

INVASIVE PLANT MANAGEMENT PLAN

RE-PLANTING PLAN

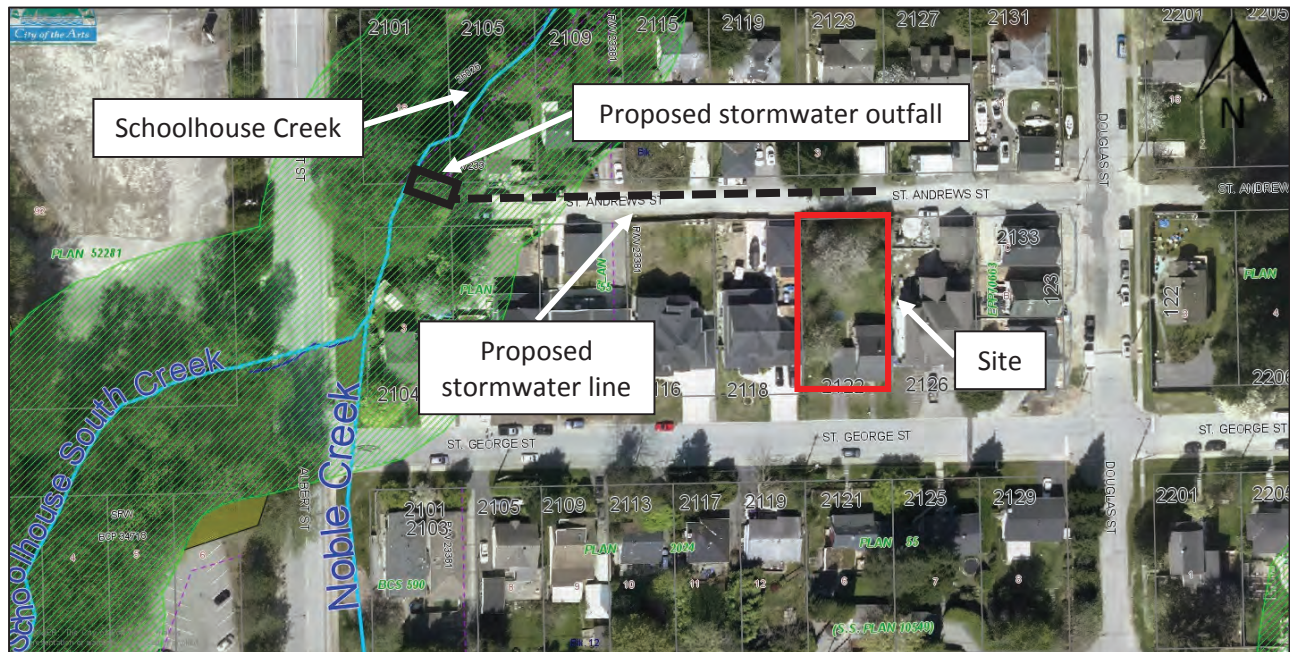
Figure 1: Site and Proposed Stormwater Infrastructure Location Overview.

AquaTerra Environmental Ltd. (AquaTerra) is pleased to provide Mr. Andrew Taylor (the “client”) with this Environmental Assessment Memorandum (the ‘memo’) for the proposed sub-division of the site, referenced as 2122 St. George Street in the City of Port Moody (the ‘City), BC. A stormwater line and a stormwater outfall are proposed as part of the sub-division. Refer to **Figure 1** for location details.

AquaTerra understands that the owner proposes to subdivide the existing lot into two (2) lots. In order to facilitate the lot subdivision and due to lacking stormwater infrastructure along St. Andrews Street, the client is proposing to construct a stormwater line and an outfall discharging to Schoolhouse Creek, approximately 100 m west of the site. Site plan is included in **Appendix A**.

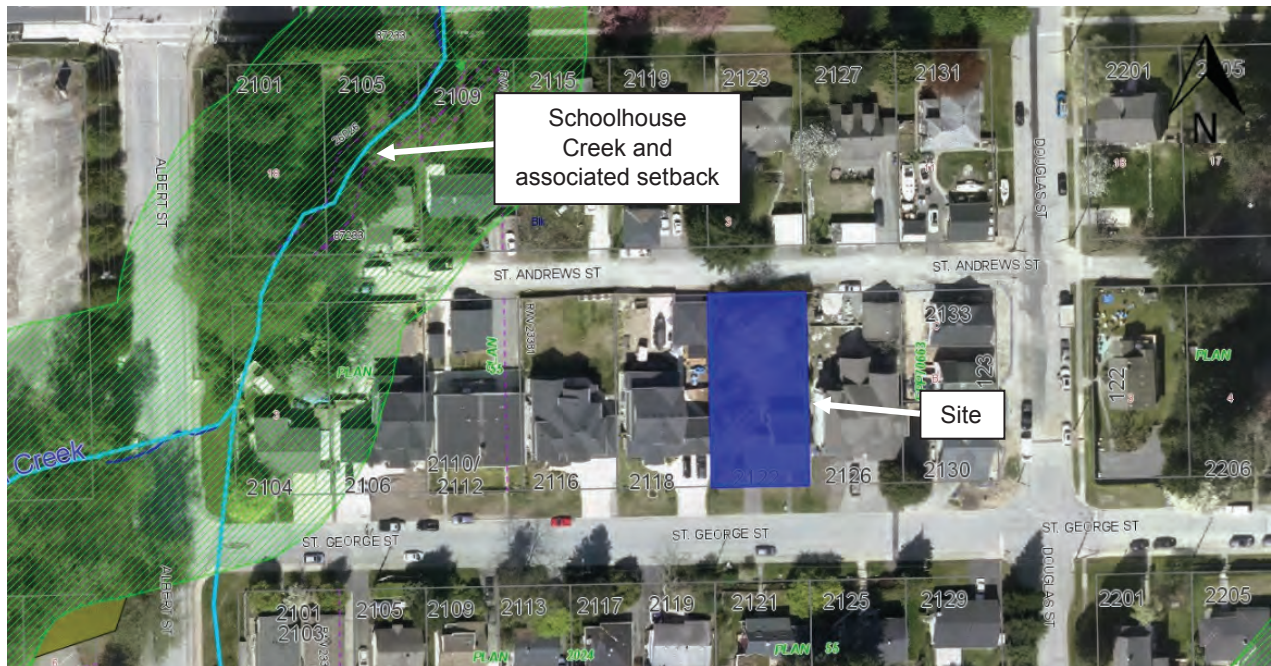
Figure 4: City of Port Moody GIS Mapping Utility Results.

The City of Port Moody GIS Mapping Utility was queried on 20 November 2020 to assess for potential watercourses within and adjacent to the site, if any, as well as associated setbacks, if applicable. The mapping utility did not identify any watercourses at the site. However, Schoolhouse Creek was identified to the west of the site, as previously mentioned above. City of Port Moody Mapping Utility results area illustrated on **Figure 4**.

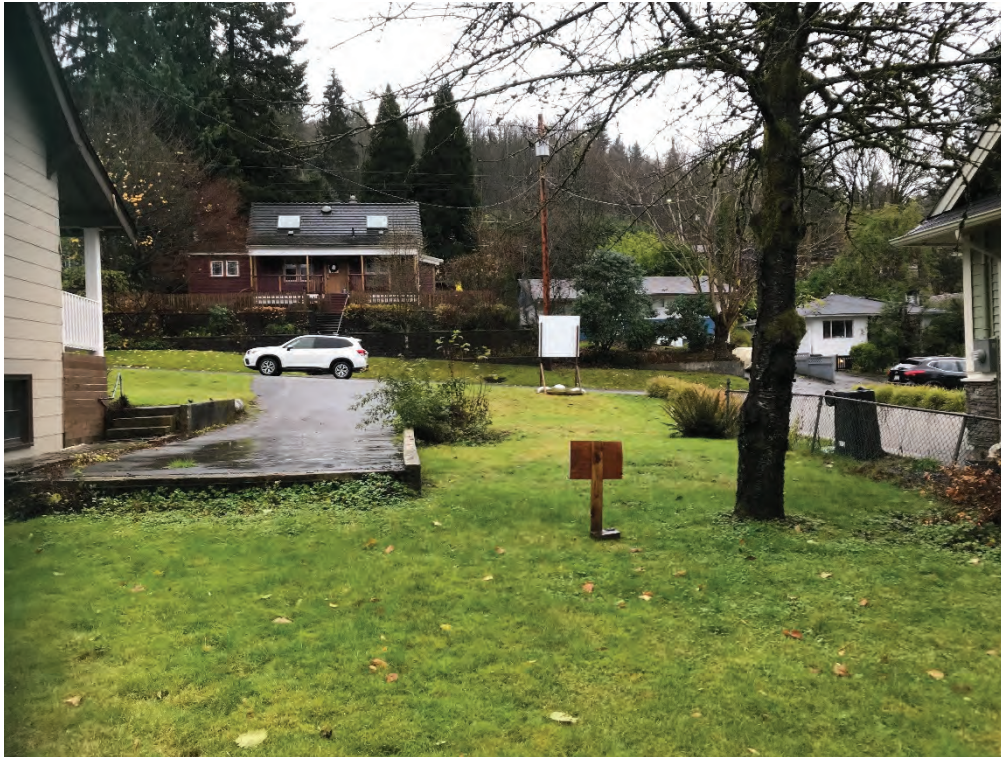
Photo 1: Site overview, looking south.

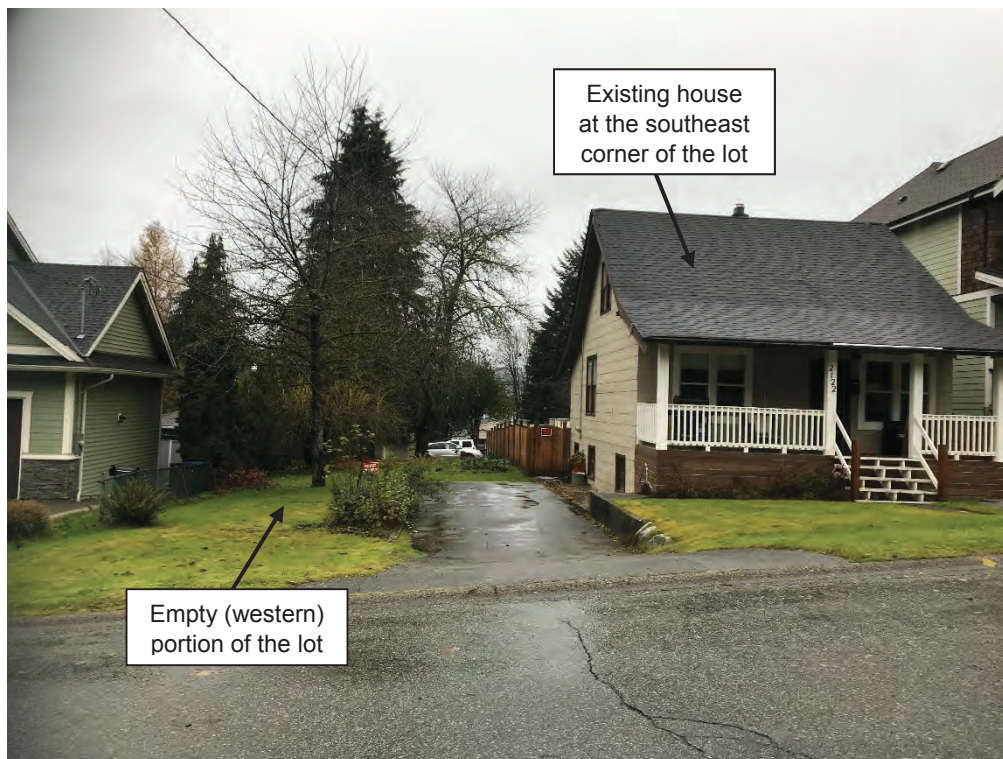
Photo 2: Site overview, looking north.

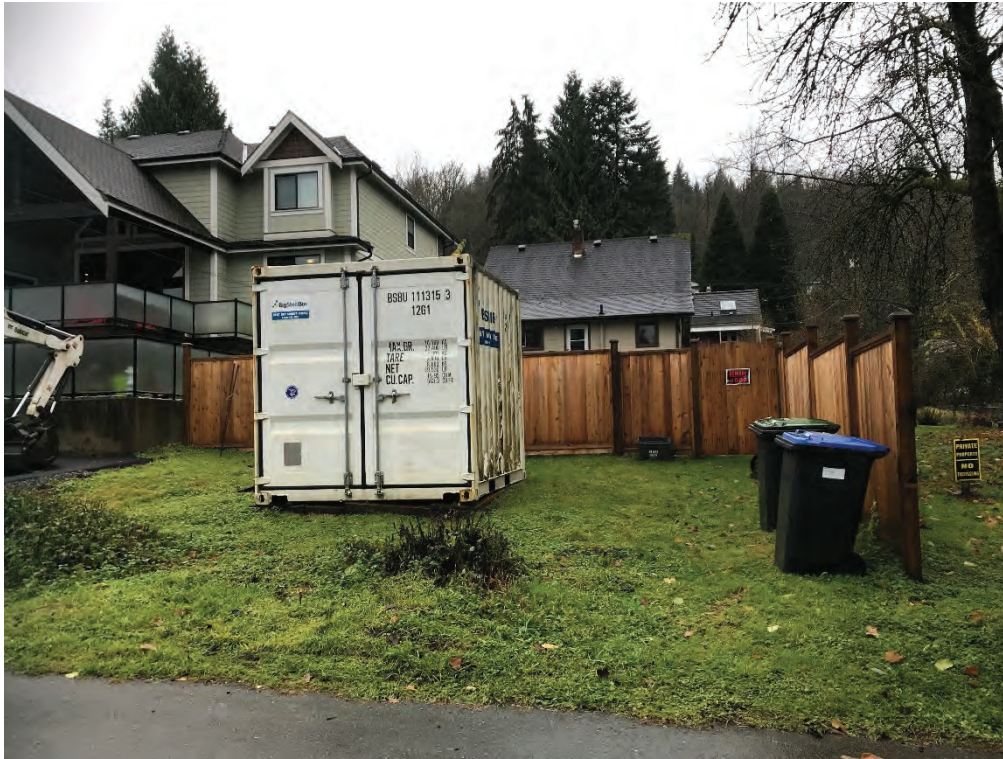
Photo 3: Wooden fence at the site, looking south.

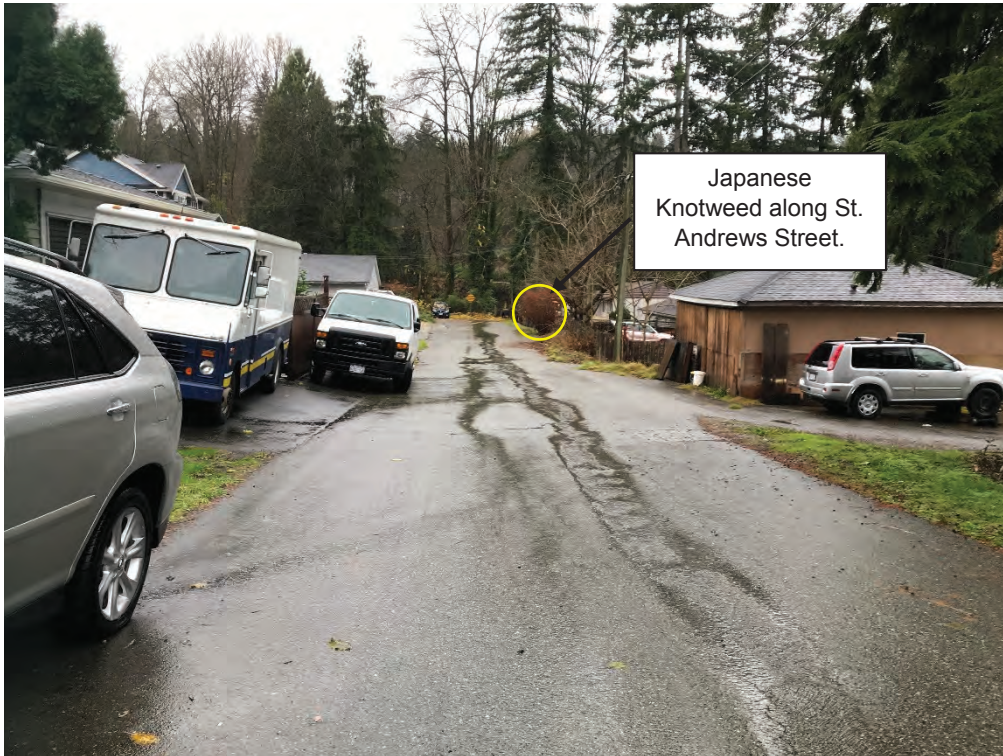
Photo 4: St. Andrews Street, looking west.

Japanese
Knotweed along St.
Andrews Street.

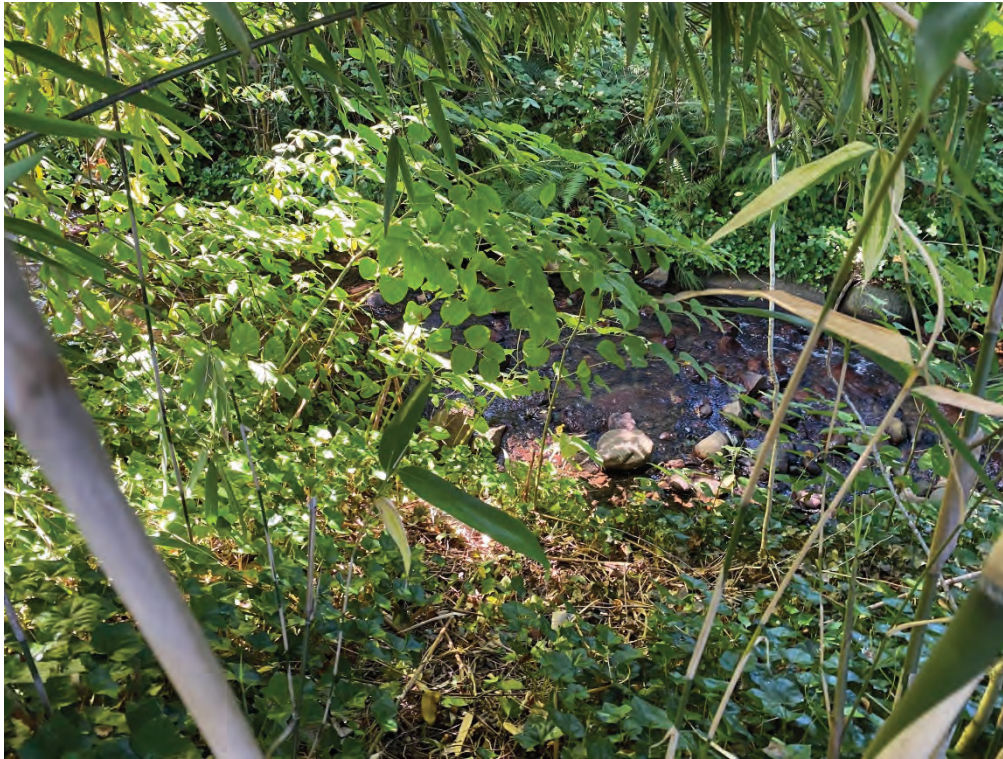
Photo 5: Japanese Knotweed present along Schoolhouse Creek.

Japanese Knotweed – a noxious weed (as identified by the Invasive Species Council of BC) was identified along the eastern slope (right bank) of Schoolhouse Creek at St. Andrews Street and a small cluster on the north side of the road at 2109 St. Andrews Street. Per the *B.C. Weed Control Act*, the City of Port Moody (the 'City') requires the residents to manage and control invasive vegetation on private property. In this case, invasive / noxious vegetation is present on the City's property; however, considering the proposed works may impact the infested areas, the proponent is responsible for avoiding the spread of the invasive and / or noxious plant species. The City allows the use of professional pesticide applicator to remove the plant using recommended approaches; however, other methods can be employed, depending on the time restraints, as pesticide application can take multiple years.

6. Consideration will be given to proper invasive species (specifically Japanese Knotweed) management per the Invasive Plant Management Plan (Appendix B).

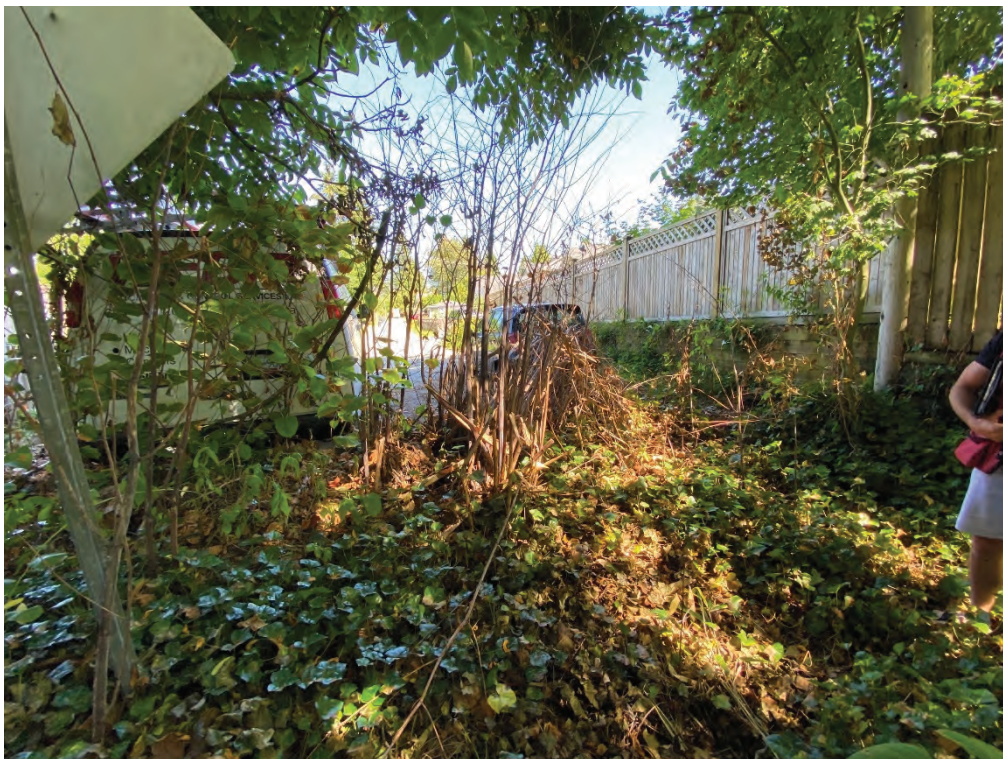
The proposed stormwater outfall location was dominated by non-native and invasive vegetation, such as English Ivy (*Hedera helix*), Bamboo (*Bambusoideae* sp.) and Japanese Knotweed. While English Ivy and Bamboo are considered species of concerns, Japanese Knotweed is a noxious weed, as identified by the Invasive Species Council of BC. Per the *B.C. Weed Control Act*, the City requires residents to manage and control invasive vegetation on private property. In this case, invasive / noxious vegetation is present on the City's property; however, considering the proposed works may impact the infested areas, the proponent is responsible for avoiding the spread of the invasive and / or noxious plant species. As previously mentioned, City had requested an Invasive Plant Management Plan (**Appendix B**) to be included as part of the submission to the City.

Photo 6: Invasive plants present within the riparian area of Schoolhouse Creek at St. Andrews Street.

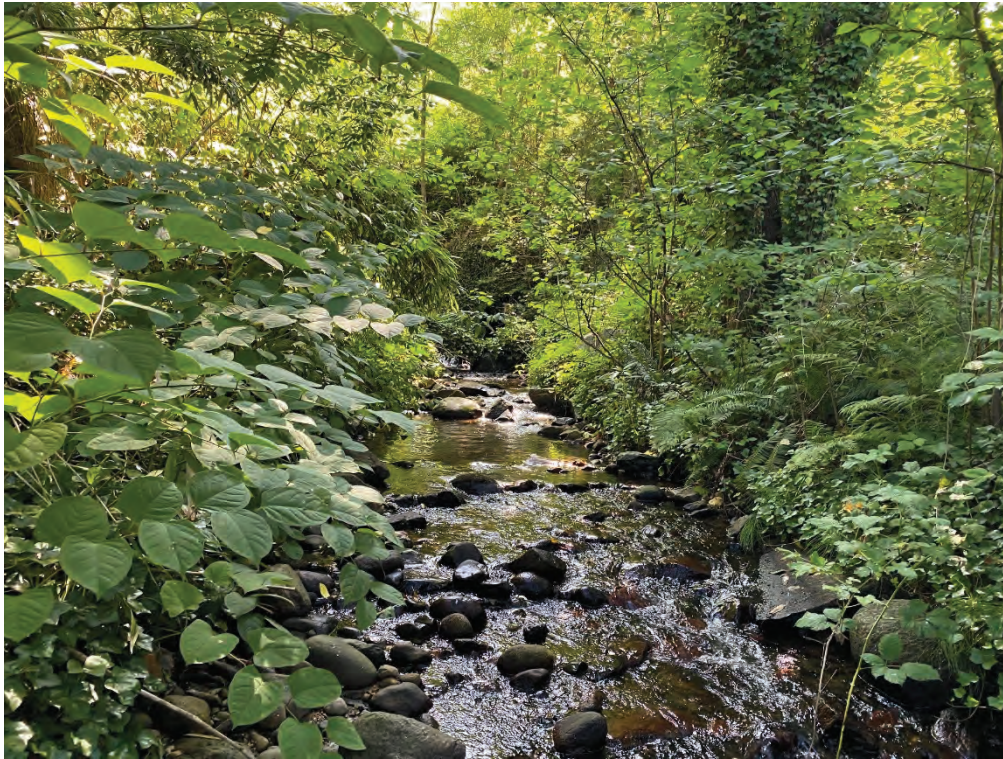
Schoolhouse Creek (the 'Creek'), located to the west of the site, was identified on the quired databases. The Creek is a fish bearing stream with salmonids present in the reach closest to the site. The wetted width of the channel was approximately 1.5 m – 2.5 m. Channel composition consisted of 40% boulder, 30% cobble, 10% gravel and 20% fines. Remnant broken pieces of concrete were also noted within the channel.

Riparian vegetation consisted of Western Hemlock (*Tsuga heterophylla*), Douglas Fir (*Pseudotsuga menziesii*), Black Walnut (*Juglans nigra*), Red Alder (*Alnus rubra*), Salmonberry (*Rubus spectabilis*), Swordfern (*Polystichum munitum*) and Blacken Fern (*Pteridium aquilium*). Non-native vegetation present along the riparian corridor consisted of Japanese Knotweed, Himalayan Blackberry (*Rubus armeniacus*), Bamboo and English Ivy. Note that majority of the trees were located on the western side of the creek (left bank) and non-native vegetation dominated the eastern side (right bank) of the creek, at St. Andrews Street.

Photo 7: Overview of Schoolhouse Creek and riparian vegetation at St. Andrews Street.

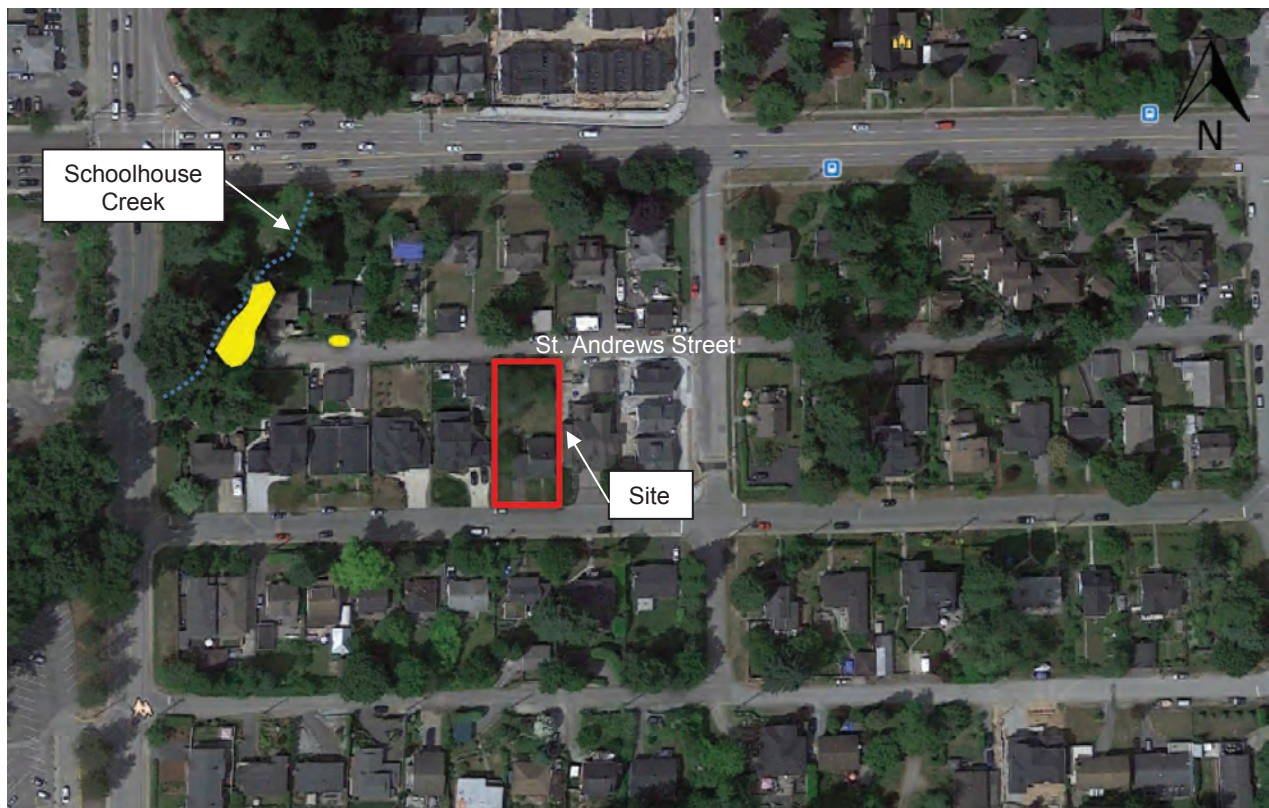
Figure 1: Approximate Locations of Japanese Knotweed and Other Invasive Plants (Yellow).

The areas infested by Japanese Knotweed along the eastern bank of Schoolhouse Creek and a small outcrop along St. Andrews Street were identified by a Qualified Environmental Professional (QEP; AquaTerra). The areas infested by Japanese Knotweed are approximately 1m x 1m along St. Andrews Street, and 4m x >10m along Schoolhouse Creek. Note that the extent of Japanese Knotweed along the creek extended beyond the proposed outfall location. As part of approving the sub-division, the client is responsible for properly managing soils containing Japanese Knotweed during construction activities.

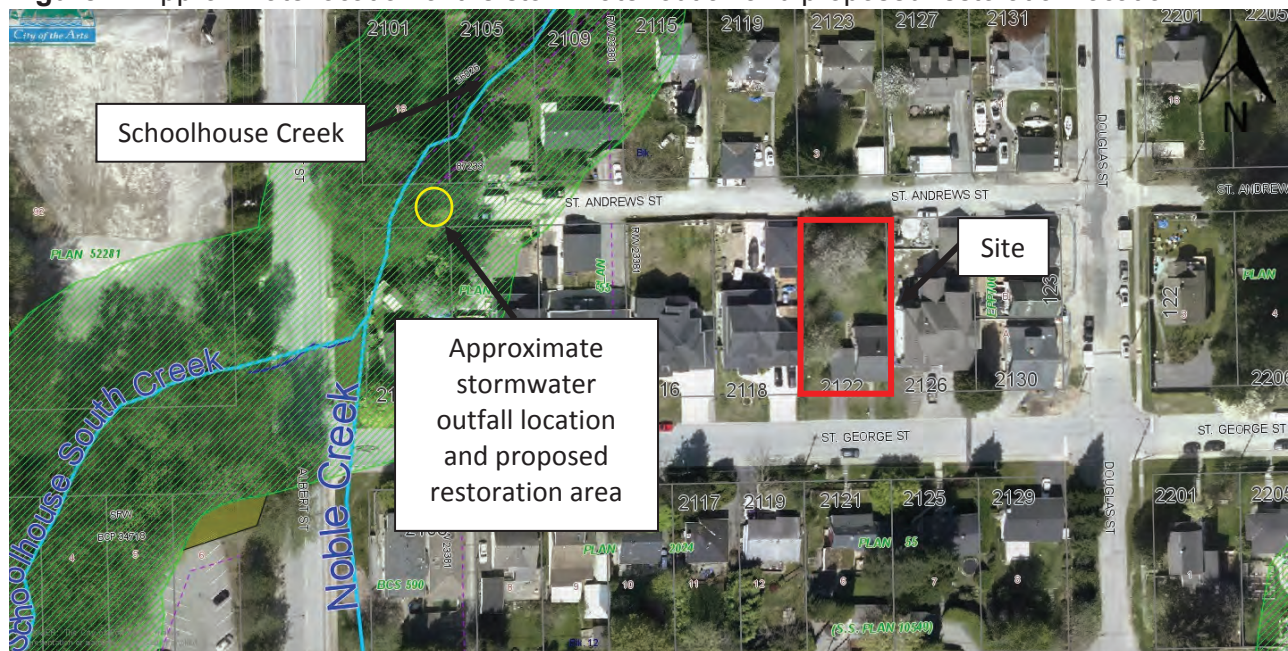
Figure 1: Approximate location of the stormwater outfall and proposed restoration location

The proposed headwall outfall is approximately 4 m in length by 2 m in width; however, it is anticipated that a larger area may be impacted to accommodate construction. Therefore, an estimated area of disturbance is 30 m². Details area provided below.
