# City of Port Moody Report/Recommendation to Council

Date:October 20, 2021Submitted by:Community Development Department – Development Planning DivisionSubject:Heritage Designation Bylaw – 2130 St. George Street, 123 Douglas Street, and<br/>2133 St. Andrews Street

To present for Council's consideration Heritage Designation Bylaw, No. 3328 to designate the properties at 2130 St. George Street, 123 Douglas Street, and 2133 St. Andrews Street as municipal heritage sites, completing the Heritage Revitalization Agreement project for the sites.

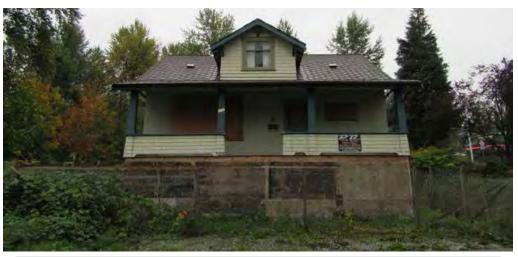
HISTORIC NAME: MOISIO RESIDENCE ORIGINAL ADDRESS: 2614 ST. JOHNS STREET CURRENT LOCATION: 2101 CLARKE STREET ORIGINAL OWNER: ESA MOISIO CONSTRUCTION DATE: 1912 HERITAGE STATUS: MUNICIPAL HERITAGE REGISTER; PROPOSED LEGAL PROTECTION

The Moisio Residence is a handsome example of a Craftsman bungalow, typical of the housing built during the pre-World War One boom period in Port Moody. Constructed in 1912, the Moisio Residence is a one and one-half storey, rectangular-plan house that features a side-gabled roof with central, gabled dormer and full-width front porch.

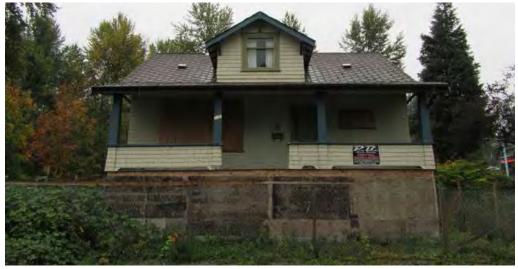
Front elevation of the Moisio Residence facing north.

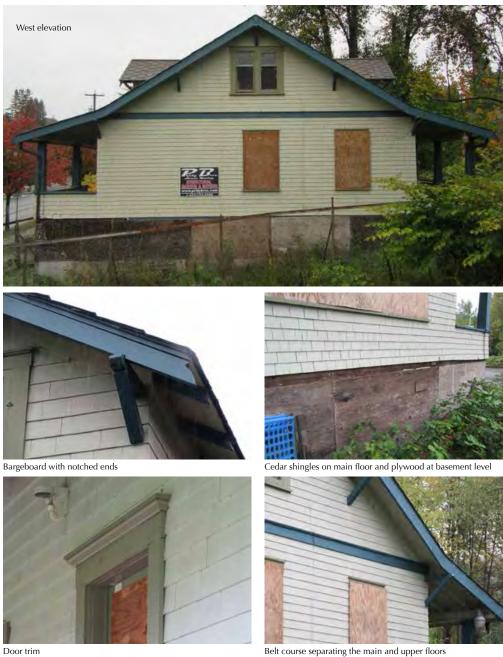
Door trim

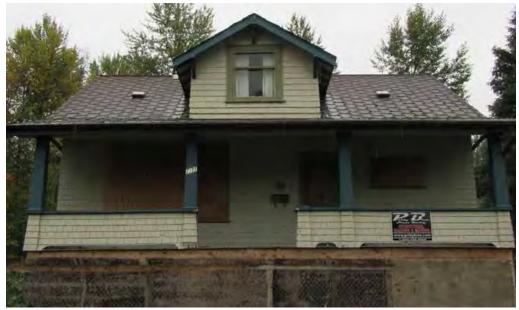
Front verandah with closed and shingled balustrades

- Preserve the front and rear verandahs as important architectural elements of the house.
- Move both verandahs with the main structure to its permanent location, if possible.
- Restore original verandah elements that are in good condition where feasible, including tapered columns with capitals and rounded base, wooden sills, exposed rafter tails and tongue-and-groove soffits.
- The closed and shingled balustrades with drainage scuppers can preserve their original detailing and height. Building code requirements can be met with alternate compliance method, e.g. installing glass panels or metal railings to meet the required height. The Heritage Consultant can advise on the design.
- Design new wooden front and rear stairs with closed treads and risers. The Heritage Consultant can advise on the design.

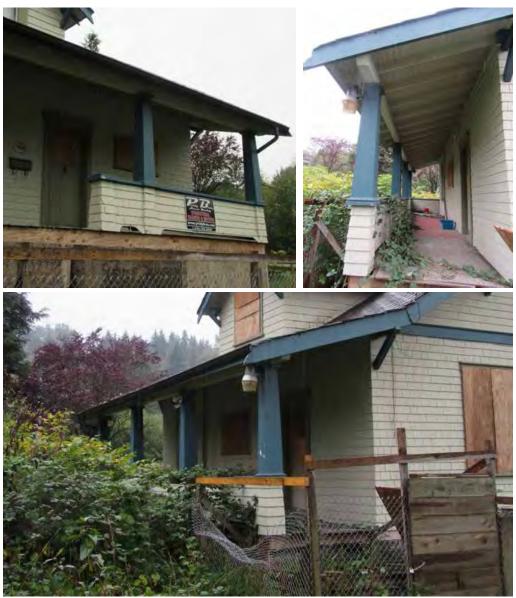
Top Left: Front verandah with tapered columns Top Right: Rear verandah ceiling featuring exposed rafter tails and tongue-and-groove soffits; Bottom: Rear verandah

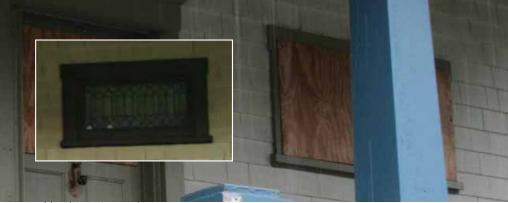
Front verandah with inset piano window

- Window restoration should be undertaken by a contractor skilled in heritage restoration.
- New windows at the basement level can be made of wood and the design should respectful to the historic character of the house.

- Prime and paint all wood windows as required in appropriate colours, based on colour schedule devised by the Heritage Consultant.

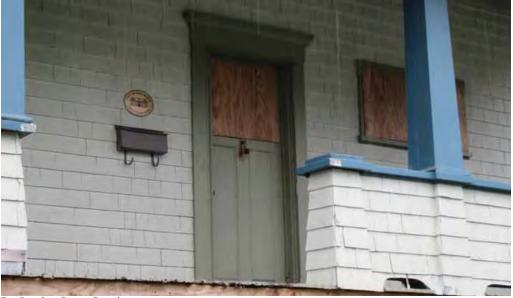
Top: Rear door; Bottom: Front door

- Preserve original front and surrounding trim and mouldings of both door openings, if possible.
- If the front door is being retained, verify that the door fits properly in its frame and joints are tight. Verify that hardware is operational, particularly that hinges are tight and hinge pins not worn. Remove built-up paint at door and jamb. Repair damaged elements to match original. To reduce air infiltration, weather stripping can be installed between door and frame.
- New doors should be sympathetic to the historic character of the house.

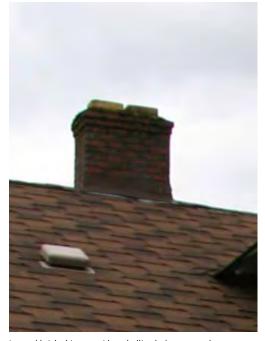
Internal brick chimney with corbelling before removal

The brick chimney may be reconstructed in its original location and original dimensions as shown in photographs. Use red-common bricks and replicate corbelling detail. Install metal flashings at the base.

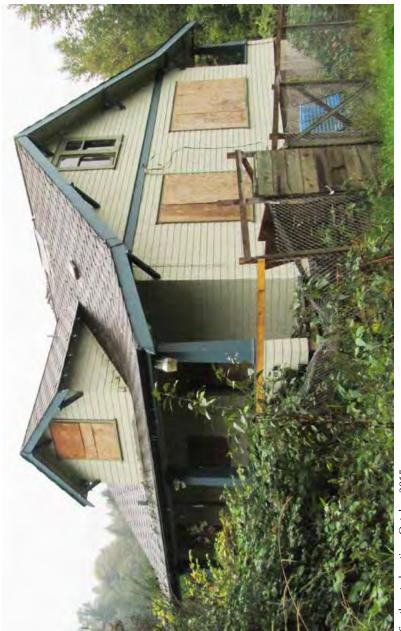
Southeast elevation, October 2015

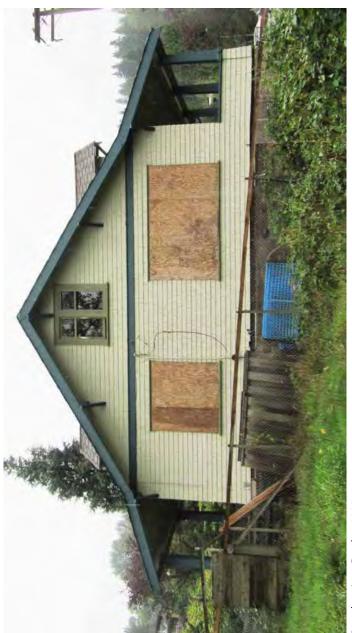
East elevation, October 2015

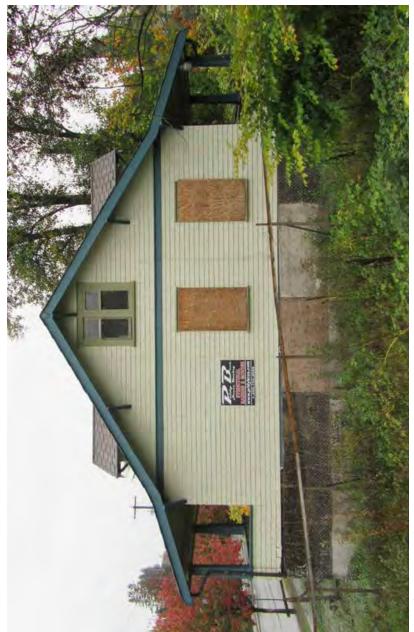
West elevation, October 2015

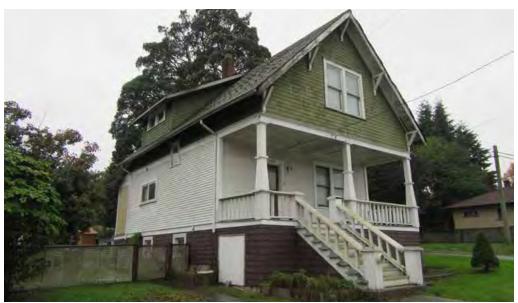
HISTORIC NAME: SIDDALL RESIDENCE CURRENT ADDRESS: 2901 ST. JOHNS STREET ORIGINAL OWNER: JAMES PRIDHAM SIDDALL CONSTRUCTION DATE: 1922 HERITAGE STATUS: MUNICIPAL HERITAGE REGISTER; PROPOSED LEGAL PROTECTION

The Siddall Residence is a handsome example of a Craftsman bungalow, typical of the housing built during the interwar period in Port Moody. Constructed in 1922, the Siddall Residence is a one and one-half storey, rectangular-plan house that features a frontgabled roof with inset full-width front porch.

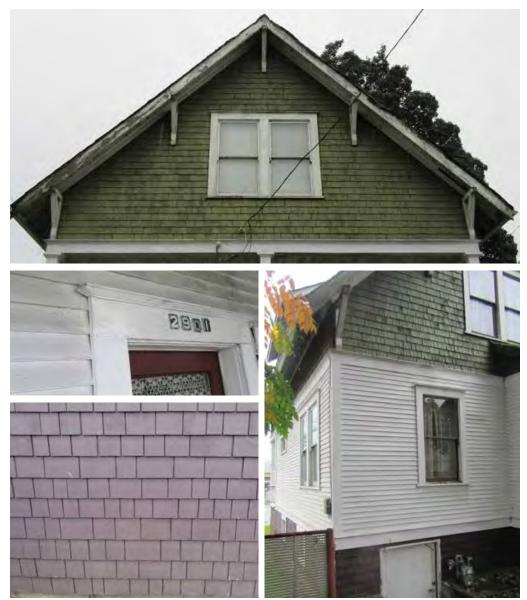
Clockwise from Top: Shingle siding at second floor; Lap siding, belt course, watertable and cornerboard; Shingle siding at basement; Door trim

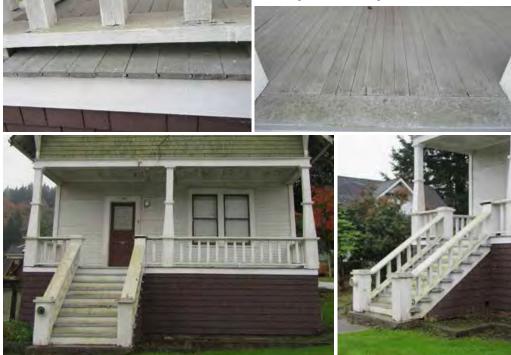
Clockwise from top left: Tongue and groove flooring; Tongue and groove flooring and closed riser; Front porch; Stairs with starting and end newels, and handrails with banisters

- Preserve and restore the front porch including the timber columns, balustrade, soffit, mouldings and other features as a significant characterdefining element.
- In order to meet building code requirements some rehabilitation measures may be required;
   e.g. floors above occupied spaces will require a waterproof membrane with new wooden decking over top. The design of the porch deck should be reviewed to ensure that the final appearance does not conflict with the restoration intent.
- Alternate compliance method will allow to retain the original balustrades while meeting building code requirements, e.g. installing glass panels or metal railings.
- Build a new wooden front stair that matches the original stair in design and location.

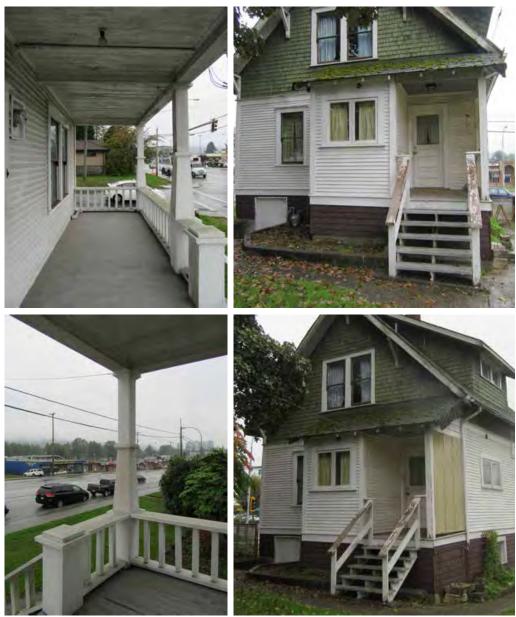
Top Left: Tongue and groove soffit and flooring; Bottom left: Tapered column; Top right and bottom right: Rear porch

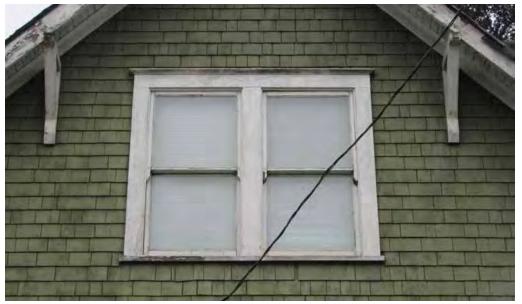
Pair of original one-over-one, double hung wooden sash windows on second storey of front façade

- Prime and paint all wood windows as required in appropriate colours, based on colour schedule devised by the Heritage Consultant.

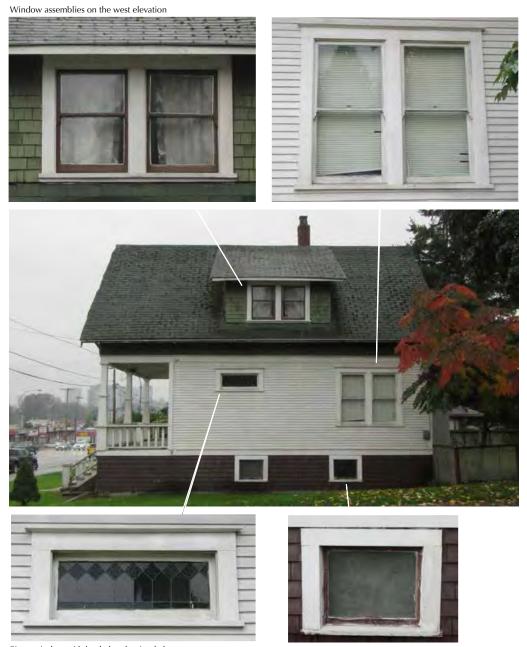
Piano window with leaded and stained glass

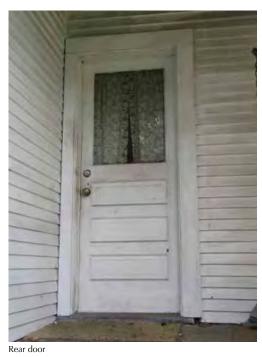
Front door

- Preserve the original door opening, front and surrounding trim. Retain the rear door if possible.
- To improve operation, verify that door fits properly in its frame and joints are tight. Verify that hardware is operational, particularly that hinges are tight and hinge pins not worn. Remove built-up paint at door and jamb. Repair damaged elements to match original. To reduce air infiltration, install weather stripping between door and frame.
- New doors should be sympathetic to the historic character of the house and made of wood.

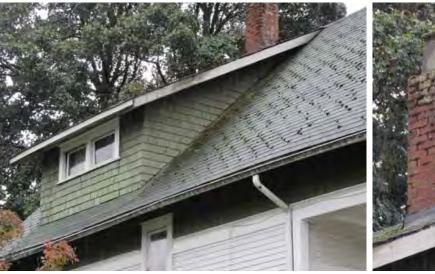
Roof with shed dormer on the east elevation

- The existing brick chimney should be retained in place and relocated with the house, if possible.
- The brickwork can be gently cleaned of dirt and the brickwork re-pointed as necessary with suitable mortar. The brickwork will remain unpainted.
- If the condition of the brick chimney is too deteriorated to be repaired, it should be carefully dismantled and bricks salvaged and used as examples for replacement bricks. A new chimney should be built to match the original in dimensions, material, and colour.
- New metal flashings should be installed.

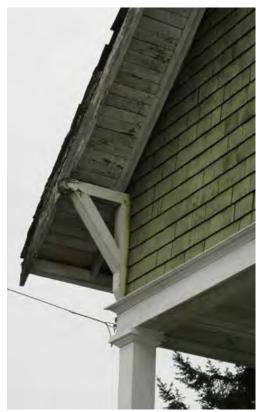
Triangular eave bracket

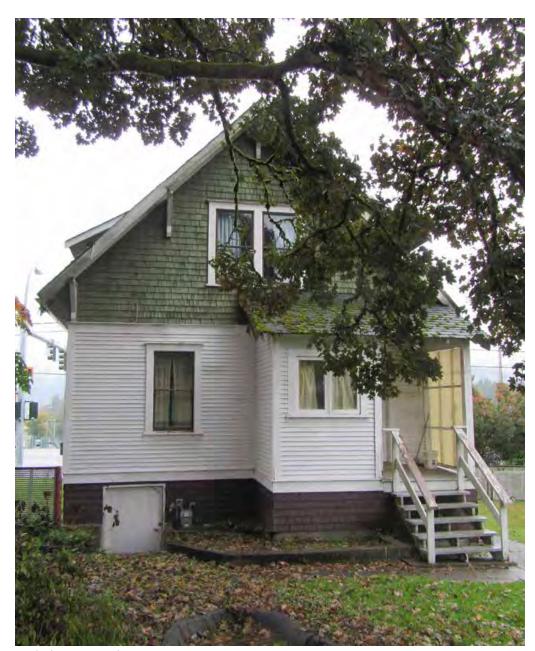
South elevation, October 2015

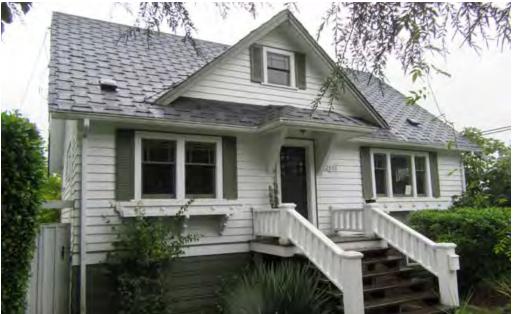
HISTORIC NAME: SUTHERLAND RESIDENCE CURRENT ADDRESS: 2830 ST. GEORGE STREET ORIGINAL OWNER: ROSS AND ELIZABETH SUTHERLAND CONSTRUCTION DATE: 1944

The Sutherland Residence is a handsome example of wartime housing, displaying Craftsman style influences. Constructed in 1944, the Sutherland Residence is a one and one-half storey, rectangularplan structure that features a side-gabled roof with off-centre gabled-dormer.

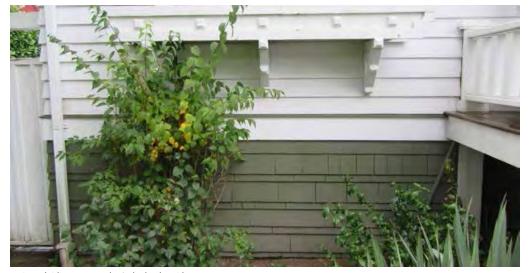
Variety of siding types on the Sutherland Residence

- Retain lap siding and restore in-place. Replace any damaged lap siding to match existing in material, size, profile.
- Combed or textured lumber, vinyl or fibre cement siding are not acceptable replacement materials on the historic house.
- Cleaning procedures of lap siding should be undertaken with non-destructive methods.
   Areas can be cleaned using a soft, natural bristle brush, without water, to remove dirt and other material. If a more intense cleaning is required, this can be accomplished with warm water, mild detergent (such as Simple Green) and a soft bristle brush. High-pressure power washing, abrasive cleaning or sandblasting should not be allowed under any circumstances on any historic material of the exterior elevations.
- Install new double-coursed cedar shingles at the basement level matching the originals in overall dimensions and installation pattern.

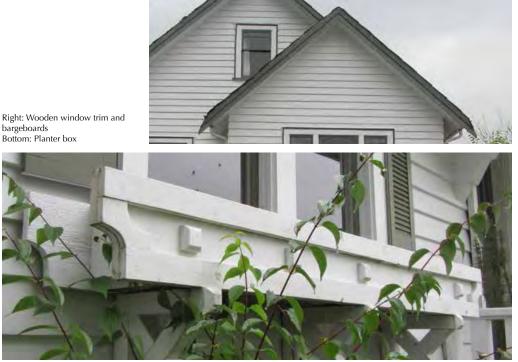
bargeboards

- Retain original trim including fascia and bargeboards, window and door trim that is in good or repairable condition.
- Cut out deteriorated trim sections and install matching trim board that is visually and physically compatible with the original.
- If the watertable cannot be preserved, salvage and reinstated at the new locatio, or replicate to match the original in material and dimensions.
- Retain the wooden planter boxed on the front facade of the house and repair as necessary.
- Combed or textured lumber, vinyl or fibre cement siding are not acceptable replacement materials on the historic house.

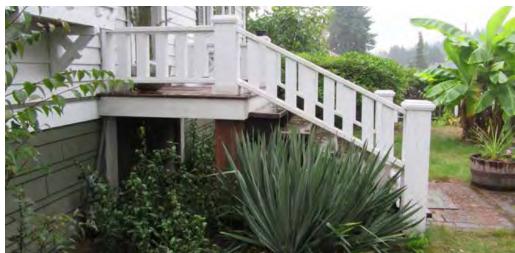
Front entryway

- Rebuild the front deck at the new location using salvaged material, if possible. Construct a new side-facing stair with wooden treads.
- The original height of the balustrade should be preserved. Only if necessary use alternate compliance method to meet building code requirements, e.g. installing glass panels or metal railings.
- Preserve the hip roof above the entry.
- Restore wood elements as required.

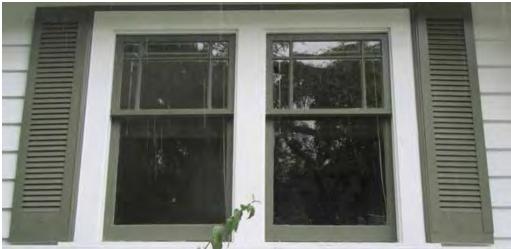
Top: Triangular siding-clad knee brackets; Bottom: Window assembly of the front facade

The window configurations were reviewed during site visits in October 2015 and March 2016. The house features on the front and side elevations original sixover-one double-hung, wood sash windows in single, double and tripartite configurations. The large tripartite window assemblies have a fixed centre sash with an arched header flanked by narrow double-hung sashes on either side. Multi-lite piano windows with true divided panes are also located on the side elevations. Only two windows on the rear elevation appear to be original while new door and window assemblies were introduced. Wide window trim with a surrounding moulding, thick mullions between double and tripartite assemblies, and simple wood sills are also original. The windows and trim and all in good condition when visually reviewed from the ground. The existing shutter elements on the front facade require further investigation to determine, if they are to be retained.

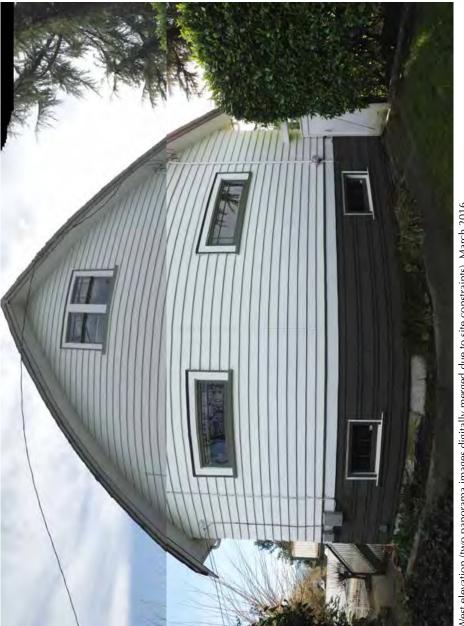
West elevation (two panorama images digitally merged due to site constraints), March 2016

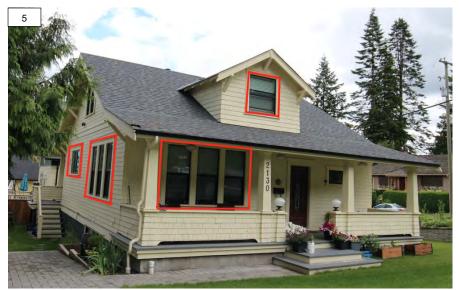
Figure 5: South-west view of Moisio Residence outlining non-wood new and replacement windows.

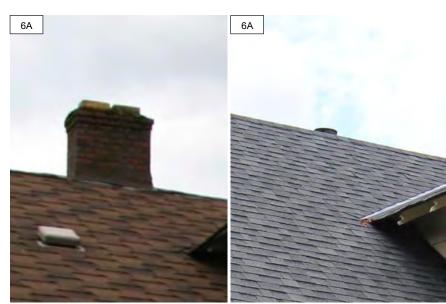
Figure 6A: Internal brick chimney with corbelling before removal. Figure 6B: Observed chimney at time of review.

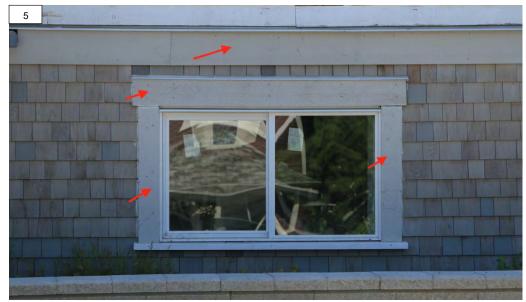
Figure 5: Detail photo showing textured lumber applications at window casing and watertable prior to painting.
