# P. BURNS & CO. BUTCHER SHOP

2419 CLARKE STREET, PORT MOODY

## CONSERVATION PLAN

OCTOBER 2021

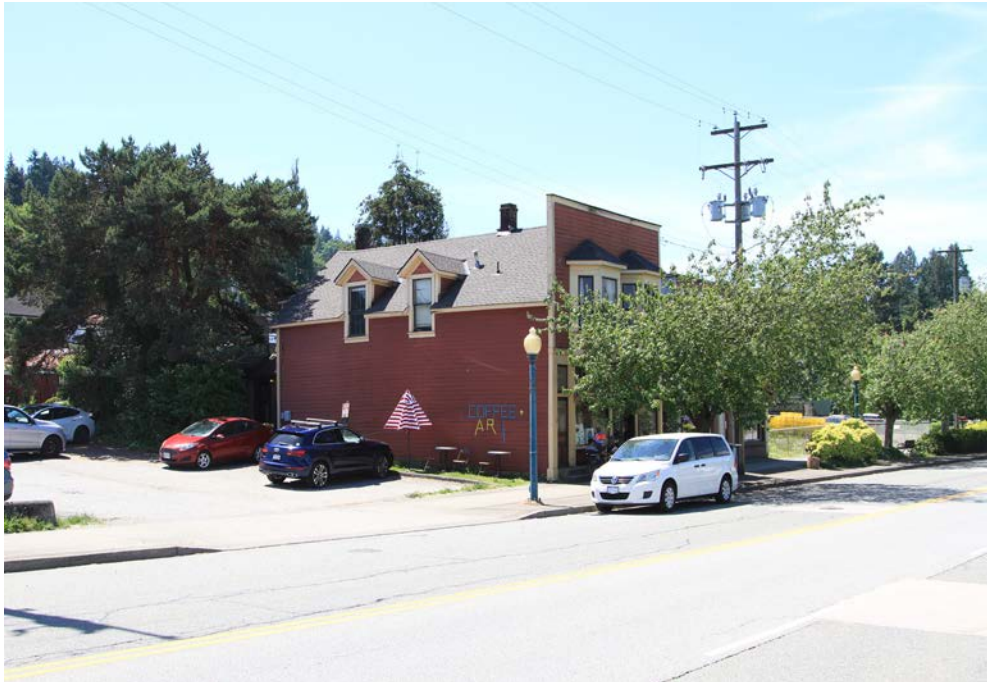
*Last surviving heritage commercial structure along Clarke Street, the P. Burns & Co. Butcher Shop was built in 1908 to 1909 by Patrick Burns & Co., Calgary, as part of their extensive chains of butcher stores. It remains as the only surviving example of a 'Boomtown' false-facade. This was achieved by which the front of the building rises to form a parapet (upper wall) above the roof line which makes for a more impressive facade.*

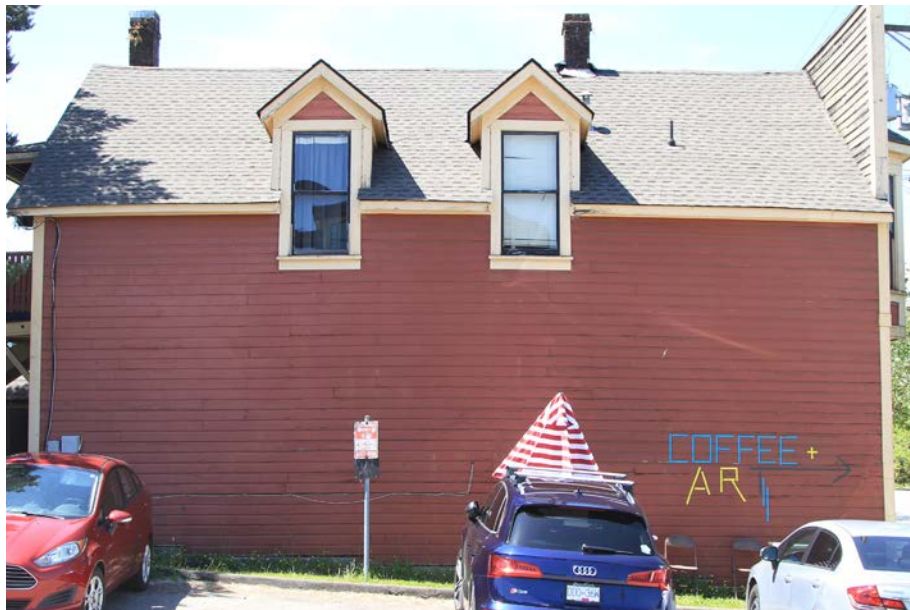
*August 2021 East Elevation of building features a stepped poured-in-place concrete foundation following the slope of the site. The intent is to relocate the heritage building to its new location on Spring Street corner Queens Street.*

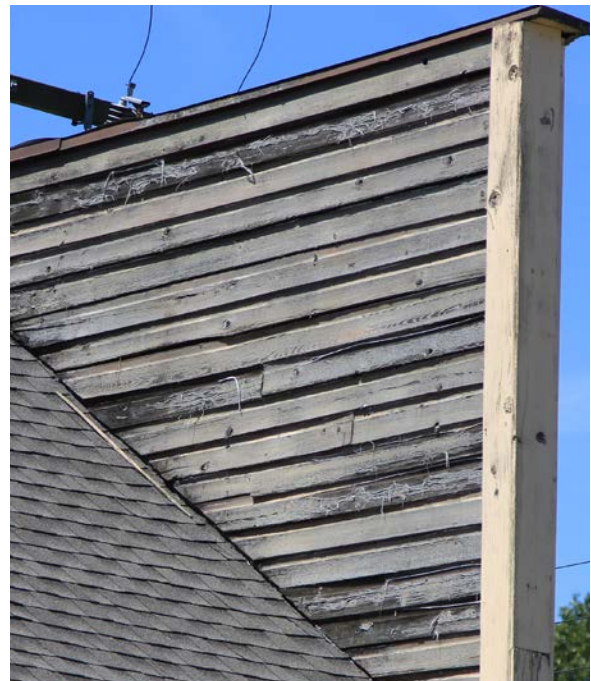
*Right: South facing weathered original drop wood siding of false-front facade in varying states of deterioration. Visible signs of pest infiltration is clearly evident on sections of the exposed sidings. Warping and buckling as a result of excessive moisture is visible. Overall exposure to weather and time has exposed all surfaces and is in need of proper maintenance.*

- Due to the integrity of wood frame structure, the exterior walls should be preserved through retention and in-situ repair work.
- Preserve the original wood-frame structure of the historic building.
- Preserve original siding on all elevations, if possible, and clean surface for repainting.
- Replace damaged siding to match existing in material, size, profile and thickness.
- Design structural or seismic upgrades so as to minimize the impact to the character-defining elements.
- Cleaning procedures should be undertaken with non-destructive methods. Areas with biological growth should be cleaned using a soft, natural bristle brush, without water, to remove dirt and other material. If a more

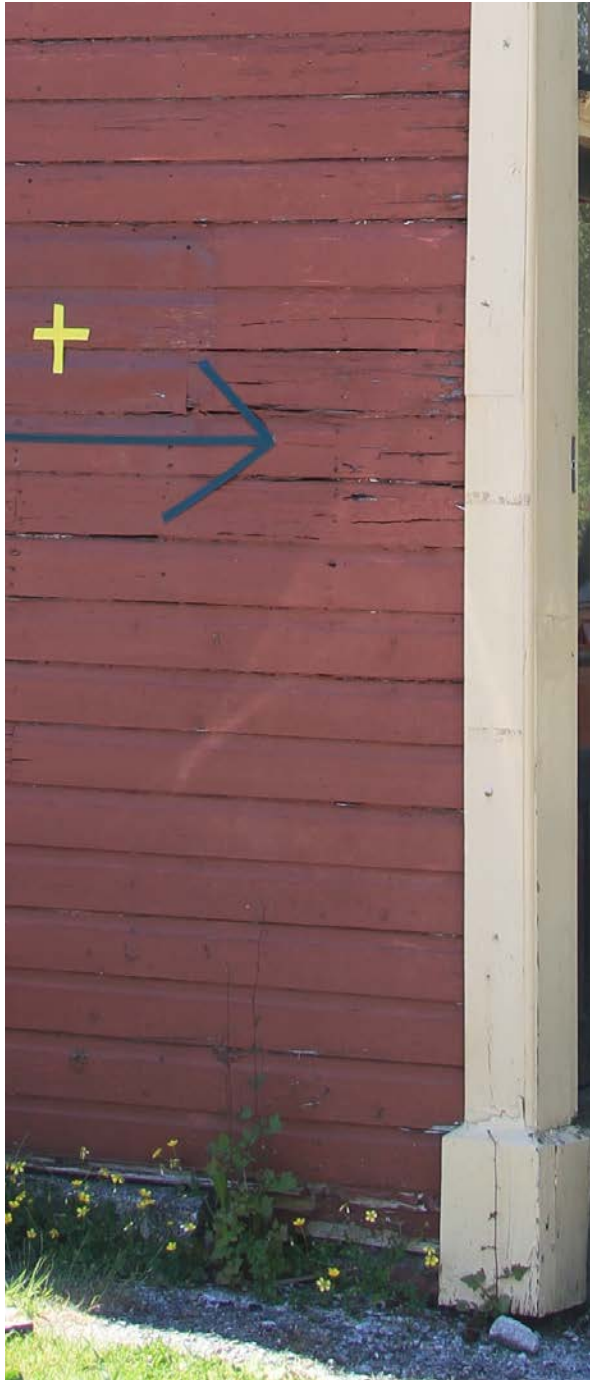
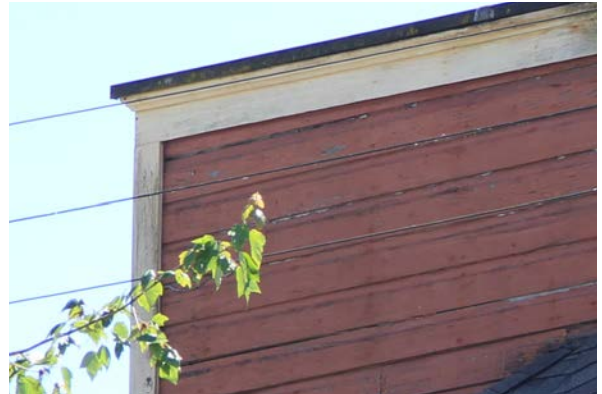
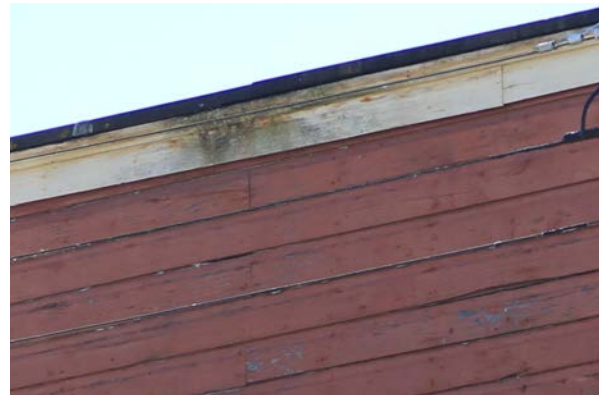
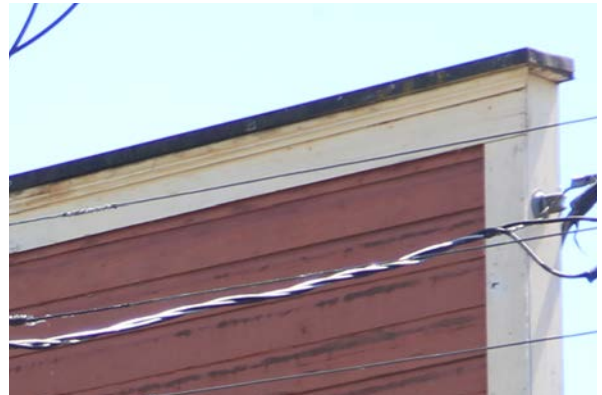
*Current state of drop wood sidings on east and north elevations of the building. August 2021. Evidence of cracks, splitting, breaking of wood is visible. Peeling flaking and staining of paint on the facade after decades of exposure to the elements.*

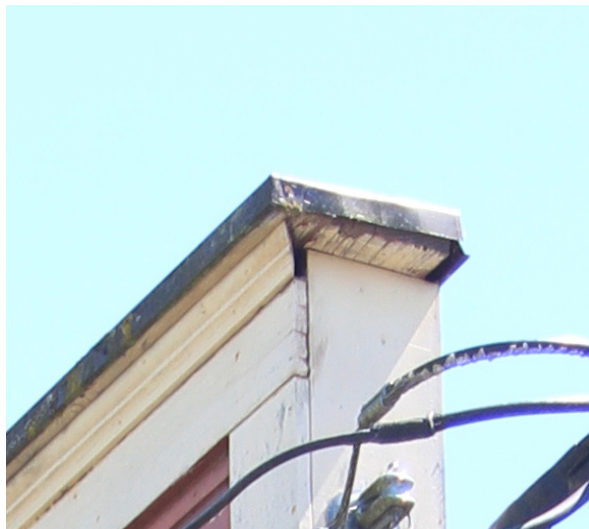
The existing entablature and metal flashing over the false-front facade's appears to have been replaced since it was built. Deterioration of the wood coping and metal flashing due to exposure of its underside to rain and water was noted during visual inspection from the ground level. Crown mouldings have been removed on either ends of the entablature.

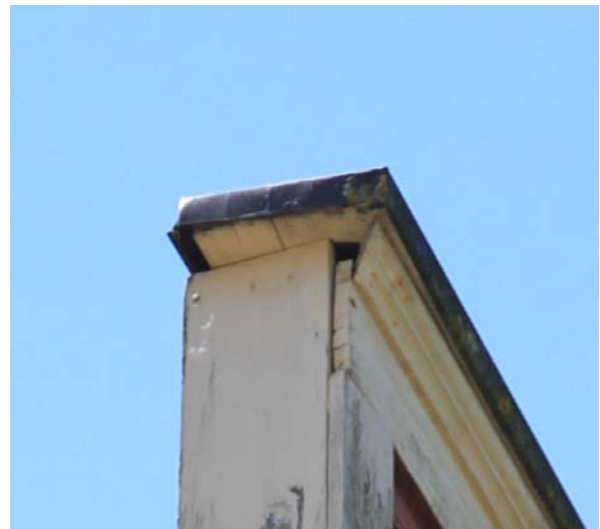
*Current state of entablature and metal flashing on left and right sides of the false-front 'Boomtown' facade. Note missing crown mouldings on the returns.*

- Evaluate the overall condition of the parapet cap flashing to determine whether more than protection, maintenance and limited repair or replacement in kind is required.
- Remove corrosion that may be discovered upon close inspection, patch and repair, caulk joints as required and apply appropriate primer for galvanized surface.
- Repair or replace deteriorated flashing, as

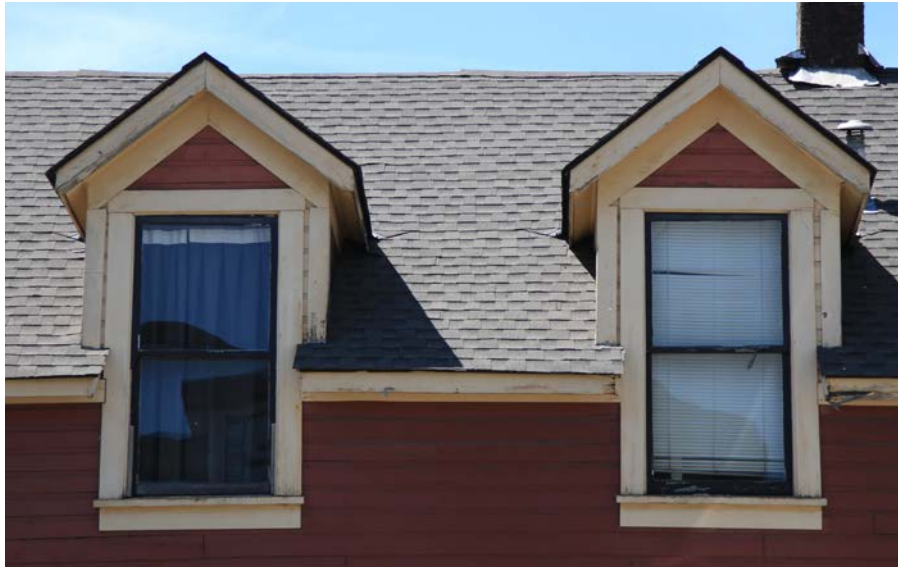
*Two sets of extant roof dormers on the East and West elevations of the building with one-over-one, double-hung wood windows appear to have been restored and preserved. Further investigation to determine its condition to be done when possible.*

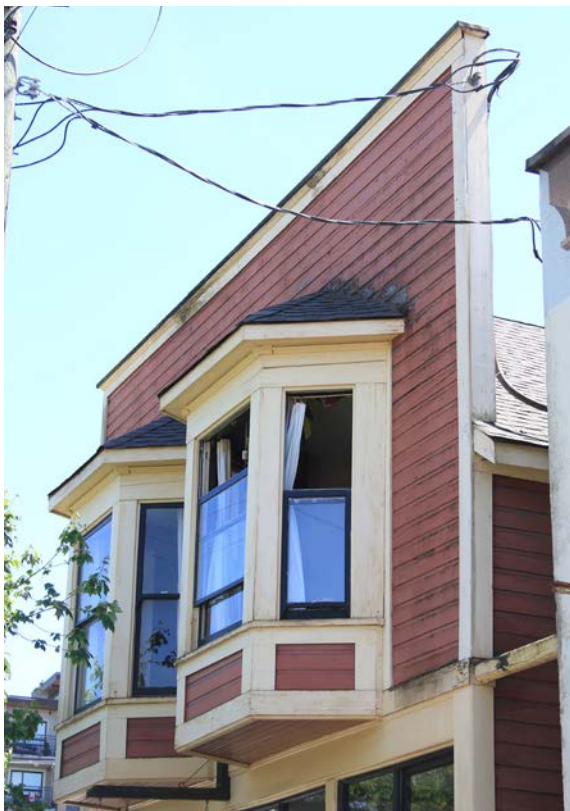
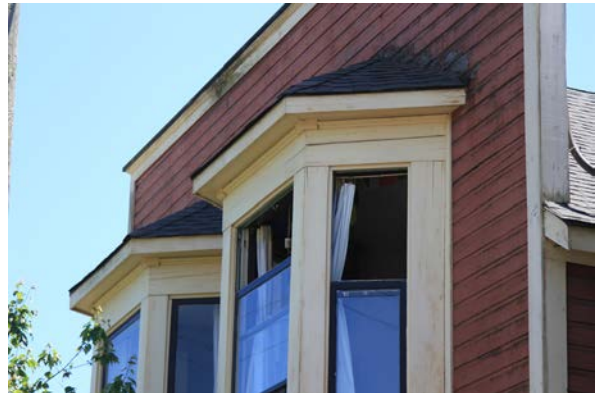
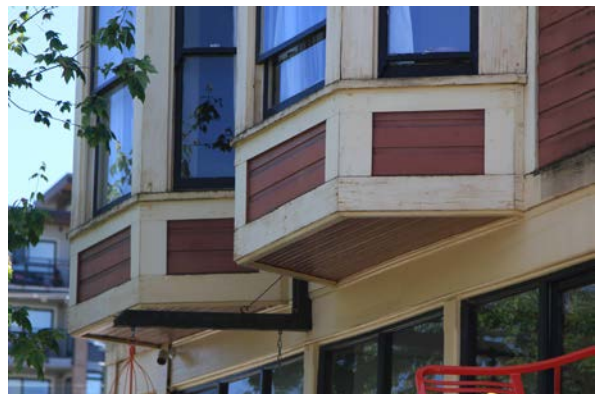
*Two extant projecting hexagonal bays above the storefront with three operable double-hung, one-over-one extant wood windows appear to have been restored and preserved.*

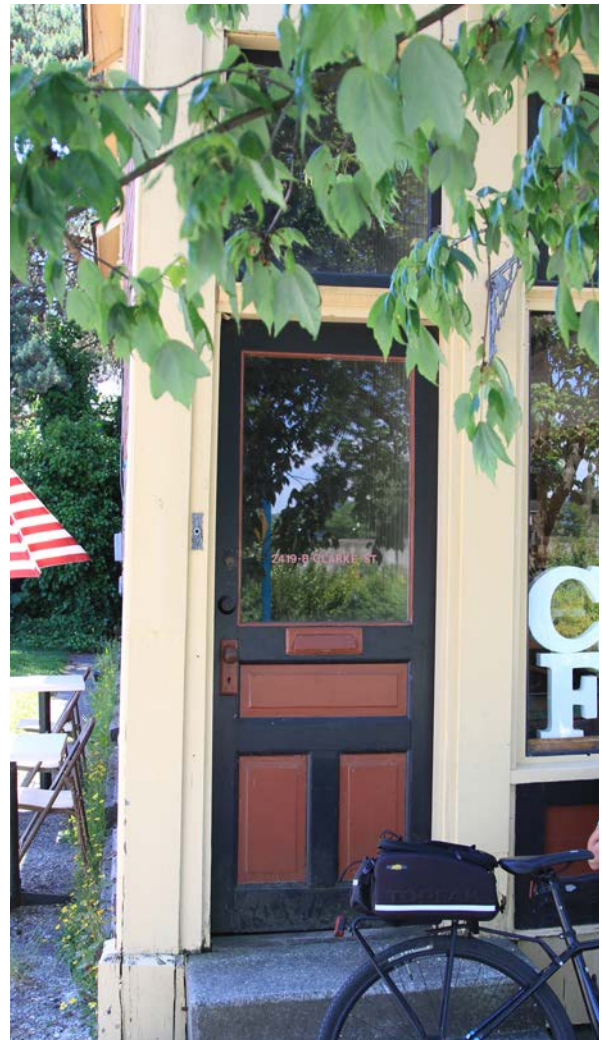
Twin wood-framed glass doors with double action spring saloon door hinges are original to the storefront's central entrance and a similar single wood-framed glass door for access to the upper level remain extant on the east side of the front elevation. A rear door on the south elevation has been observed but not reviewed at the time of this review and will have to be verified.

*Original door opening on east side of the front elevation provides direct access from Clarke Street. Note metal mail slot, door hardware original to the paneled combination 2/3 glass and (3) Three panelled door.*

All extant door assemblies original to the heritage structure should be refurbished, repaired and restored as part of the conservation.

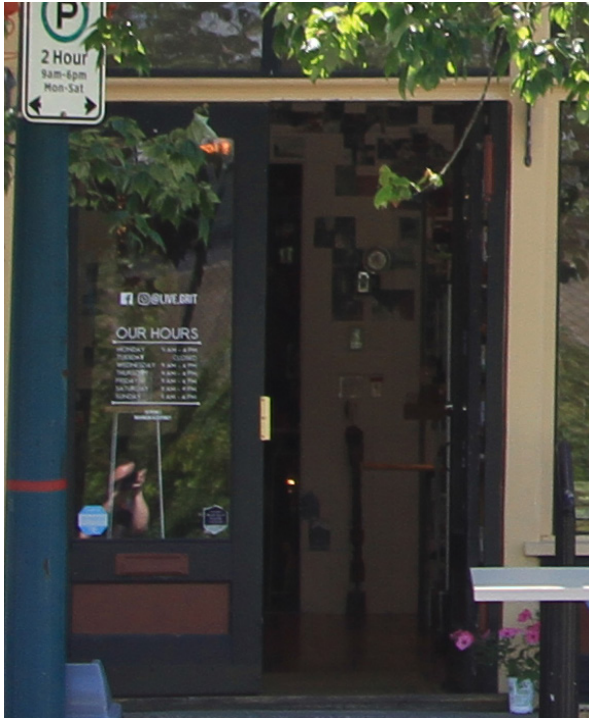
Existing double swing doors of main level commercial space facing Clarke Street. Note original metal mail slot on left paneled combination 3/4 glass and (1) One paneled door.

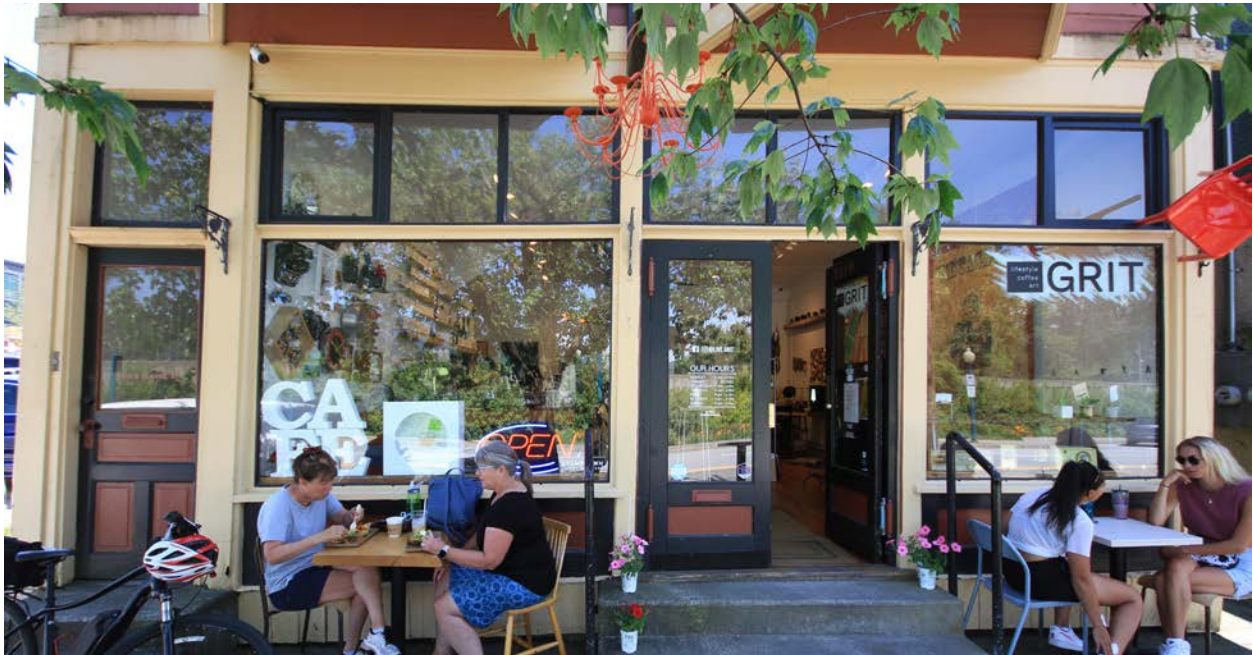
The existing false-front storefront retains original fine woodworking details still evident on all its vertical and horizontal wood framing. The centrally located double doors and are framed by two large display windows with a solid base and overhead transoms. Adjacent to the commercial storefront towards the east is the entry doorway that leads to the upper level. The residential doorway is framed by an overhead transom. All window glazing appears to have been replaced with new.

Existing Storefront wood elements: Tapered central posts with chamfered edges flanking main doorway, transom window horizontal banding across entire building facade equally divided into 8 panels, 3 of which are operable; 2 oversized window displays over paneled storefront base; 2 corner end posts and signage banding over transoms framing the main level units.

Further investigation is necessary to verify the condition of entire storefront and its components in order to determine the best approach for its conservation.

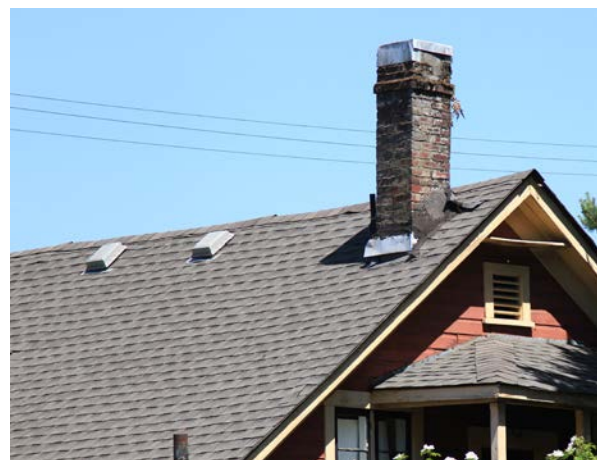
The building features two internal brick chimneys. Access was not available at the time of investigation, and further inspection is required. Condition and structural integrity of both original chimneys are unknown. Visual observation from the ground level shows extensive biological growth on both chimneys; possible structural failure; in need of cleaning; remortaring and repointing.

Chimney may be rehabilitated or dismantled and re-built as per relocation requirements, and should replicate historic original as per archival photos, as possible.

- Preserve the chimneys in its original configuration, if possible.
- Both chimneys may require structural stabilization.
- Investigate condition of brickwork. If required, brickwork may be repointed and cleaned using a natural bristle brush and mild rinse detergent.

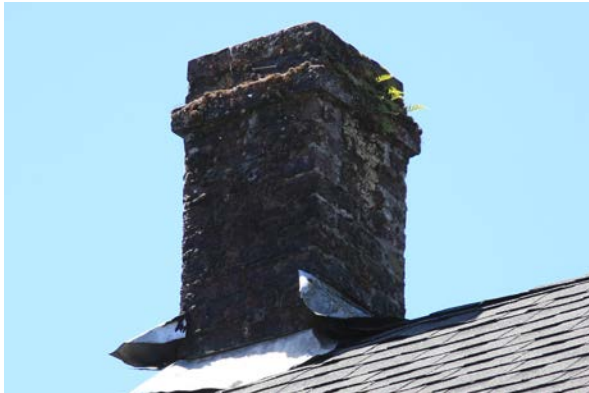
*Extant chimney on the northeast side of the roof towards to front of the building at the apex of the gable roof*

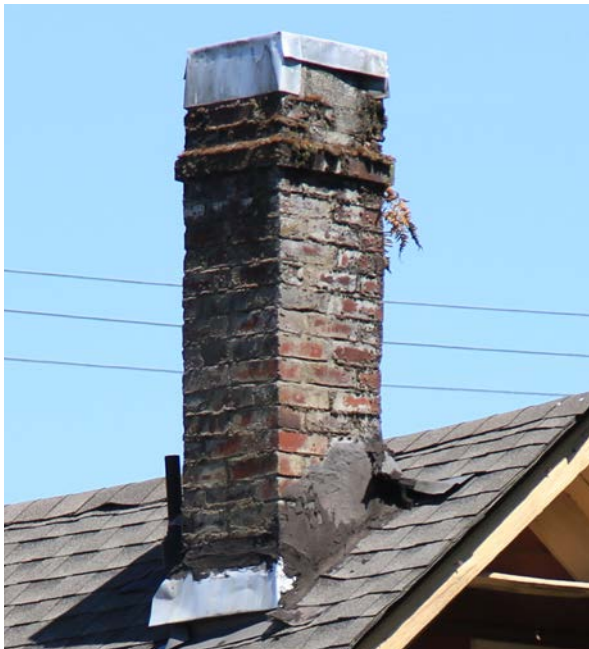
*Extant chimney on the southwest side of the roof at the rear of the building.*

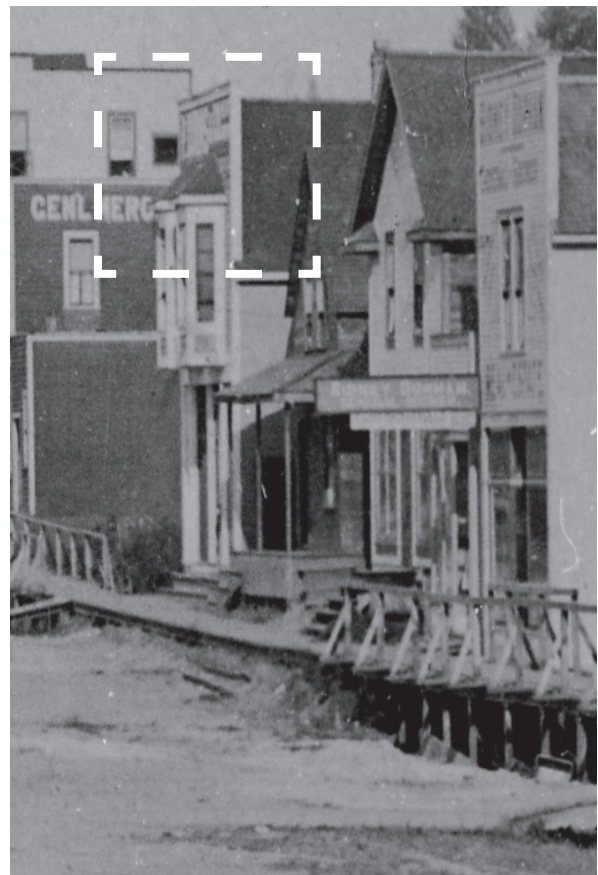
*Dashed lines of painted 'P. Burns & Co.', above projecting bay windows advertising their business.*

As part of the redevelopment, the facade fronting Clarke Street would benefit from a paint analysis to uncover painted ghost signs of the past that might have been original to the structure at the time it was built.
