## ***Environmental Assessment and Restoration Plan***

**2025 St. Johns Street  
Port Moody, BC**

**Prepared for: Marcon Albert (GP) Ltd.**

**Project No. 14296  
April 2022**

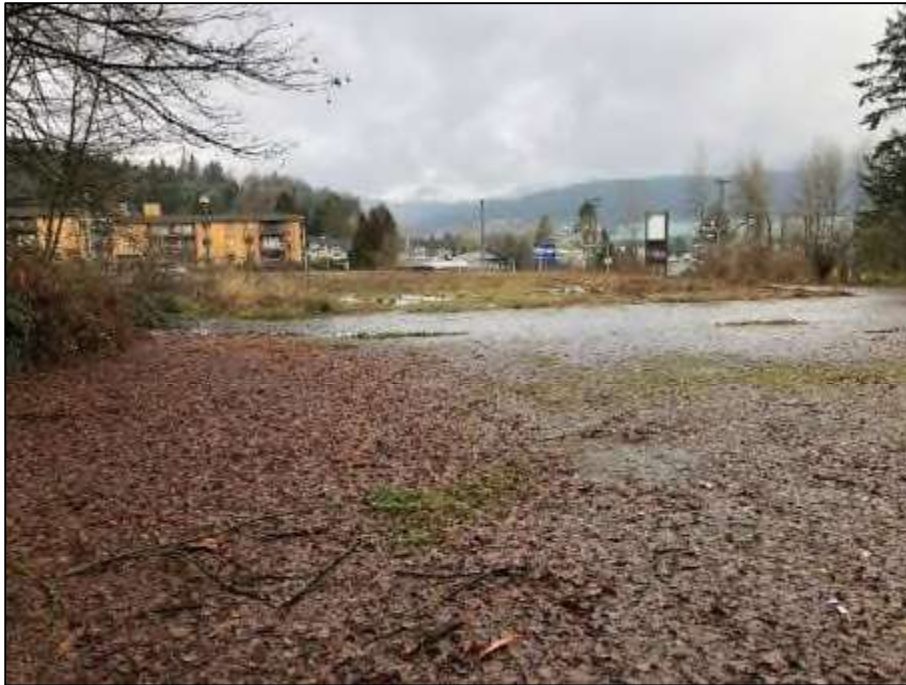
The majority of the Site that had evidence of previous development was relatively flat, and the surface conditions were composed of asphalt paving or hard-packed gravel (Photograph 1). The edge of the exiting asphalt is presented on Figure 1. There was a narrow slope of maintained grass located at the north perimeter of the paved/gravel area, located above an existing retaining

**Photograph 1:** Looking northeast at the brownfield portion of the Site.

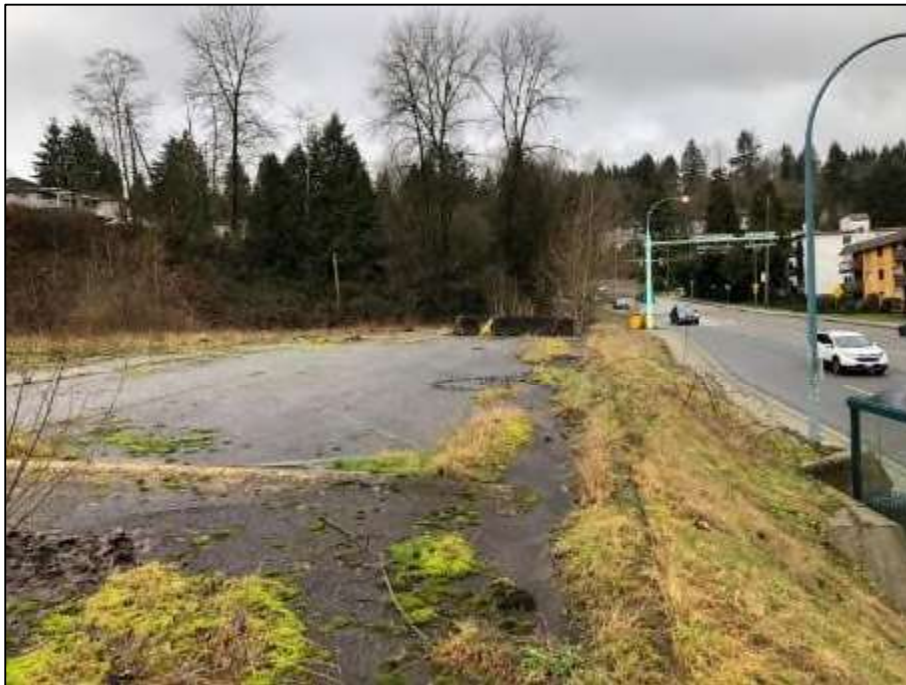
wall (Photograph 2). This retaining wall extended around the Site frontage on St. Johns Street and Albert Street to support the raised elevation of the Site.

**Photograph 2:** Looking west at the north perimeter of the Site.

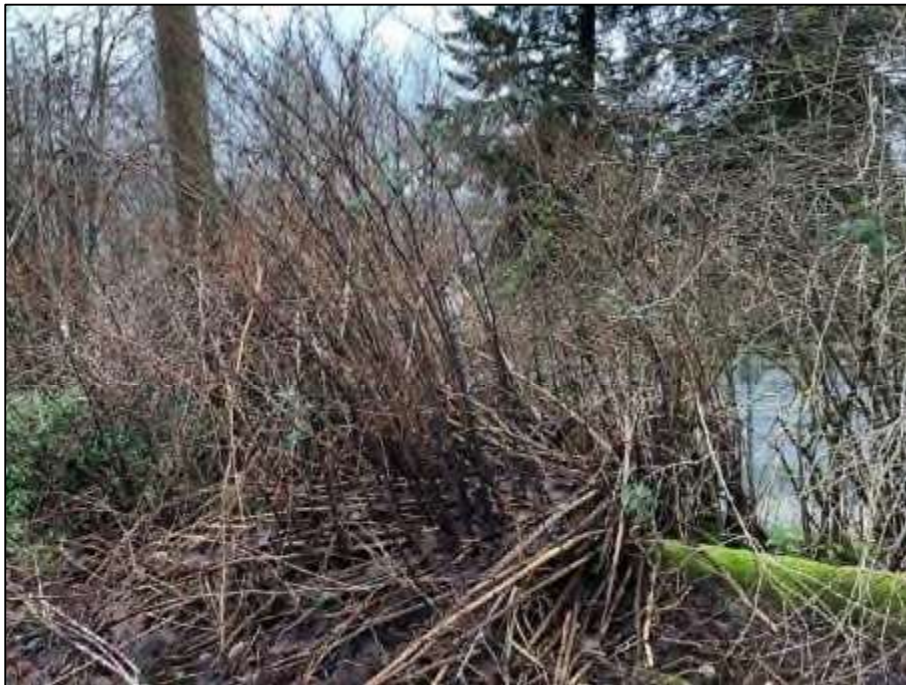
Landscaping vegetation was present on the east perimeter of the Site. A patch of Japanese knotweed, approximately 40 m<sup>2</sup> in area, was present near the northeast corner of the Site (Photograph 6).

**Photograph 6:** Looking northeast at canes of Japanese knotweed located near the northeast corner of the Site.

According to the City, knotweed treatment did not take place in 2019. It is recommended that chemical knotweed treatment by a professional applicator during the growing season be considered prior to construction and vegetation removal.

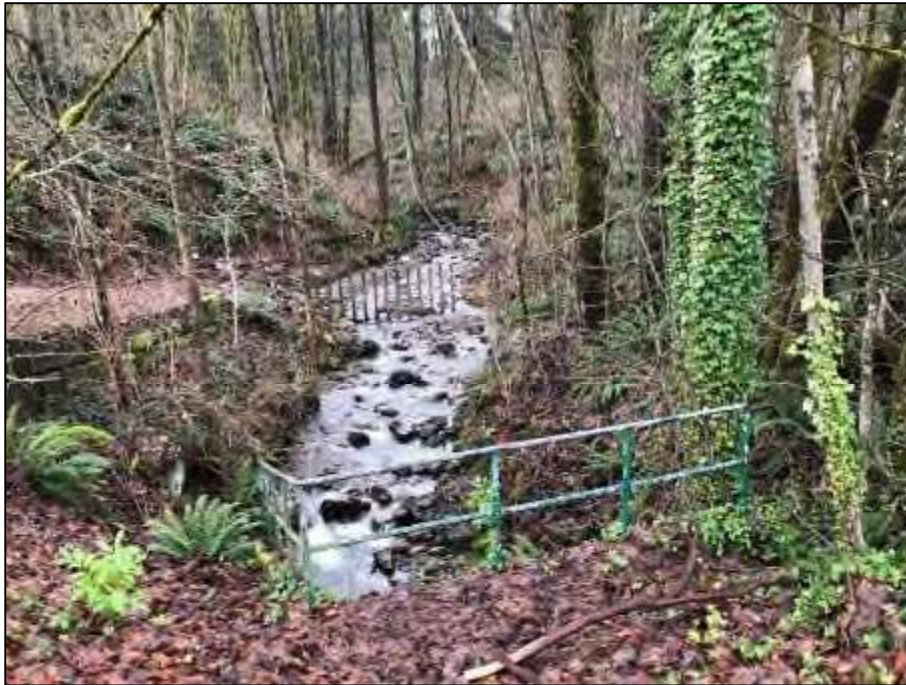
Based on observations and measurements recorded during the initial field assessment on August 14, 2018, Schoolhouse South Creek flows northeast in a low-gradient (approximately 2%) channel. Channel width averaged 5.1 m and instream substrate was mixed, dominated by gravel, cobble, and sand, with sub-components of boulders and fines (Photographs 7 and 8).

**Photograph 7:** Looking west at Schoolhouse South Creek from the edge of Albert Street.

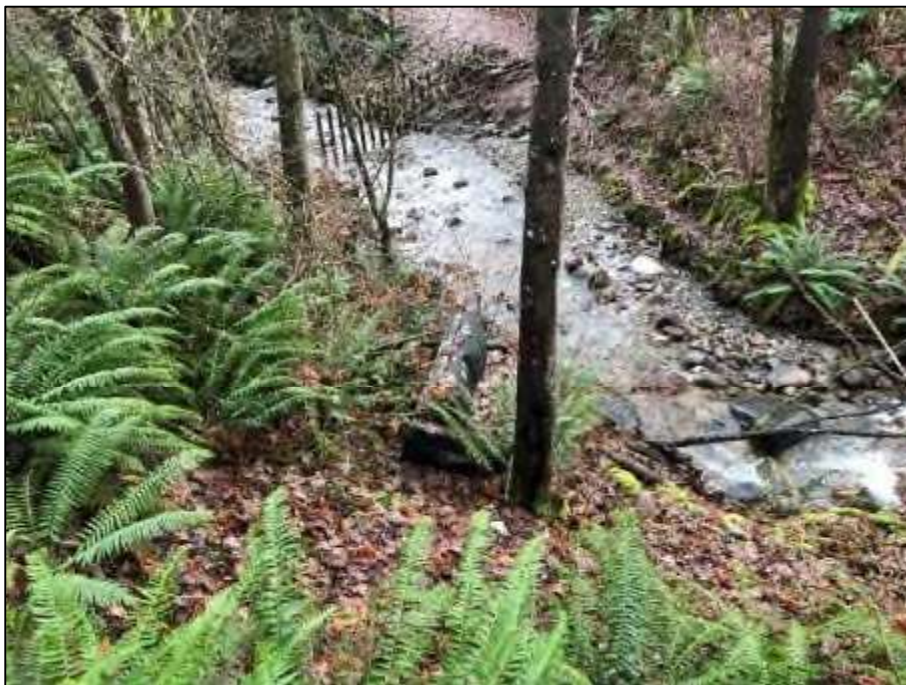
**Photograph 8:** Looking southeast at Schoolhouse South Creek from the top-of-bank immediately south of the Site.

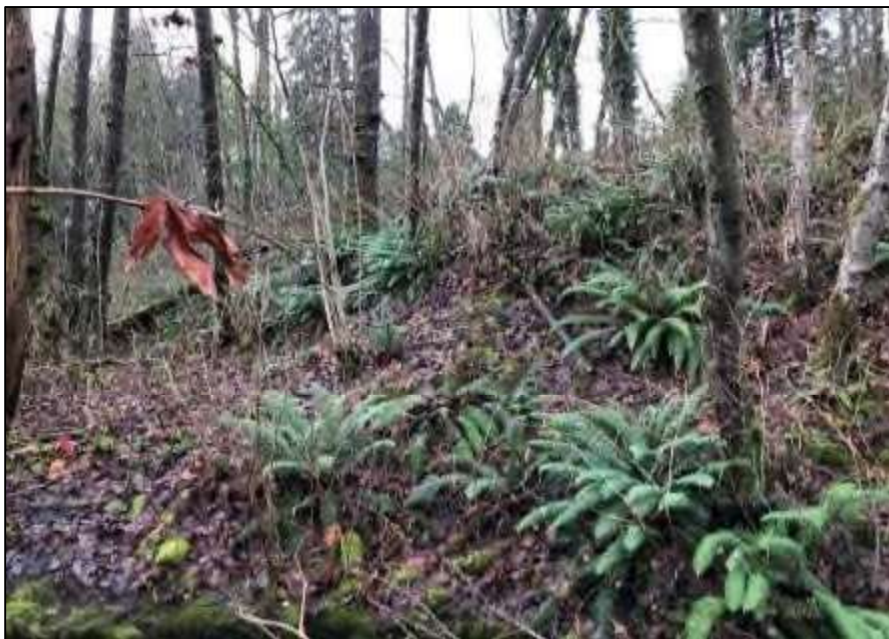
(*Athyrium filix-femina*) and red elderberry (*Sambucus racemosa*) as the main sub-dominant species (Photograph 10).

**Photograph 10:** Looking northwest at native understory vegetation on the north bank of Schoolhouse South Creek.

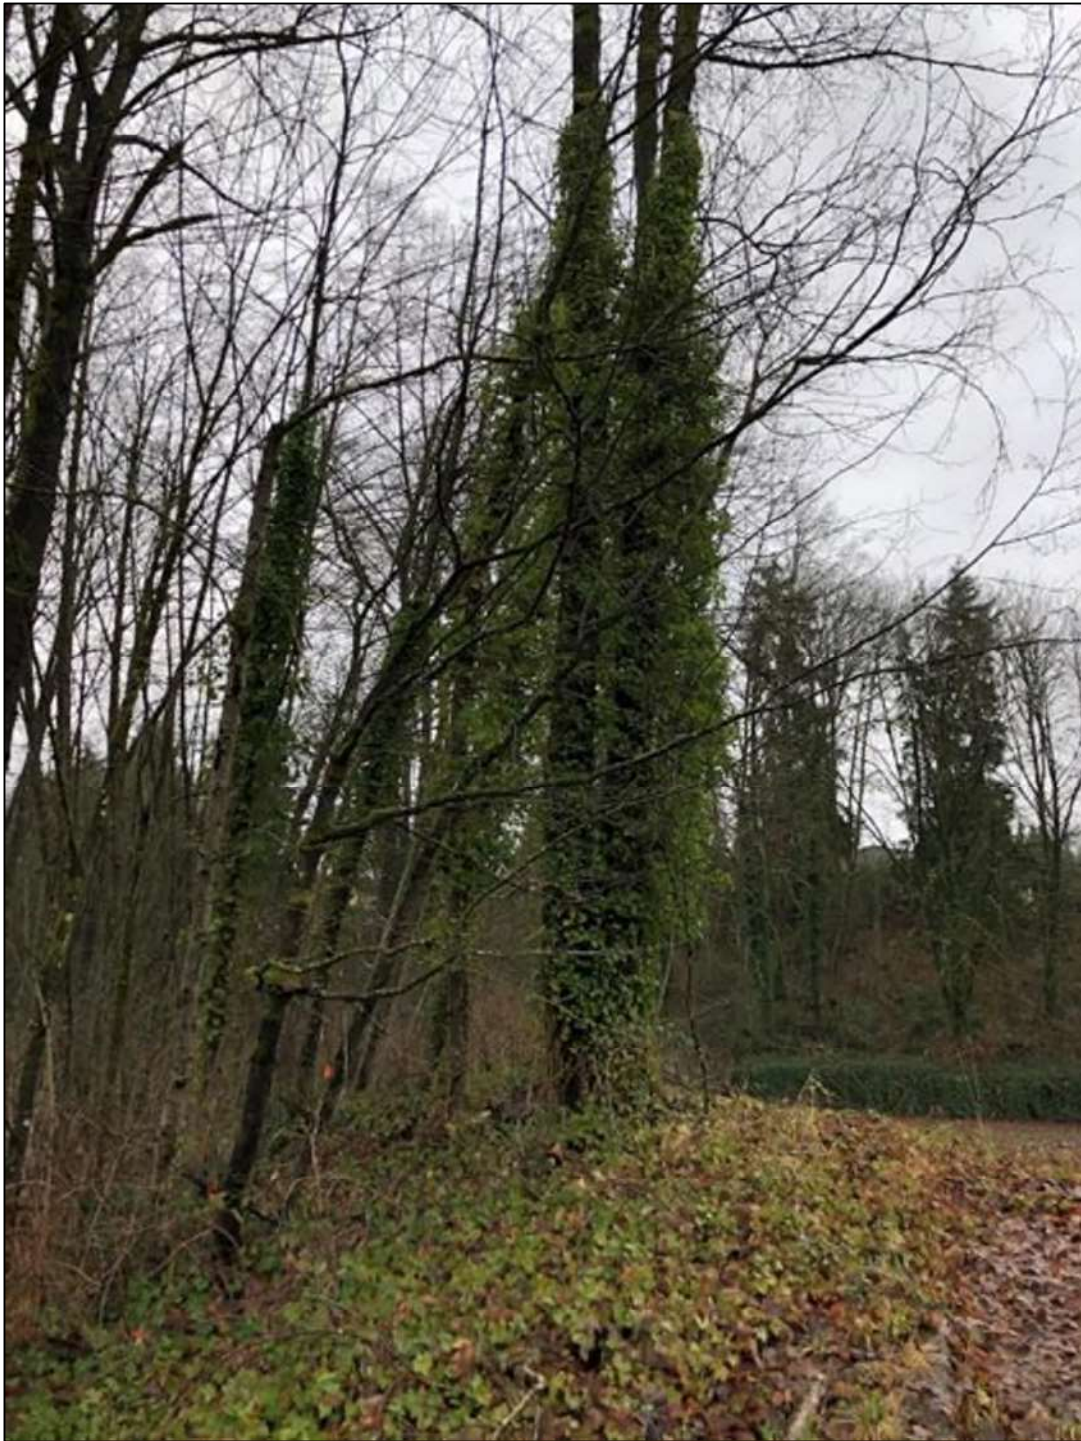
Significant invasive vegetation was present in the Schoolhouse South Creek riparian area, particularly near and above the top-of-bank in the road right-of-way on the northwest side of the brook. English ivy (*Hedera helix*) was well-established along the top-of-bank and appeared established on a significant portion of the native trees in this area (Photographs 11 and 12). Occurrences of English holly (*Ilex aquifolium*), spurge laurel (*Daphne laureola*), cherry laurel (*Prunus laurocerasus*) and small-flowered jewelweed (*Impatiens parviflora*) were also observed in the riparian area.

**Photograph 11:** Looking west at English ivy growing on trees near the Schoolhouse South Creek top-of-bank.

- Ivy vines should be cut and pulled from the ground, taking care to minimize damage to native shrubs.
- Ivy on trees should be cut at a comfortable height (e.g., 1.5 m). The rooted portion of the vine should be pulled by hand and the upper portion should be left to desiccate, as removal may harm the tree.

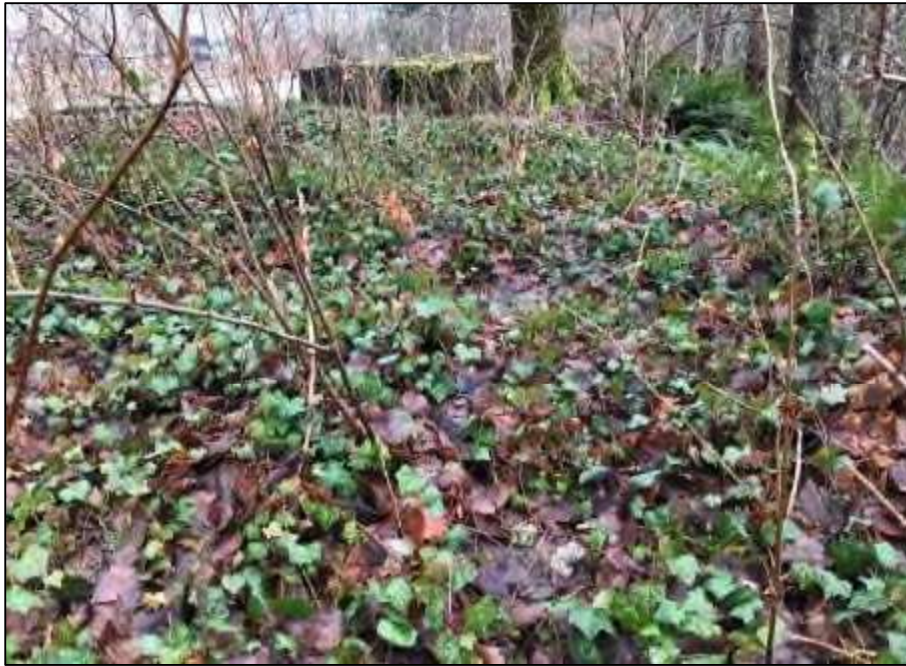
**Photograph 12:** Looking northeast at ground-cover ivy located above the top-of-bank in the Schoolhouse South Creek riparian area.

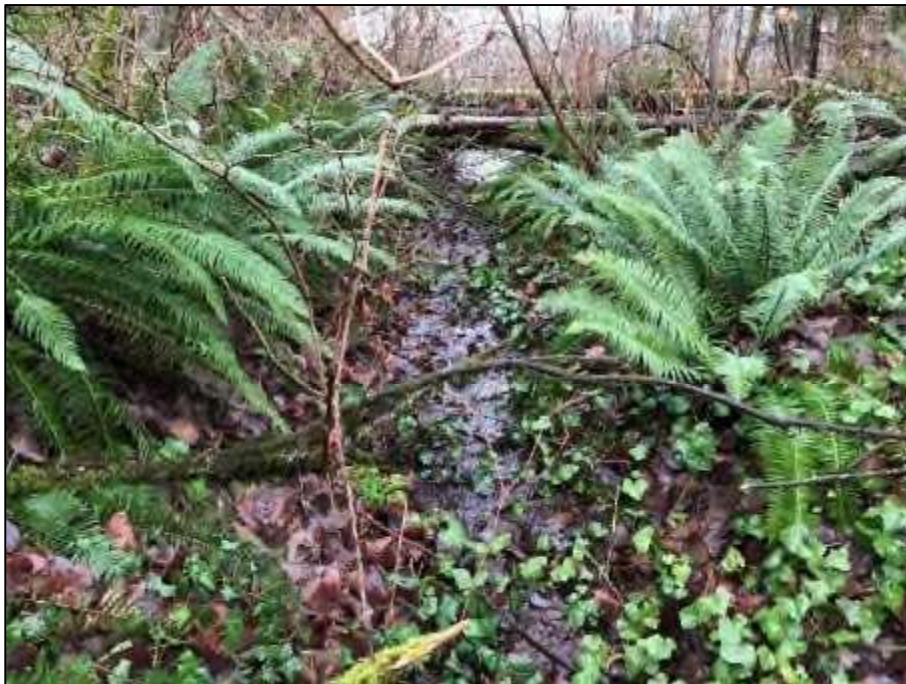
An unnamed ditch was identified within the Schoolhouse South Creek riparian area south of the Site (Figure 1) (Photograph 13). The ditch did not originate from headwaters or a significant source of groundwater, and appeared to collect surface water flow from the slope to the west. The upper reach was linear, with a consistent channel width of 1.4 m, suggesting it may be a historically constructed drainage channel. The ditch appeared ephemeral as it was dry during the August 14, 2018 field survey but contained water during the January 24, 2019 survey (Photograph 14). Water in the ditch appeared stagnant and flow was not observed during the January 2019 visit, however, scour patterns in the leaf litter on the bank of Schoolhouse South Creek indicated that water from the ditch flows to the brook during rainfall events. This ditch is considered to be non-fish bearing, based on the lack of upstream fish habitat and the steep slope between the watercourse and Schoolhouse South Creek.

**Photograph 13:** Looking north and upgradient at the unnamed drainage ditch.

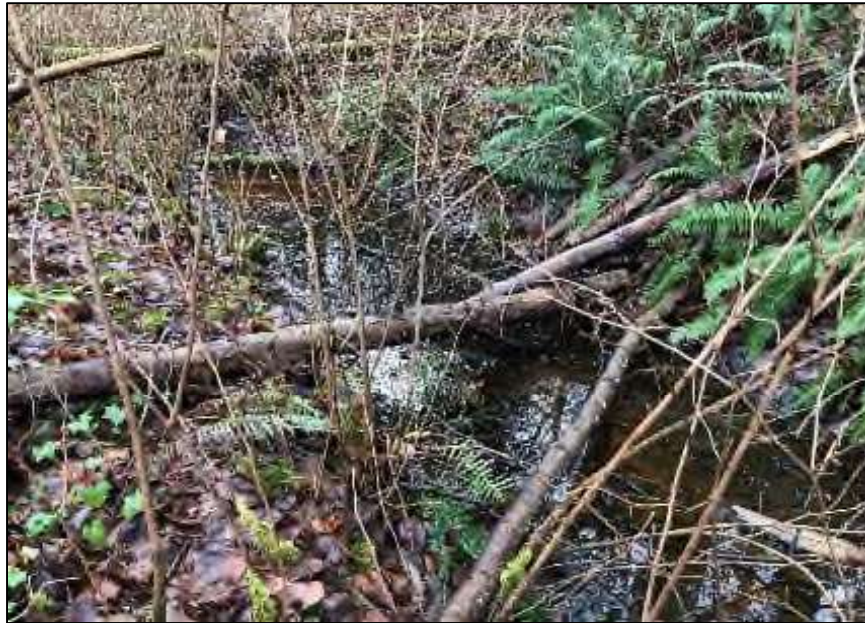
**Photograph 14:** View looking down-gradient of the upstream excavated section of the unnamed drainage ditch.

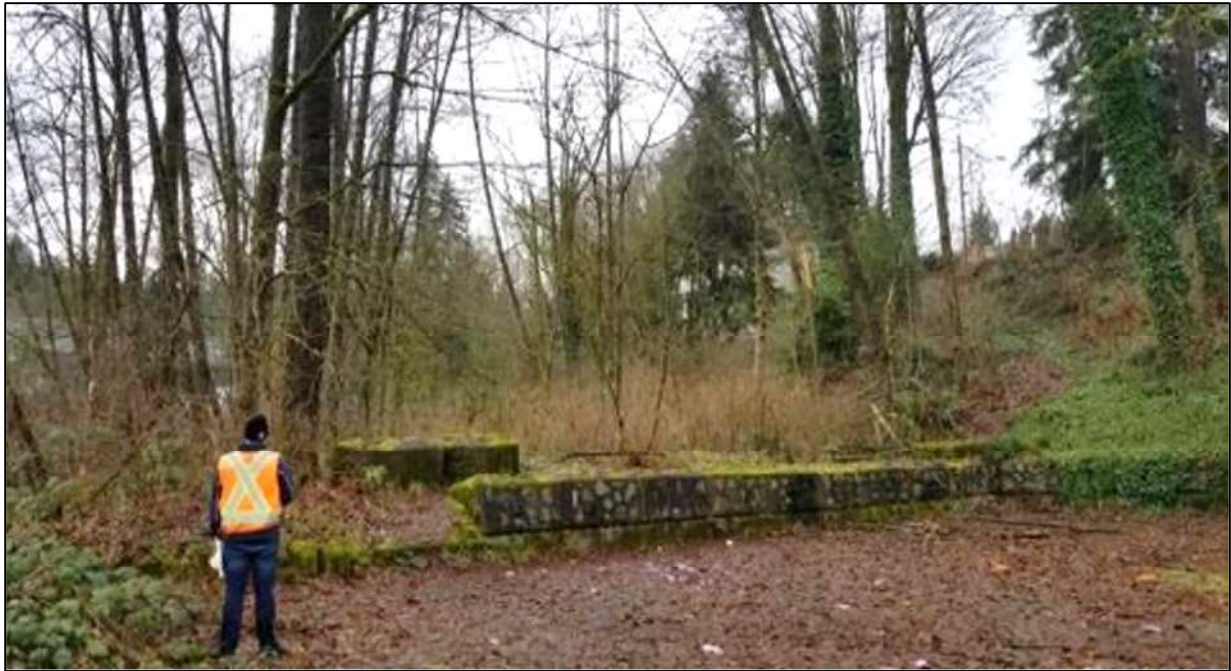
**Photograph 16:** Looking southwest at the southwest corner of the lock block retaining wall located within the Schoolhouse South Creek riparian area.

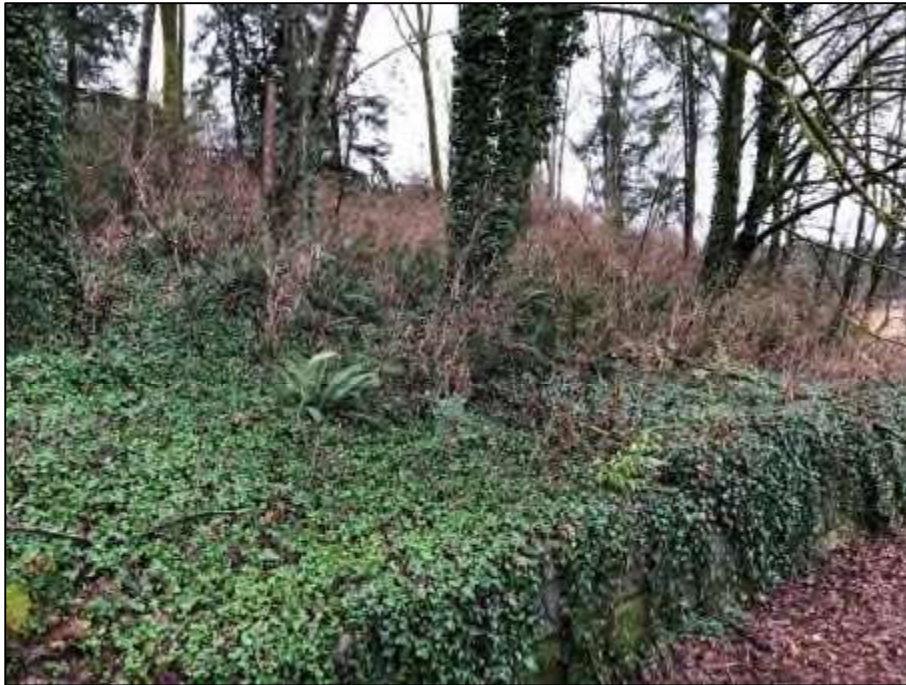
**Photograph 18:** Looking northwest at extensive English ivy within the southern part of the ESA.

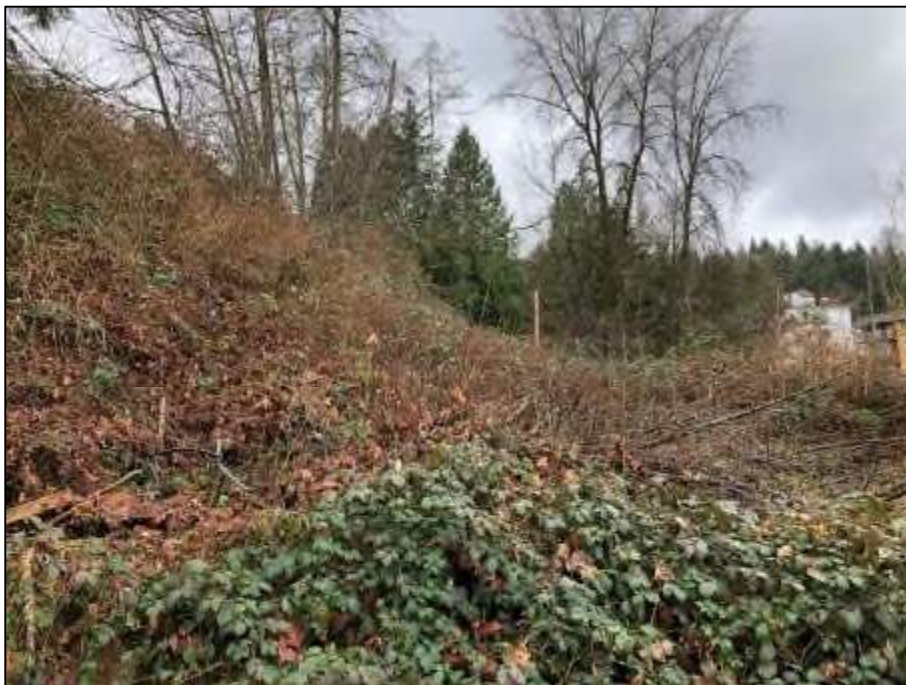
**Photograph 19:** Looking northwest at extensive Himalayan blackberry within the northern part of the ESA.

- Use due care and attention when grubbing and clearing near native trees to prevent root, bole and stem damage. Low-intensity removal with use of hand-held manual or powered equipment where possible when clearing blackberry material within the drip line of native trees while achieving a 10-30 cm root removal depth.

- Shake soil loose from rhizomes and avoid plant material left in the soil, as blackberry can become re-established from root fragments.
- Use tarps, plastic sheets or equivalent to contain plant fragments for disposal separate from the soil, and dispose off-site at a facility that accepts invasive plant material.

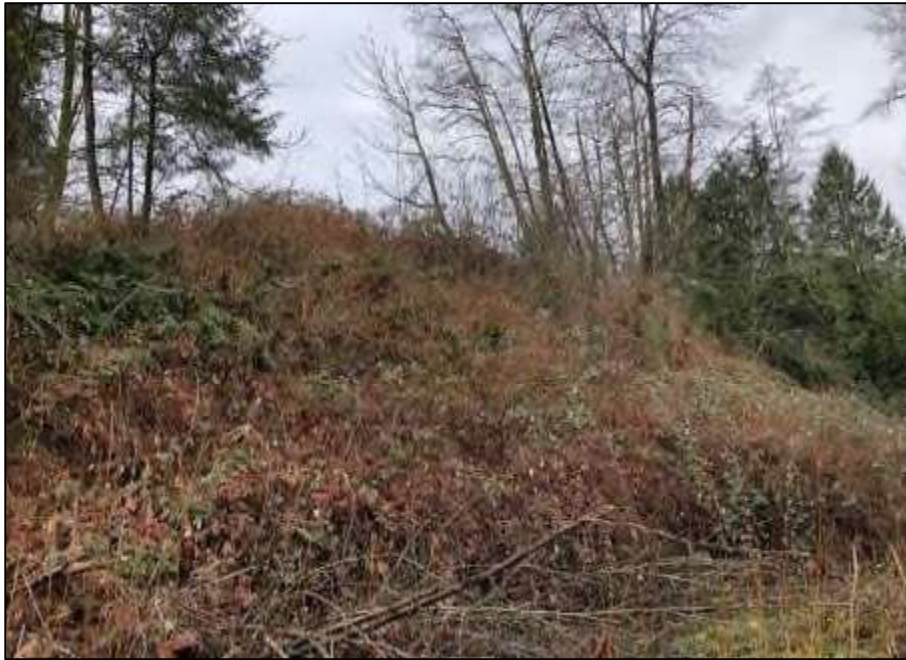
Evidence of a historic slope failure was visible near the central on-Site portion of the ESA, which included a portion of the slope where mature trees were not present (Photograph 20), as well as accumulation of deadfall timber and soil/vegetation material on the paved area at the base of the ESA (Photograph 21). Areas originally designated by the City as ESA (located on and north of the lock block retaining wall, including the section north of the retaining wall in the northwest corner of the Site) were not found to exhibit typical ESA values due to the extent of asphalt (see attached topographic survey plan), previous disturbance from commercial land use, and dominance of invasive plant species. The approximately 139 m<sup>2</sup> paved area is considered to have Nil ESA value, as shown on Figure 1.

**Photograph 20:** Looking west at the section of the ESA slope where mature trees were not present.

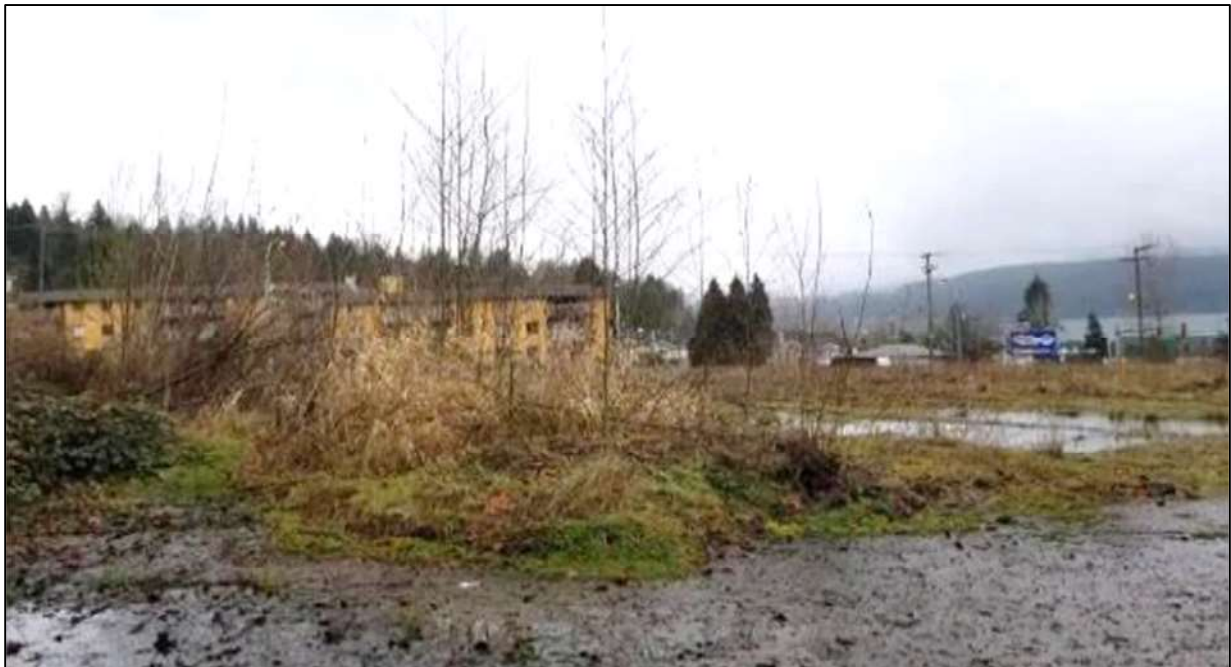
**Photograph 21:** Looking north at a mound of material with vegetation growth on top of asphalt.
