# City of Port Moody

## Report/Recommendation to Council

Date: November 29, 2022  
Submitted by: Community Development Department – Development Planning Division  
Subject: Rezoning (RS-1S) – 1008 Tuxedo Drive (CityState Consulting)

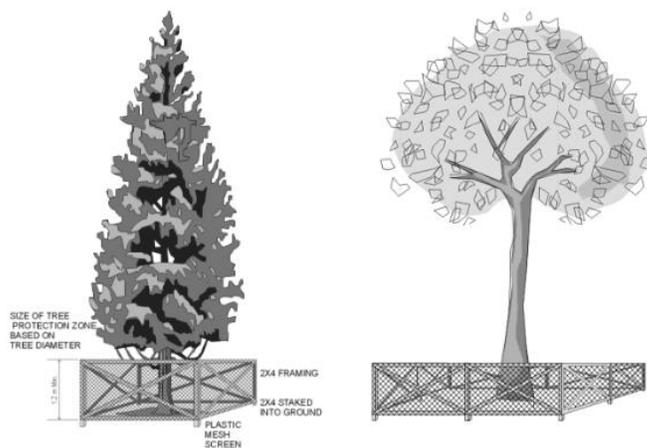
All trees identified above will require tree protection barriers to protect and prevent the tree trunk, branches and roots being damaged by any construction activities/operations. Prior to any construction activity on site, tree protection fences must be constructed at the specified distance from the tree trunks. The protection barrier or temporary fencing must be at least 1.2 m in height and constructed of 2 by 4 lumber with orange plastic mesh screening. Structure must be sturdy with vertical posts driven firmly into the ground. This must be constructed prior to excavation or construction and remain intact throughout the entire period of construction. Further standards for fencing construction can be found at: *City of Port Moody Tree Protection Bylaw, 2015, No. 2961*

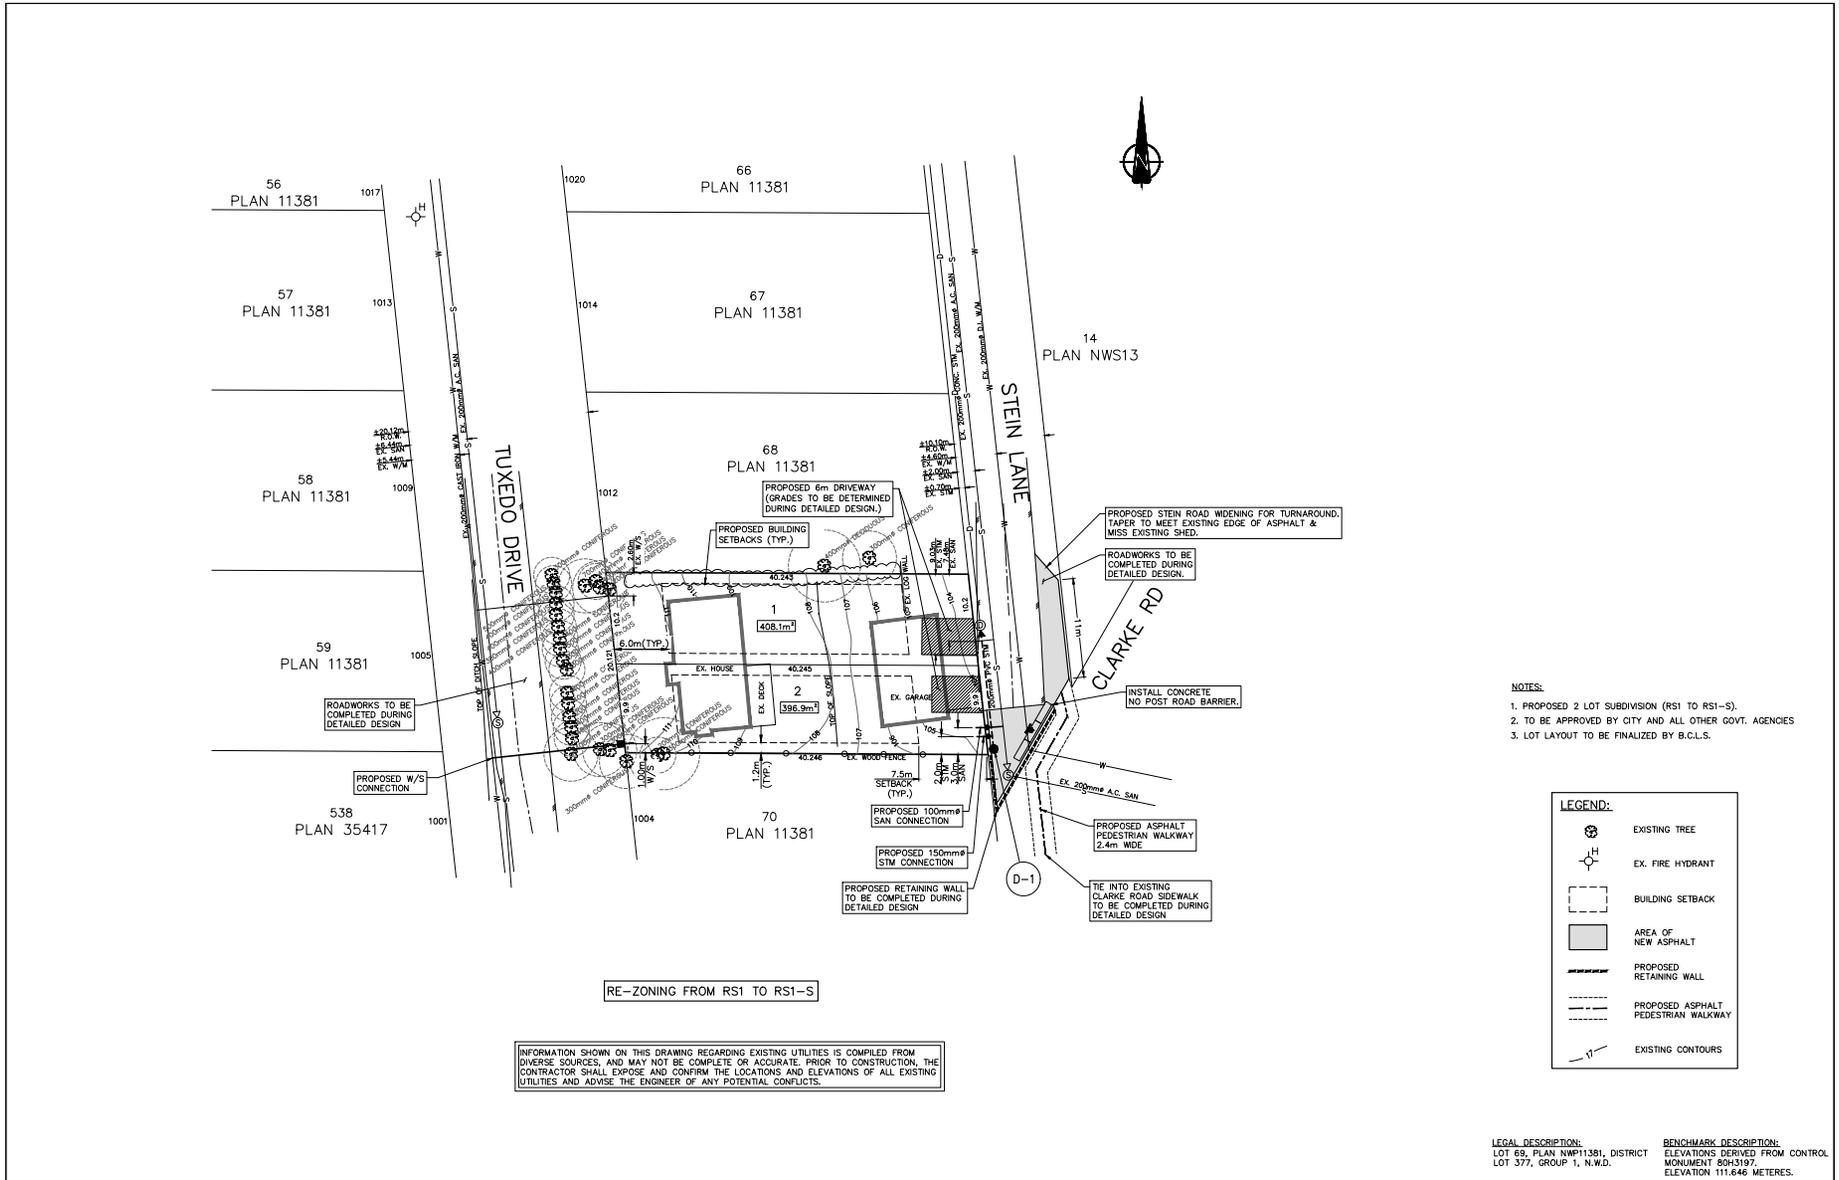
- NOTES:**
1. PROPOSED 2 LOT SUBDIVISION (RS1 TO RS1-S).
  2. TO BE APPROVED BY CITY AND ALL OTHER GOVT. AGENCIES
  3. LOT LAYOUT TO BE FINALIZED BY B.C.L.S.

The proposal involves the subdivision of the existing property into two side-by-side lots, as shown in the site plan included as **Attachment 5**. The following table shows the proposed lots when compared with the minimum lot width and area requirements under the RS1-S Zone.

Regulation	RS1-S Minimum	Proposed Lot 1	Proposed Lot 2
Width	9 m (29.5 ft)	10.25 m (33.63 ft)	9.86m (32.35 ft)
Area	325 m <sup>2</sup> (3,498 ft <sup>2</sup> )	410 m <sup>2</sup> (4,413 ft <sup>2</sup> )	394 m <sup>2</sup> (4,240 ft <sup>2</sup> )
