Bylaw No. 3420

A Bylaw to enter into a Heritage Revitalization Agreement with the Owner of the Heritage Property at 2407-2421 Clarke Street, 85 Kyle Street, and 50 Queens Street.

P. Burns & Co Butcher Shop, 2419 Clarke Street, Port Moody, Conservation Plan, Donald Luxton and Associates Inc.

CONSERVATION PLAN

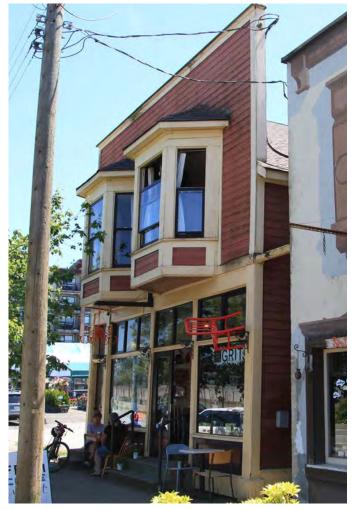
Existing facade of P. Burns & Co. Butcher Shop August 2021.

"This building is in virtually original condition, and has been completely and authentically restored including the reconstructed upstairs suite."

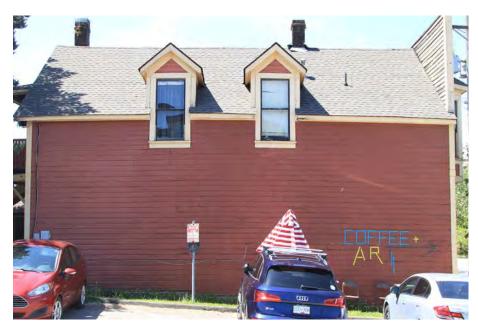
August 2021 East Elevation of building features a stepped poured-inplace concrete foundation following the slope of the site. The intent is to relocate the heritage building to its new location on Spring Street corner Queens Street.

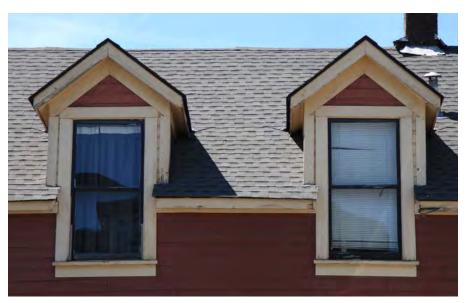
Two sets of extant roof dormers on the East and West elevations of the building with one-over-one, double-hung wood windows appear to have been restored and preserved. Further investigation to determine its condition to be done when possible.

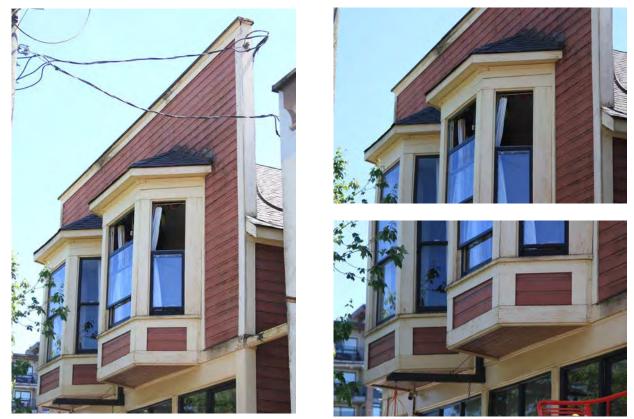
Two extant projecting hexagonal bays above the storefront with three operable double-hung, one-over-one extant wood windows appear to have been restored and preserved.

required. Repairs should be physically and visually compatible.

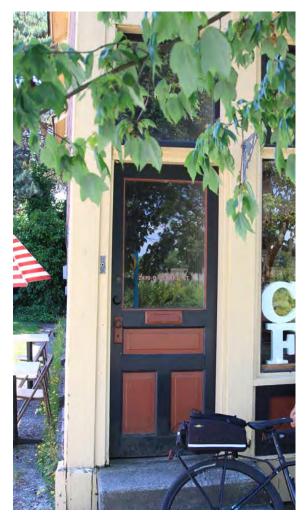
Original door opening on east side of the front elevation provides direct access from Clarke Street. Note metal mail slot, door hardware original to the paneled combination 2/3 glass and (3) Three panelled door.

All extant door assemblies original to the heritage structure should be refurbished, repaired and restored as part of the conservation.

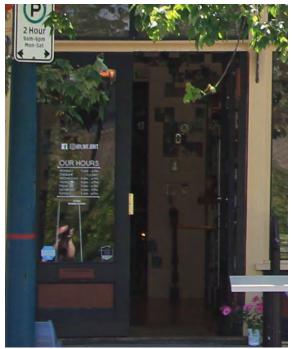
Existing double swing doors of main level commercial space facing Clarke Street. Note original metal mail slot on left paneled combination 3/4 glass and (1) One paneled door.

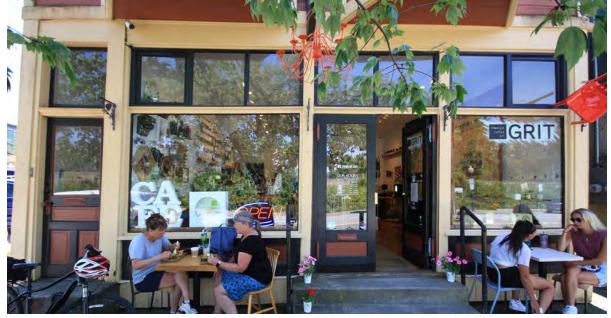
Existing Storefront wood elements: Tapered central posts with chamfered edges flanking main doorway, transom window horizontal banding across entire building facade equally divided into 8 panels, 3 of which are operable; 2 oversized window displays over paneled storefront base; 2 corner end posts and signage banding over transoms framing the main level units.

The existing false-front storefront retains original fine woodworking details still evident on all its vertical and horizontal wood framing. The centrally located double doors and are framed by two large display windows with a solid base and overhead transoms. Adjacent to the commercial storefront towards the east is the entry doorway that leads to the upper level. The residential doorway is framed by an overhead transom. All window glazing appears to have been replaced with new.

Further investigation is necessary to verify the condition of entire storefront and its components in order to determine the best approach for its conservation.
