# City of Port Moody

## Report to Finance Committee

Date: July 3, 2020  
Submitted by: Environment and Parks Department – Parks Division  
Subject: Alfred Howe Trail – Geotechnical Repairs

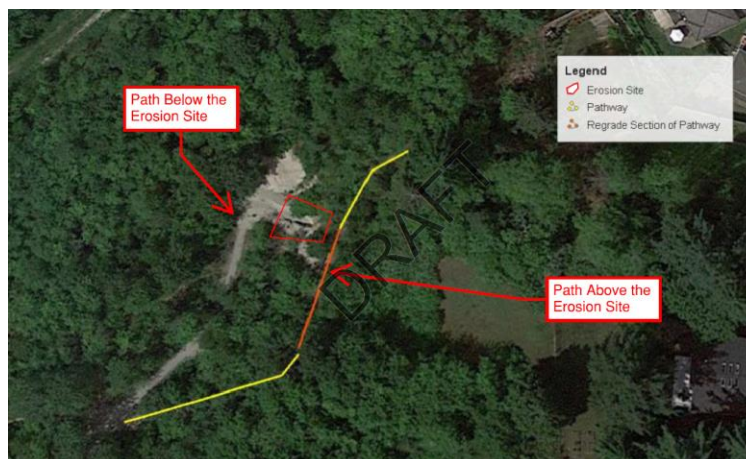
In April 2020, staff retained Thurber Engineering Ltd. (“Thurber”) to complete a geotechnical assessment of an area of bank instability located about 120m northwest of the intersection of Washington Drive and Princeton Avenue, where there is a mid-trail connection from Washington Drive to Alfred Howe Trail. During routine trail inspections in 2018, staff noted an area of slope erosion at the site and continued monitoring. Inspection this spring lead to the identification of significant slope erosion that will require remediation.

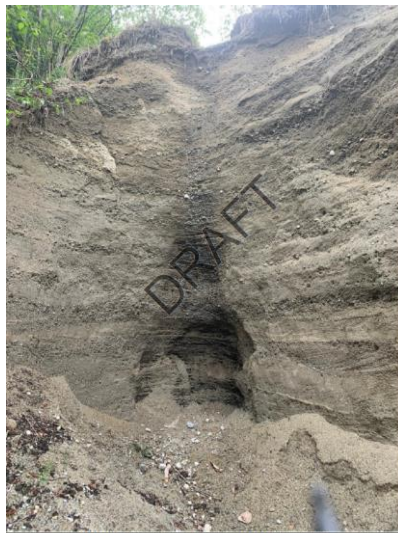
Photo 1: Looking east from the base of the eroded slope.

The area of slope erosion is shown in photos 1 and 2 below. The site area has dense sand with some gravel and cobbles. The area of slope that has eroded has resulted in an exposed, near vertical face that is 4-5m high and about 4m wide (photo 2). The geotechnical engineer made a series of recommendations in the draft report to mitigate the area of erosion, including a redirecting of surface runoff from the erosion site through a re-grading of a section of the trail, a reinstated ditch above the site, and the backfilling of the eroded section with a geotextile and granular product that will be more resistant to future erosion.

As a result of these geotechnical concerns, staff have undertaken some minor improvements to redirect water flow down the trail to mitigate further erosion, and have installed temporary fencing to restrict pedestrian access near the top and bottom of the erosion site. Staff continue to inspect the site for public safety concerns and have deemed that the trail can safely remain open at this time. Based on the assessment, the slope repair work is recommended to be undertaken by a qualified contractor before the winter months to prevent additional erosion and to ensure that the trail connection remains safe for continued public use.
