## **BUILDING ENVELOPE CONDITION ASSESSMENT**

### **KYLE CENTER**

125 KYLE STREET  
PORT MOODY, BC

July 14, 2020

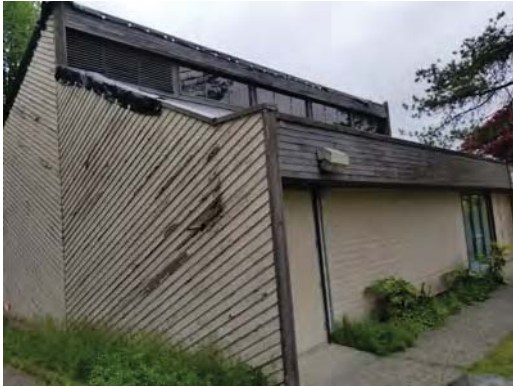
Photo 1

The building is a one storey recreational center with vaulted ceilings, with cedar cladding on all elevations, including wall areas which extend above the roof level (photo 1).

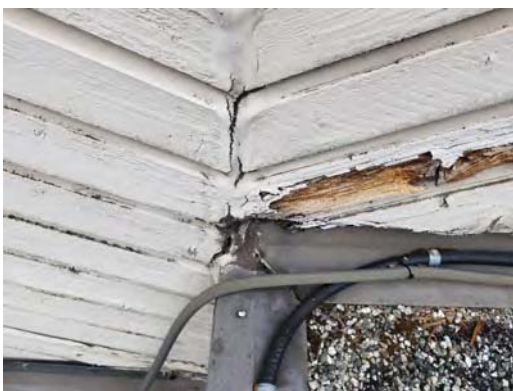
Photo 7

- Wall sealants were found to be in poor condition (photo 7).
- A mechanical rooftop penetration with multiple plies of loose membrane adhered to the cladding was noted (photo 8).

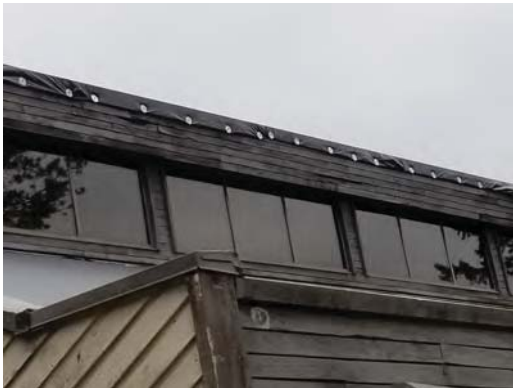
Photo 9

- Several fastener penetrations through the cladding were noted, for the installation of roof tarps as part of emergency repairs (photo 9)
- Exposed building paper was noted behind damaged cladding, much of which was damaged and torn. (photo 10)

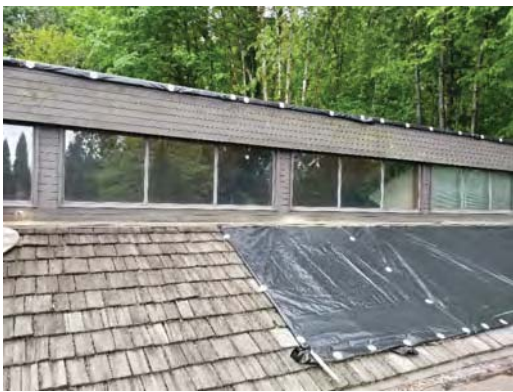
Photo 11

The windows at the building consist of aluminium-framed and steel-framed, double glazed windows. The insulated glazing units (IGUs) include an aluminum spacer bar (photo 11). Some of the steel-framed windows have aluminium operable inserts fastened into the steel frames (photo 12). The IGUs are held in place with removable exterior glazing stops which vary in type and material, depending on the window assembly. In general, all the windows have an interior butyl wet seal, sealing the glass to the frame. At the exterior, the aluminum windows and inserts have a dry rubber gasket sealing the glass to the removable glazing stops. Many of the IGUs are dated 2009, indicating an IGU replacement occurred during or after that year.

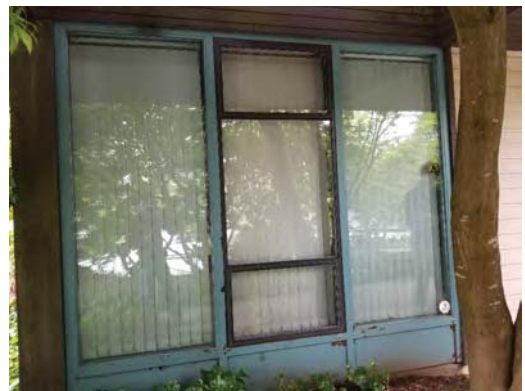
Photo 12

- Failing and flaking paint finish was noted on both the aluminium and steel window frames (photos 12-13).
- Exterior dry rubber gaskets are in poor condition (photo 13). The rubber has dried out and cracked and many of the gaskets have shrunk, providing a location for water to penetrate into the window the assembly.
- Multiple layers of failed sealant were observed around the window perimeters (photo 14).
- Corrosion was observed on aluminium spacer bars within the IGU's indicating IGU failure (photo 15).
- The interior butyl wet seal has compressed out of the joint between the frame and glass, which affects the air seal and weather tightness of the window assembly (photo 16).
- Visible moisture droplets and fogging was observed within several IGUs, indicating failure of the IGUs (photo 17).
- Visible moisture staining on interior sills was noted (photo 18).

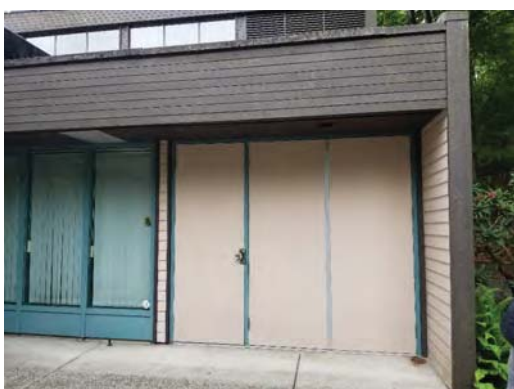
Photo 19

All of the exterior doors on the building are steel swing doors (photo 19) installed into pressed-steel frames. The front doors have glass inserts set into the door leafs. All doors are located under overhang protection (ranging between 3 ft to 8 ft) except for the basement door, which has no overhang protection.

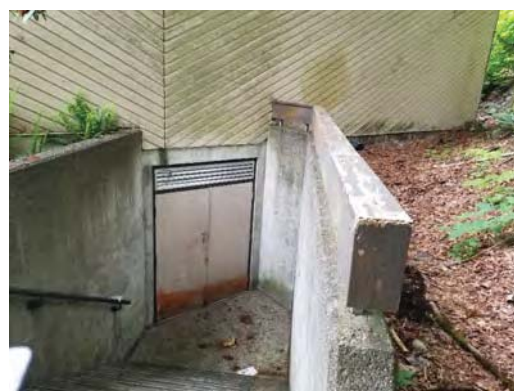
Photo 20

- The lower portions of the basement doors (roughly 1 foot high) are corroded (photo 20)
- Minor paint flaking and surface corrosion were observed on the steel frame doors (photo 21)

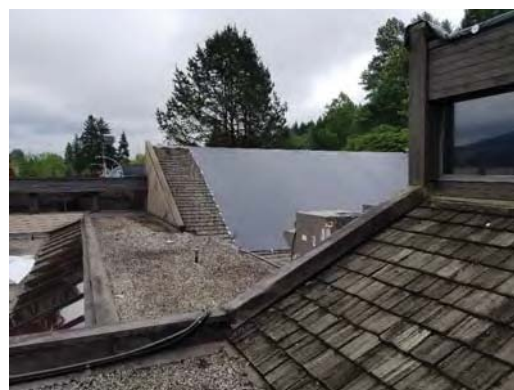
Photo 22

There are two types of low slope roofs on the building: Multi-ply Built-Up-Roof (BUR) and 2-ply SBS roof (photos 22 and 23). Architectural drawings indicate that the low slope roof assembly consists of the following (exterior to interior):

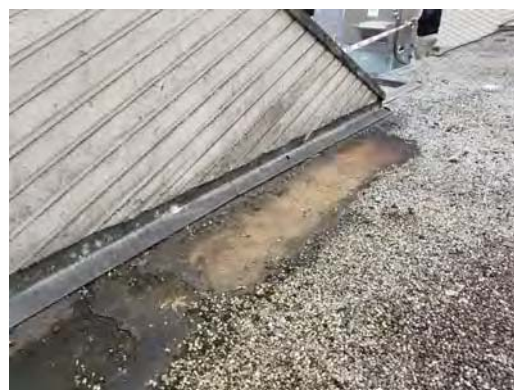
Photo 24

- Gravel protection for the underlying BUR asphalt was noted to be missing and exposing the underlaying assembly in several areas (photo 24).
- Deterioration of the built-up roof assembly was observed across all the BUR roof areas, including drying and shrinking of exposed asphalt (alligatoring, photo 25), blistering, and asphalt blueberries (photo 26).

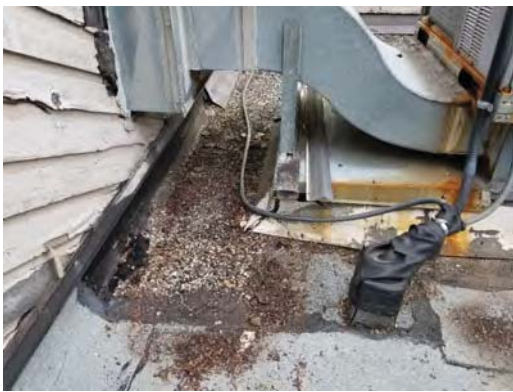
Photo 27

- At-risk roof membrane interface detailing was noted at mechanical rooftop penetrations, access hatches, wall upturns and at interface details with adjacent roof assemblies (photo 27).

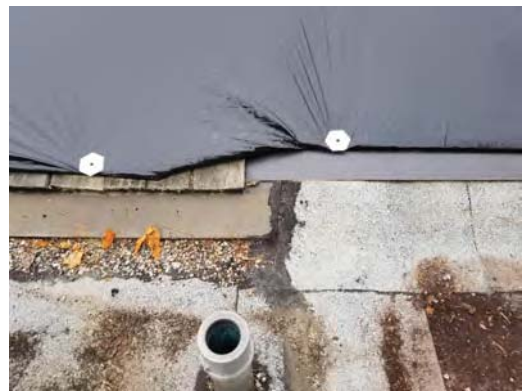
Photo 28

- A large area of the low-slope roof has been replaced with a 2-ply SBS-modified bitumen membrane assembly. The new roof assembly has simply been lapped onto the original BUR in some areas, which continues to serve as an at-risk tie-in within the existing roof systems (photo 28).

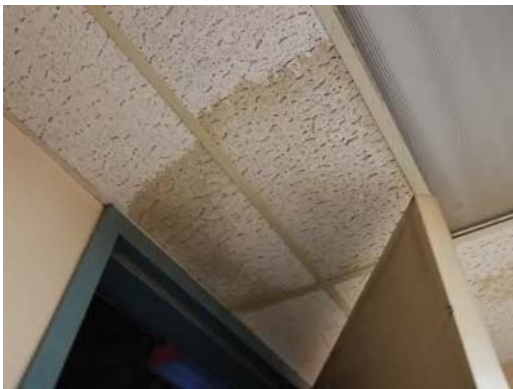
Photo 29

- Water was observed between plies of the SBS-modified bitumen roof membrane at exploratory opening 2 (appendix B).
- Significant staining was observed on several ceiling areas beneath the low slope roofs (photo 29).

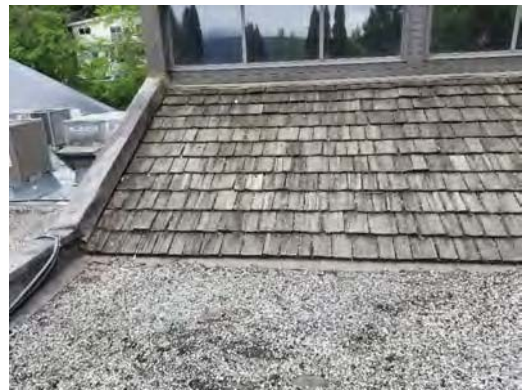
Photo 30

There are several sloped roof areas on all elevations of the complex (photo 30). Architectural drawings indicate that the sloped roof assembly consists of the following:

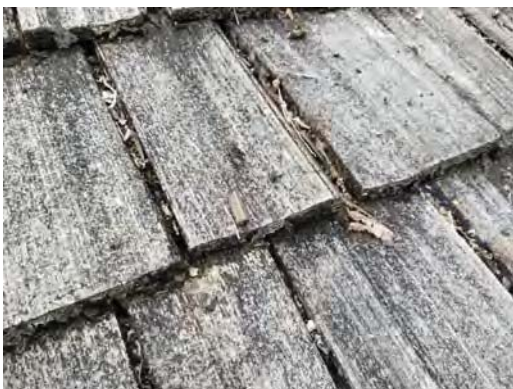
Photo 31

- Damaged and split shingles were observed throughout. In general, the cedar shakes are in poor condition (photo 31).
- Evidence of past, incompatible repairs were observed throughout, including asphalt shingles, sheet metal patches, etc. (photo 32).
- Large areas of the sloped roofs have been tarped over to address recurring leaks (photo 33).
- Fastener penetrations for the tarps were observed throughout the sloped roof assemblies (photo 34).
- Significant staining and water damage was observed beneath the roof decks for the sloped roof areas (photos 35-36).

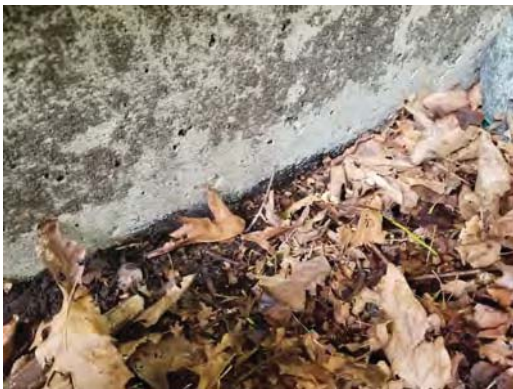
Photo 37

- Evidence of damp-proofing was observed on the foundation walls at grade level (photo 37).
- Localized efflorescence and staining was observed on the north elevation wall, primarily at the concrete cold-joint between the slab and below-grade wall (photo 38).
- Extensive corrosion was observed on the frame and exterior face of the entry door to the basement. This may be due to past issues of standing water or snow at the bottom of the stairwell (photo 39).

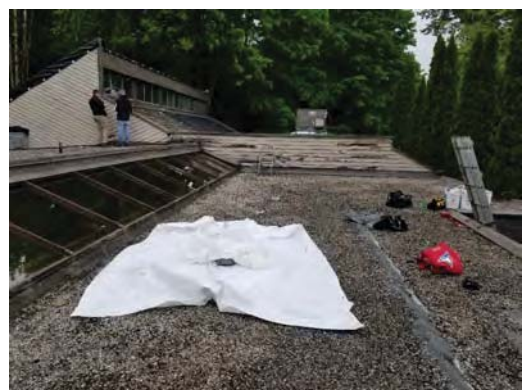
Photo 40

There are two areas of sloped skylights (sloped south to north). One is located between roofs C and A (drains onto roof A, photo 40) and the other is located north of roof H and drains into an eavestrough on the side of the building (photo 41).

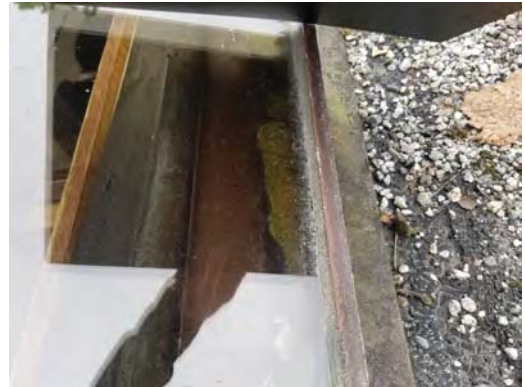
Photo 42

- The skylights were found to be aluminium framed 'T-bar' type construction.
- Moss and organic growth on interior condensation tracks was noted (photo 42).
- Glazing beads at the glazing-frame interface were found to be replaced with sealant (photo 43).
- An active leak was noted at the east corner of the skylights at location H (photo 44).

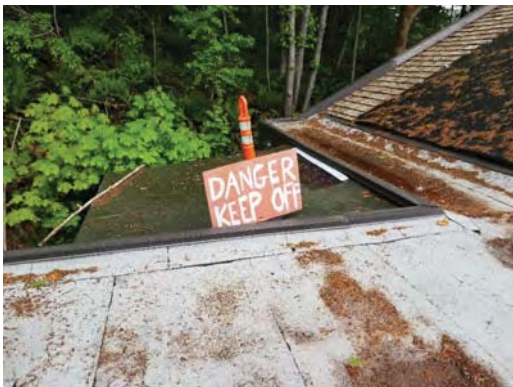
Photo 45

- The storage room is not shown on the architectural drawings (see appendix C).
- The roof framing is in very poor condition, with significant evidence of moisture-related deterioration. It has been tarped over and a “Danger” sign posted on the rooftop (photo 45)
- The roof joists and deck appear to have deflected indicating structural failure (photo 46).
- Increased moisture and humidity levels were recorded within room.

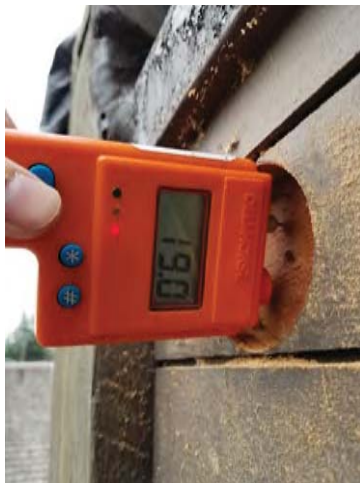
# EO 14

<b>Location:</b>	North-facing wall on roof
<b>Detail:</b>	Cedar cladding, top of wall, below parapet cap flashing
<b>Moisture Content:</b>	19.0%

Assembly	Condition
<ul style="list-style-type: none"> <li>Channel cedar siding</li> <li>Building Paper</li> <li>1/2" plywood</li> <li>2"x6" wood framing at 16" o/c</li> <li>6" batt insulation between studs</li> <li>6 mil polyethylene vapour barrier</li> <li>Interior finishes</li> </ul>	<ul style="list-style-type: none"> <li>Cladding in poor condition at this location.</li> <li>Building paper was in generally good condition at the time of our review.</li> <li>Moisture observed behind building paper.</li> <li>High moisture content in sheathing.</li> </ul>
Comments	
<ul style="list-style-type: none"> <li>Moisture noted behind building paper.</li> <li>Poor sealant and separated cladding noted at roof parapet above this location.</li> </ul>

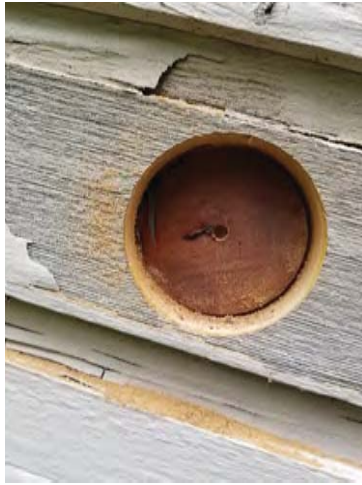
<b>Location:</b>	South-elevation	<b>EO 19</b>
<b>Detail:</b>	Cedar cladding, adjacent to vertical sealant joint	
<b>Moisture Content:</b>	13.2%

Assembly	Condition
<ul style="list-style-type: none"> <li>• Channel cedar siding</li> <li>• Building Paper</li> <li>• 1/2" plywood</li> <li>• 2"x6" wood framing at 16" o/c</li> <li>• 6" batt insulation between studs</li> <li>• 6 mil polyethylene vapour barrier</li> <li>• Interior finishes</li> </ul>	<ul style="list-style-type: none"> <li>• Cladding in poor condition at this location.</li> <li>• Building paper was in generally fair condition at the time of our review.</li> <li>• Sheathing appeared dry at the time of our review.</li> </ul>
Comments	
<ul style="list-style-type: none"> <li>• Assembly was dry at the time of our review.</li> </ul>

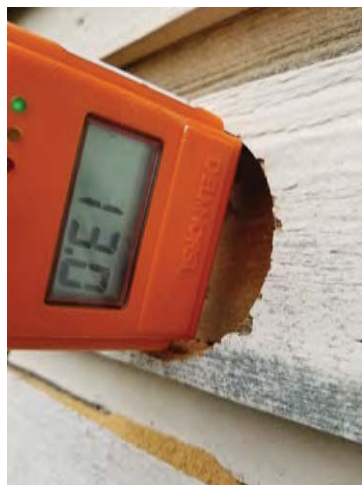
EO 21

<b>Location:</b>	East-elevation, north corner
<b>Detail:</b>	Cedar cladding, below roof parapet flashing
<b>Moisture Content:</b>	13.0%

Assembly	Condition
<ul style="list-style-type: none"> <li>Channel cedar siding</li> <li>Building Paper</li> <li>1/2" plywood</li> <li>2"x6" wood framing at 16" o/c</li> <li>6" batt insulation between studs</li> <li>6 mil polyethylene vapour barrier</li> <li>Interior finishes</li> </ul>	<ul style="list-style-type: none"> <li>Cladding in poor condition at this location.</li> <li>Building paper was in generally fair condition at the time of our review.</li> <li>Sheathing appeared dry at the time of our review.</li> </ul>
Comments	
<ul style="list-style-type: none"> <li>Assembly was dry at the time of our review.</li> </ul>

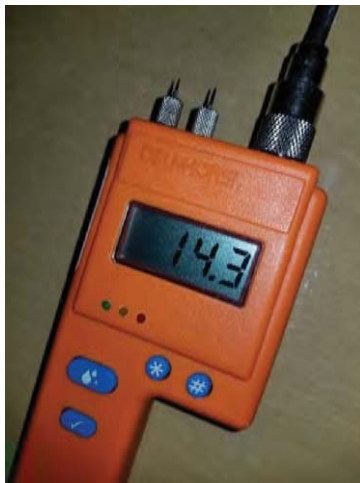
<b>Location:</b>	Billiards Room, west elevation (See Appendix C)	<b>IO 1</b>
<b>Detail:</b>	Cedar cladding, base of wall.	
<b>Moisture Content:</b>	Sheathing: 14.3% / Framing: 10.1%

Assembly	Condition
<ul style="list-style-type: none"> <li>Channel cedar siding</li> <li>Building Paper</li> <li>1/2" plywood</li> <li>2"x6" wood framing at 16" o/c</li> <li>6" batt insulation between studs</li> <li>6 mil polyethylene vapour barrier</li> <li>Interior finishes</li> </ul>	<ul style="list-style-type: none"> <li>Organic growth between drywall and poly.</li> <li>Stained studs, sill plate and sheathing.</li> <li>Fibreglass batt insulation is dirty, indicating air movement across the wall assembly.</li> </ul>
Comments	
<ul style="list-style-type: none"> <li>Organic growth observed on backside of interior gypsum finish.</li> <li>Fungal air sampling was conducted at this location (see Appendix D, Sample S4).</li> <li>Evidence of moisture related deterioration observed at this location.</li> </ul>

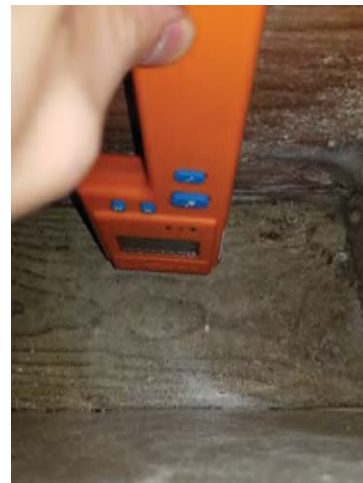
<b>Location:</b>	Rock & Gem Room, south elevation (See Appendix C)	<b>IO 2</b>
<b>Detail:</b>	Cedar cladding, base of wall.	
<b>Moisture Content:</b>	Sheathing: 16.9% / Framing: 10.3%

Assembly	Condition
<ul style="list-style-type: none"> <li>• Channel cedar siding</li> <li>• Building Paper</li> <li>• 1/2" plywood</li> <li>• 2"x6" wood framing at 16" o/c</li> <li>• 6" batt insulation between studs</li> <li>• 6 mil polyethylene vapour barrier</li> <li>• Interior finishes</li> </ul>	<ul style="list-style-type: none"> <li>• Staining and organic growth observed on interior face of sheathing.</li> <li>• Fibreglass batt insulation is dirty, indicating air movement across the wall assembly.</li> </ul>
Comments	
<ul style="list-style-type: none"> <li>• Fungal air sampling was conducted at this location (see Appendix D, Sample S6).</li> <li>• Evidence of moisture related deterioration observed at this location.</li> </ul>

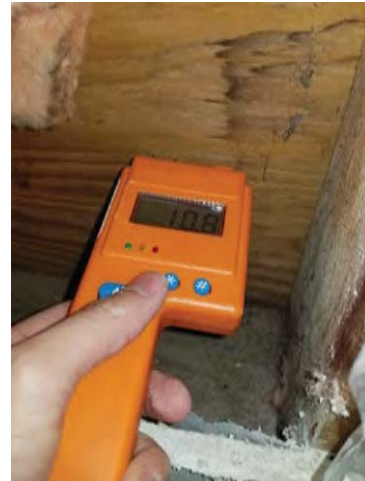
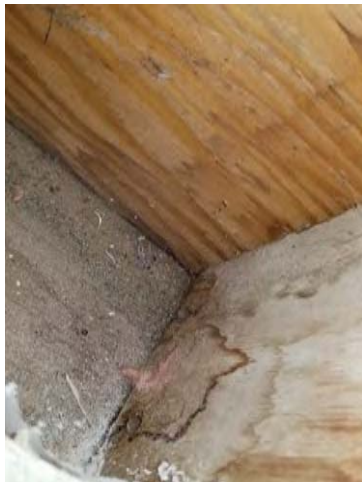
Assembly	Condition
<ul style="list-style-type: none"> <li>Channel cedar siding</li> <li>Building Paper</li> <li>1/2" plywood</li> <li>2"x6" wood framing at 16" o/c</li> <li>6" batt insulation between studs</li> <li>6 mil polyethylene vapour barrier</li> <li>Interior finishes</li> </ul>	<ul style="list-style-type: none"> <li>Stained studs, sill plate and sheathing.</li> <li>Fibreglass batt insulation is dirty, indicating air movement across the wall assembly.</li> </ul>
Comments	
<ul style="list-style-type: none"> <li>Evidence of moisture related deterioration observed at this location.</li> </ul>

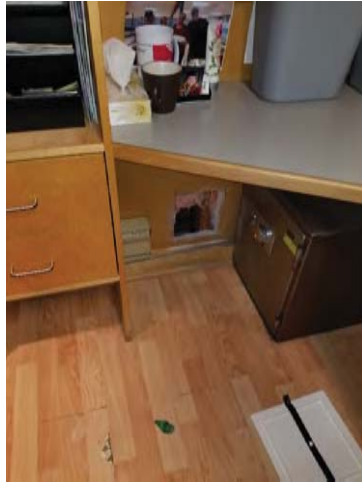
Location:	Front Office, north elevation (see Appendix C)	105
Detail:	Cedar cladding, base of wall	
Moisture Content:	Sheathing: 12.8% / Framing 8.6%	
<div>
