Conservation Plan

Martha Johnston Residence – 2131 St. Johns Street, Port Moody

January 2022

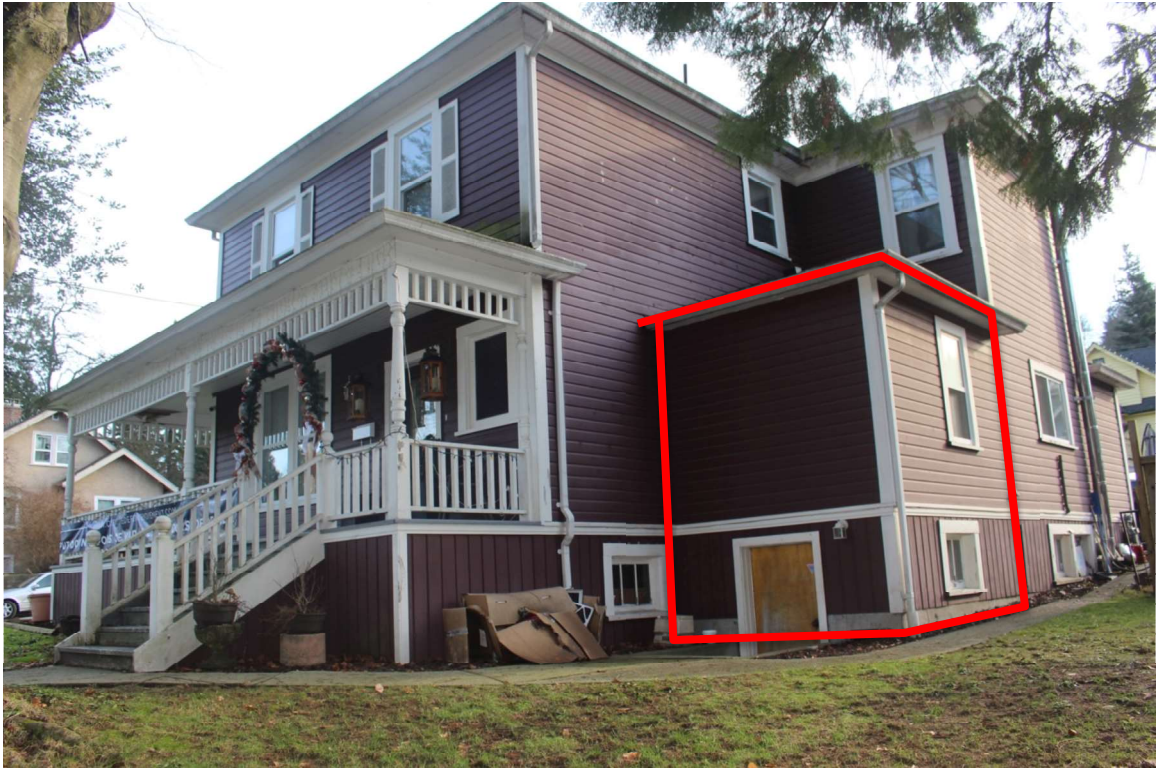
At a later date, the porch was removed and replaced by a single-storey enclosure on a new concrete foundation with basement space. This is evident from examining the concrete foundation: a line distinguishing the original concrete from the newer is visible along the west side (Figure 6).

Figure 6: Current view of front of Martha Johnston Residence with enclosed porch area highlighted.

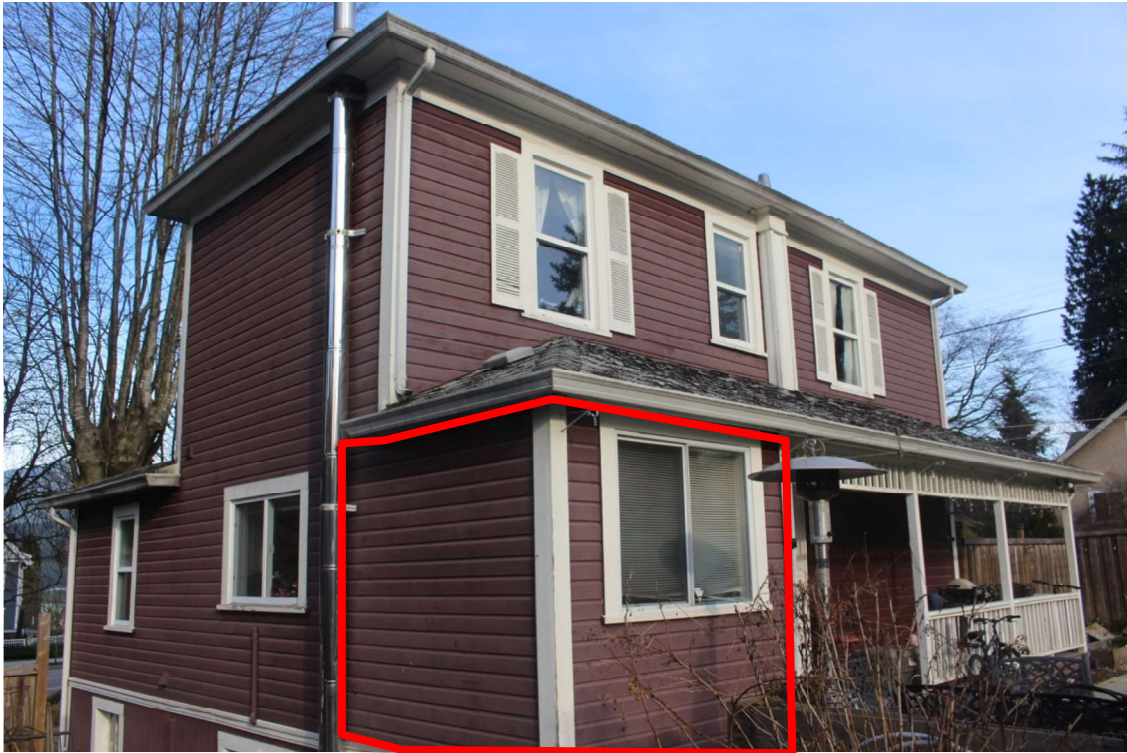
The partial-width rear porch was removed and replaced with an extension to the kitchen (in the form of an eating nook), and a new rear porch was added to span the remainder of the rear (Figure 9).

Figure 9: Rear of Martha Johnston Residence, with the rear addition to the kitchen; the porch was extended to span the full width of the rear.
