# IOCO TOWNSITE

HERITAGE CONSERVATION AREA  
PORT MOODY, B.C.

## PRESERVATION AND PREVENTATIVE MAINTENANCE PLAN

NOVEMBER 2015

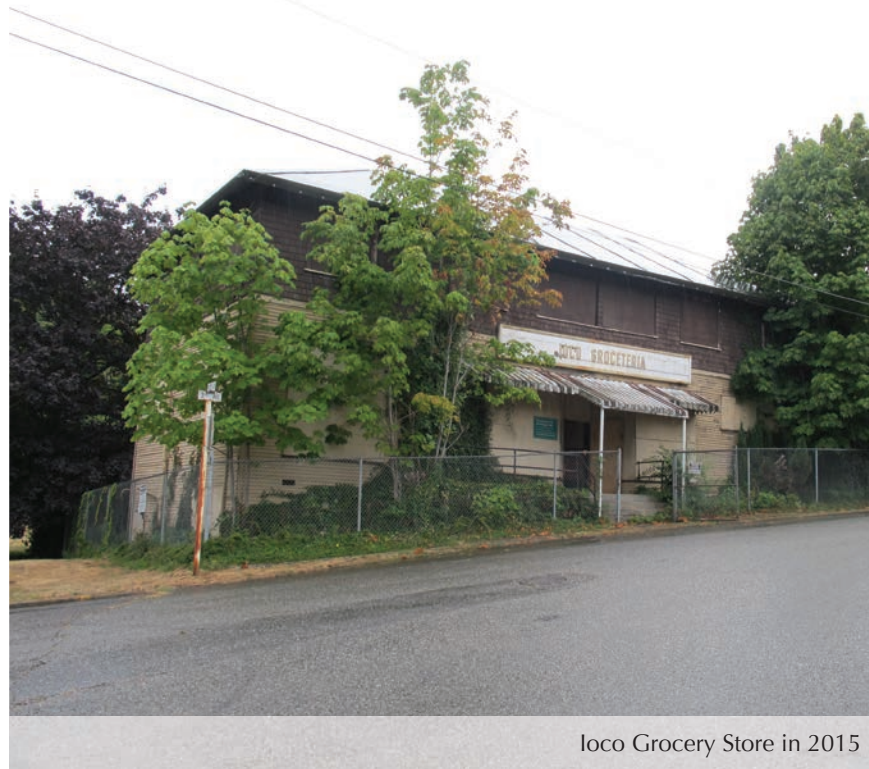
The Ioco Grocery Store is sited prominently on Third Avenue, adjacent to Ioco Hall. The site features mature deciduous and coniferous trees that create an informal landscape. The site slopes gently downward to the south, and there are signs indicating that trespassing is forbidden and that the building is a protected heritage site. Currently the site is fenced off, and many of the plantings near the building have begun to grow into to cladding, causing damage to the building materials.

- Trees in close proximity to the historic building should be pruned so that no branches are touching the structure or holding moisture against the envelope. Potentially hazardous branches should be removed. Trees should not be removed unless posing a significant threat to the building.

- Carefully remove all other plants from within the fenced-off area. The use of chemicals can potentially harm the historic building materials and should be avoided. Extra precaution should be taken when removing plants that have begun to grow into the narrow wood lap siding of the building, as not to damage the historic cladding. Once cleared, the landscaping should be maintained to ensure that plants do not hold moisture against the building, or grow into the building materials.

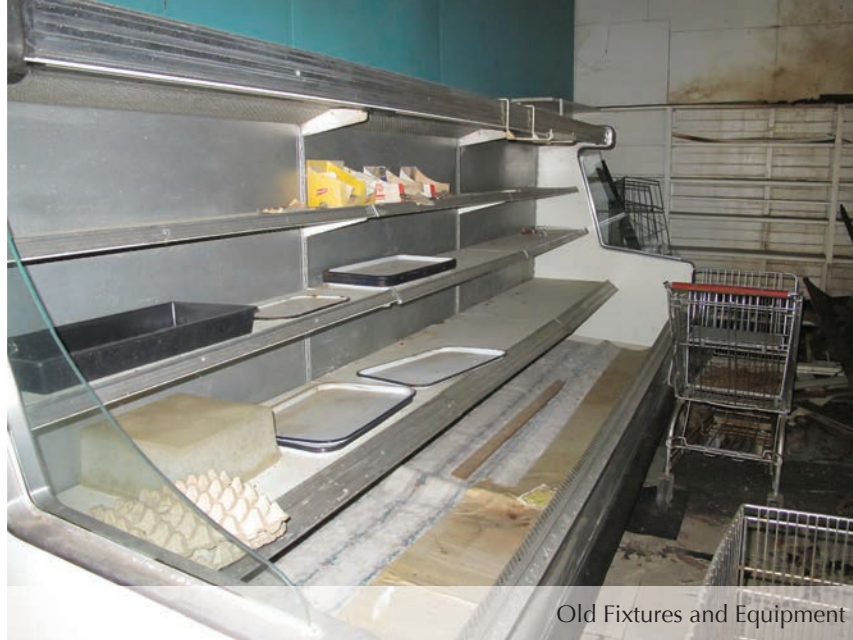
The interior of the historic structure has numerous areas of water damage, and has suffered fire damage in places. There is debris and some grocer's equipment remaining inside the building.

- Trash, hazardous materials such as inflammable liquids, poisons, paints, and canned goods that could freeze and burst should be removed from the interior of the building.

- The interior should be broom clean.
- Damp areas or materials with water damage should be inspected for mold, and all materials with mold removed or adequately treated.

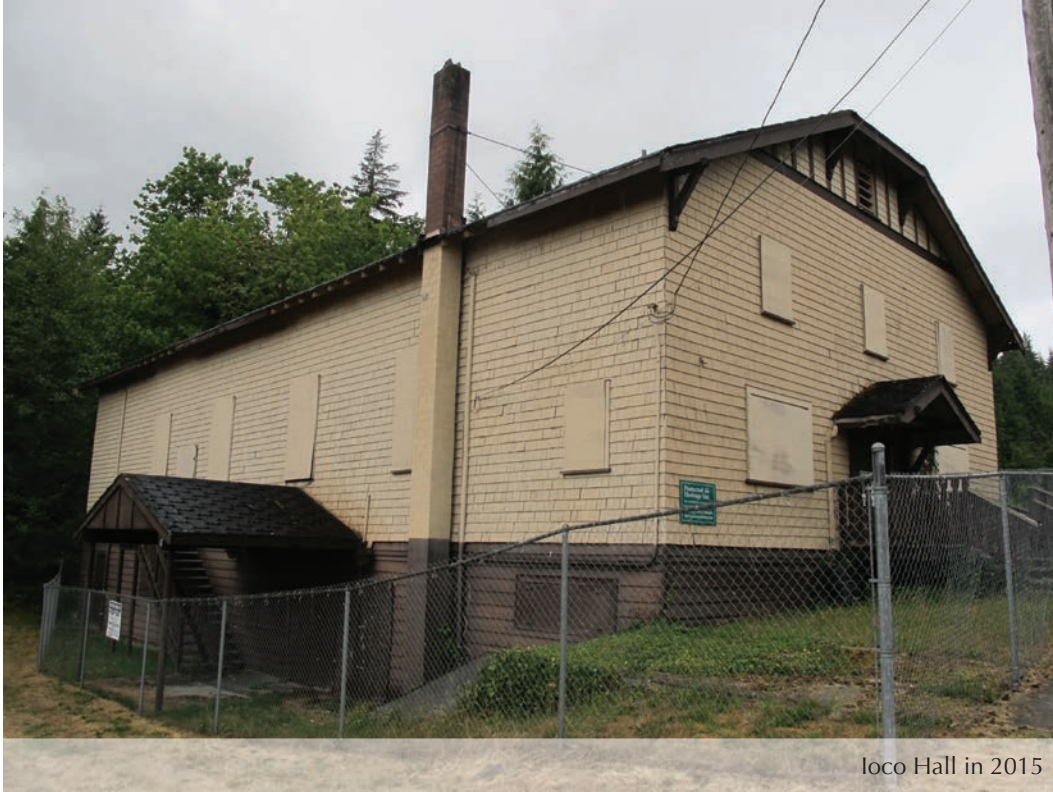
Ioco Hall is sited on the west side of Third Avenue, adjacent to Ioco Grocery Store. The site features fewer mature trees than the grocery store to the south, mostly at the rear of the building. The site slopes gently downward to the west, and there are signs indicating that trespassing is forbidden and that the building is a protected heritage site. Currently the site is fenced off, and many of the plantings near the building have begun to grow into the cladding, causing damage to the building materials.

- Trees in close proximity to the historic building should be pruned so that no branches are touching the structure or holding moisture against the envelope. Potentially hazardous branches should be removed. Trees should not be removed unless posing a significant threat to the building.
