CITY OF PORT MOODY

DEVELOPMENT PERMIT No. 2021-140 (File No. 3060-20-140)

DEVELOPMENT PERMIT - 4th READING 3000 BLOCK HENRY STREET PORT MOODY, BC

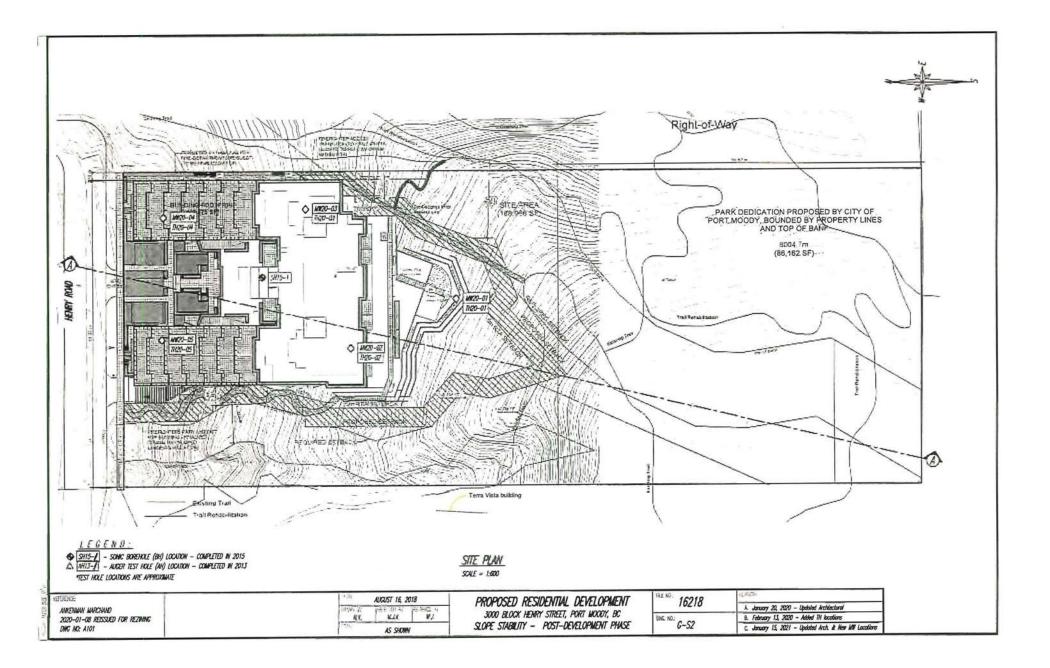
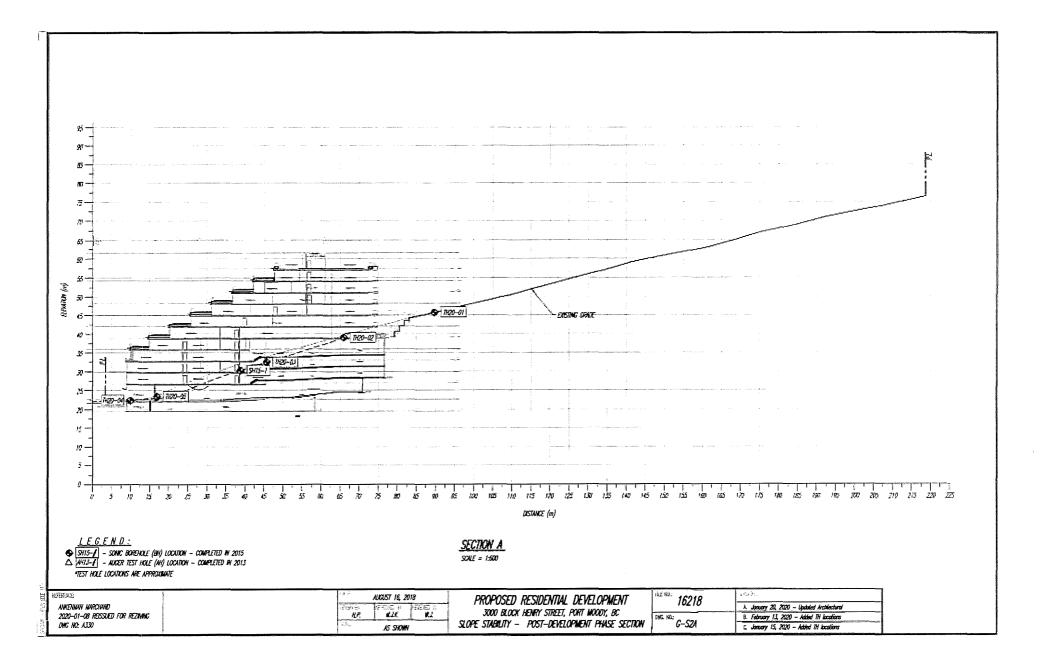
(Drawing No. 16218 G-S2 and G-S2A)

Site Plan and Section

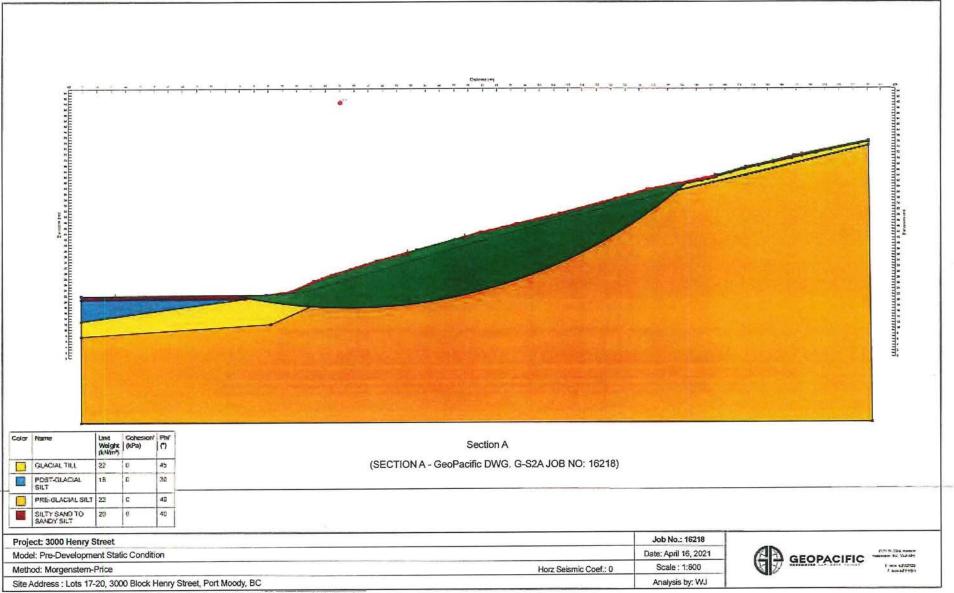
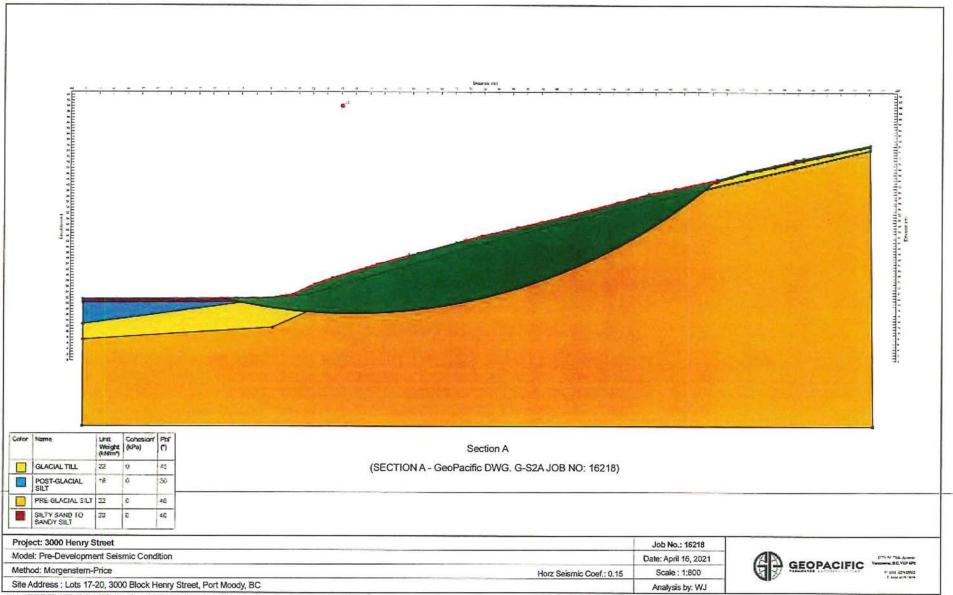
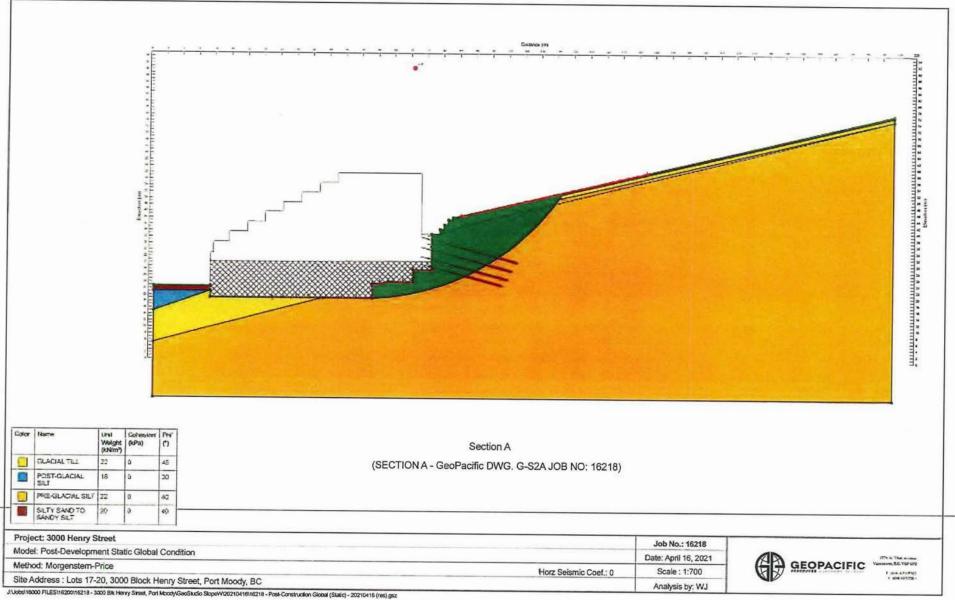
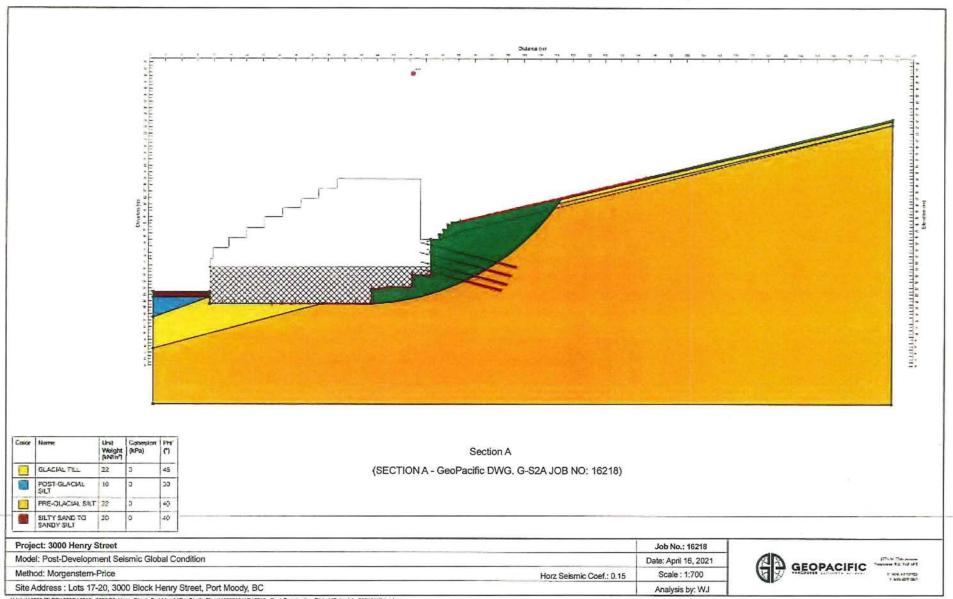
Slope Stability Assessment Results

J:Uobs116000 FILES/16200116218 - 3000 Bik Henry Street, Port Mocdy/GeoSludio Slope/W20210416/16218 - Pre-Construction (State) - 20210416.gsz

J*Uobs116000 FILES116200/16218 - 3000 Bik Henry Streel, Port Moody/GaoStudio SopeM/20210416/16218 - Pre-Construction (Seismic) - 20210418 gsz

J:Uobs116000 FILES/18200116218 - 3000 Bik Henry Street, Port Moody/GeoStudio StopeW/20210416116218 - Post-Construction Global (Seismic) - 20210416 (res).gsz

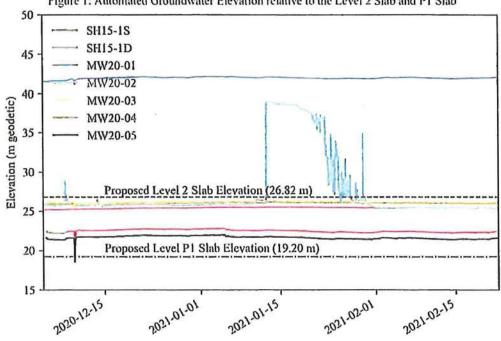
Figure 1: Automated Groundwater Elevation relative to the Level 2 Slab and P1 Slab

Figure 1 shows variations in groundwater level elevations between December 4, 2020 and February 22, 2021, collected by the automated data loggers installed at SH15-1 and MW20-01 through MW20-05. As indicated previously, SH15-1S, SH15-1D, MW20-01 and MW20-02 are screened within the pre-glacial silt, MW20-03 is screened within a sand lens noted within the pre-glacial silt deposits and MW20-04 and MW20-05 within the silty sand and gravel till. The Level 2 slab elevation is shown to be 26.82 m geodetic while the Level P1 slab elevation is at 19.20 m geodetic and arc provided as a datum for comparison.

The data collected from the majority of the monitoring wells indicate that groundwater levels have been relatively stable during our monitoring period. The sudden increase in groundwater levels at MW20-02 on December 7, 2020 corresponds to the significant rainfall event on that day (64 mm in 24 hours based on the data from the Government of Canada "Port Moody Glenayre" Rain Gauge). There were additional significant rainfall events (20 + mm of precipitation on December 13, 16, 18, 19, 29, 30, 2020) that did not appear as large spikes in data. Therefore, we can assume that the well was likely screened, completed and installed appropriately until January 12, 2021.

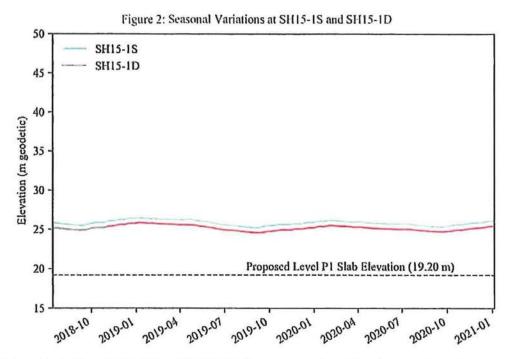
Figure 2 presents the groundwater monitoring data obtained from the nested wells installed at SH15-1. Data denoted as SH15-1S and SH15-1D represent the shallow and deep wells, respectively. The proposed Level P1 slab-on-grade elevation of 19.20 m geodetic, as referenced in architectural drawings prepared by Ankenman Marchand Architects, (dated January 11, 2021) is included for reference.

The data collected from SH15-01S and SH15-1D shows seasonal variation in groundwater levels over the past 2.5 years of monitoring. High groundwater levels are generally found throughout the wetter winter months between January and February, while lower groundwater levels are experienced in September to November, following the drier summer months of July and August. Based on the data collected, the total amount of seasonal variation and total difference between the maximum and minimum groundwater levels at both monitoring wells is 1.36 m. Groundwater levels within the pre-glacial silt sequence are about 7.0 m above the expected Level P1 slab elevation.

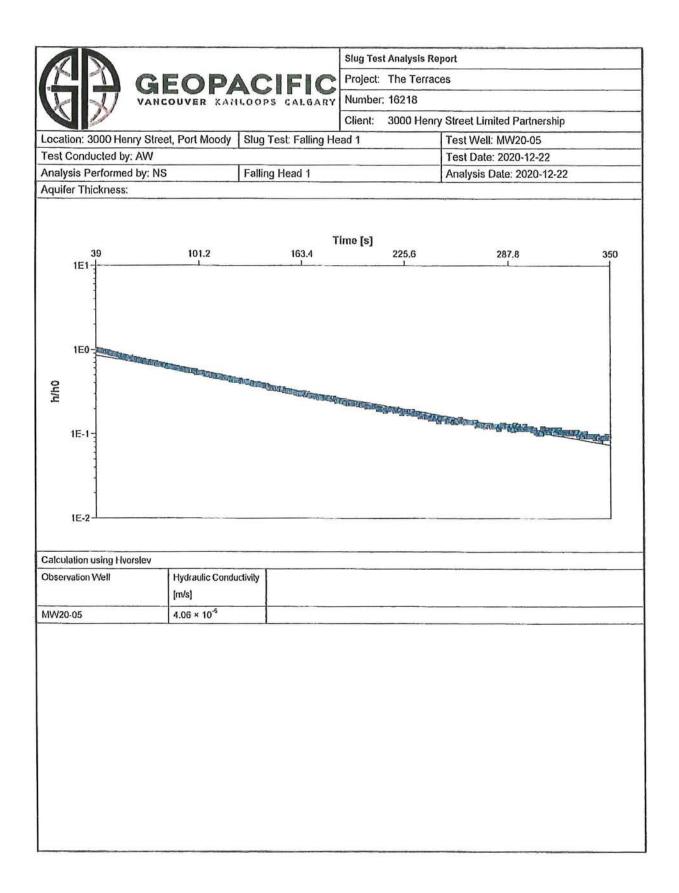
Slug Test Analysis Report				
GEOPACIFIC			Project: The Terraces			
			Number: 16218			
			Client: 3000 Henry Street Limited Partnership			
Location: 3000 Henry Stre	et, Port Moody Slug	Test: Rising He	a contract of the second second second	Test Well: MW20-05	, 	
Test Conducted by: AW	······································	read riding rid		Test Date: 2020-12-22		
Analysis Performed by: N	S Risin	g Head 1		Analysis Date: 2020-12-22	2	
Aquifer Thickness:				11111,000 1010, 2010 12 2		
2197 1E0	2217.6	2238.2	ime [s] 2258.8 1	2279.4	2300	
-		Stand Bab	CITED COLORING			
-				and the constants and a second second	1	
				- and the second		
				- chaft	Hard Conce	
1E-2				1		
Calculation using Hvorslev		and the first state of the first	· · · · · · · ·			
Observation Well	Hydraulic Conductivity [m/s]					
MW20-05	9.09 × 10 ⁻⁶
