CITY OF PORT MOODY

DEVELOPMENT PERMIT No. 2019-35-10

FLOOD HAZARD ASSESSEMENT FOR PROPOSED DEVELOPMENT

PREPARED FOR: CITY OF PORT MOODY

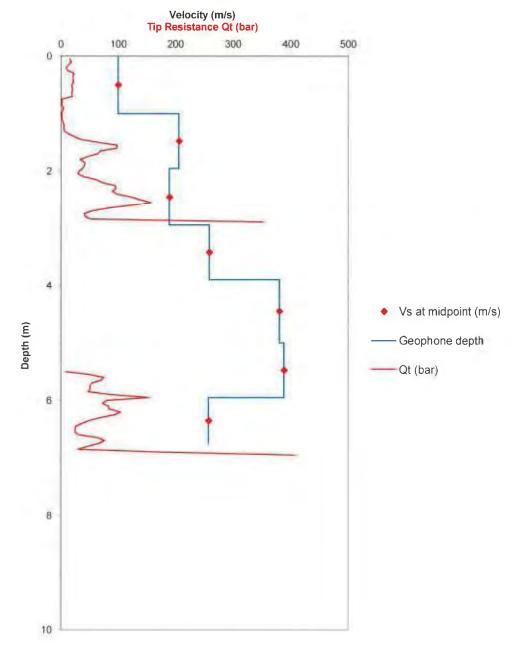
$\Sigma(d/Vs) = 0.0325$ average Vs = $\Sigma d / \Sigma(d/Vs) = 208$

File: 15258
Project: RESIDENTIAL DEVELOPMENT
Client: MARCON JOHNSTON (GP) LTD
Location: 2800-2831 ST. GEORGE STREET, PORT MOODY, BC
Sounding: SCPT17-02
Date: 2017-Aug-18

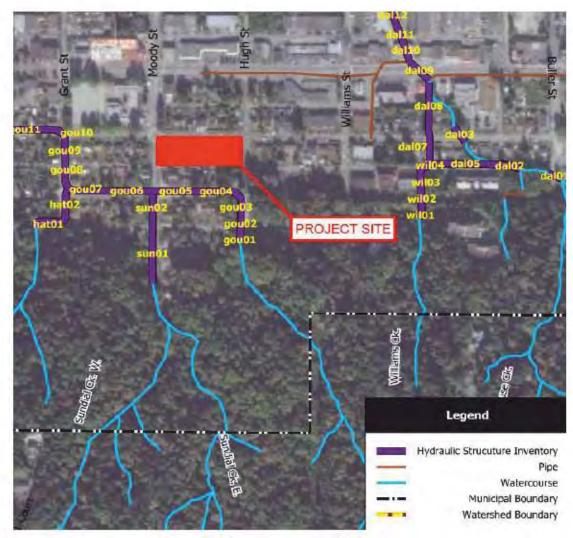
Inset from Figure E-1 (above)

- Chines ISMP Figure E-1 Major Trunk Drainage System in Port Moody
- Chines ISMP Table E-1 Pipe Data Collection Table
- Chines ISMP Figure E-3 Hydraulic Model Network
- Chines ISMP Table E-8 Peak Flow and HGL Assessment Table for 100-year Event
- Chines ISMP Figure D-1 Hydraulic Field Reconnaissance
- Chines ISMP Field Reconnaissance Photo ID 447
- Chines ISMP Field Reconnaissance Photo ID 449

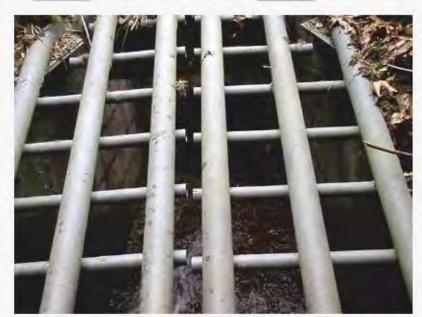
Photo ID: 447

Survey Number: 60 Dates June 14, 2011 Weather Sunny Inlet or Outlet: Structure: Inlet Headwall CONC 900 Material: Dia or Width (mm): Risk Level: Low Road Crown Height (m): 1.8 Type: Road Sediment Depth (m): 0.01 Low Channel Width (m): Right Bank Height (m): Left Bank Height (m): 1.8 1.8 1.5 Left Bank Slope (H:V): Right Bank Slope (H:V): 3:1 Low Channel Depth(m): 0.2 3:1 Left Bank Roughness: Right Bank Roughness: 0.035 Channel Roughness: 0.035 0.035

P:\20112817\00_ISMP\Engineering\01.08_Photos\June_14_2011\P6140047JPG

During field reconnaissance it was observed that the intake structures appear to be well maintained without signs of debris or sediment build-up, and there were no obvious signs of channel overtopping.

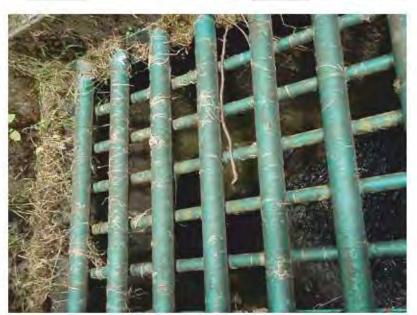
Photo ID:	449
GPS Height (m):	43.96
Northing:	5457879.753
Easting:	511057.258
Comment:	Goulet Creek int

Survey Number:	6	Date:			June 14, 2011	
		Weat	her		Sunny	
Inlet or Outlet:	Inlet	Struct	ure:		Headwall	
Material:	CONC	Dia or	Width (mm):	900	
Risk Level:	Low	Road	Crown Heigh	rit (m):	1.5	
Type:	Road	Sedin	nent Depth (m):	0.01	
Left Bank Height (m):	1.5 Rig	ght Bank Height (m):	1.5	Low C	nannel Width (m):	2
Left Bank Slope (H:V):	3:1 Rig	ght Bank Slope (H:V):	3:1	Law Ch	nannel Depth(m):	0.1
Left Bank Roughness:	0.035 Rig	ght Bank Roughness:	0.035	Chann	el Roughness:	0.035

P:\20112817\00_ISMP\Engineering\01.08_Photos\June_14_2011\P6140049.JPG
