## Memorandum

Date: January 13, 2022  
Submitted by: Legislative Services Division  
Subject: Heritage Designation Bylaw – 2130 St. George Street, 123 Douglas Street, and  
2133 St. Andrews Street – Third Reading

HISTORIC NAME: MOISIO RESIDENCE

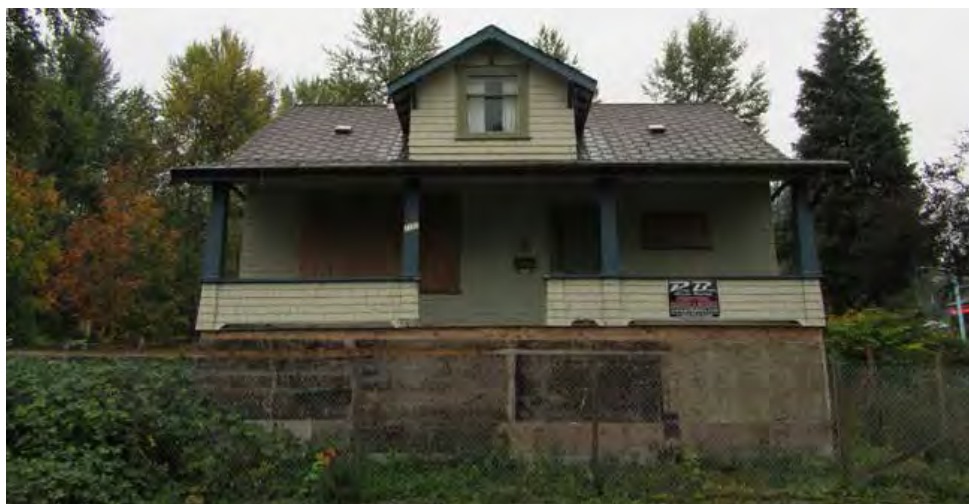
Front elevation of the Moio Residence facing north.

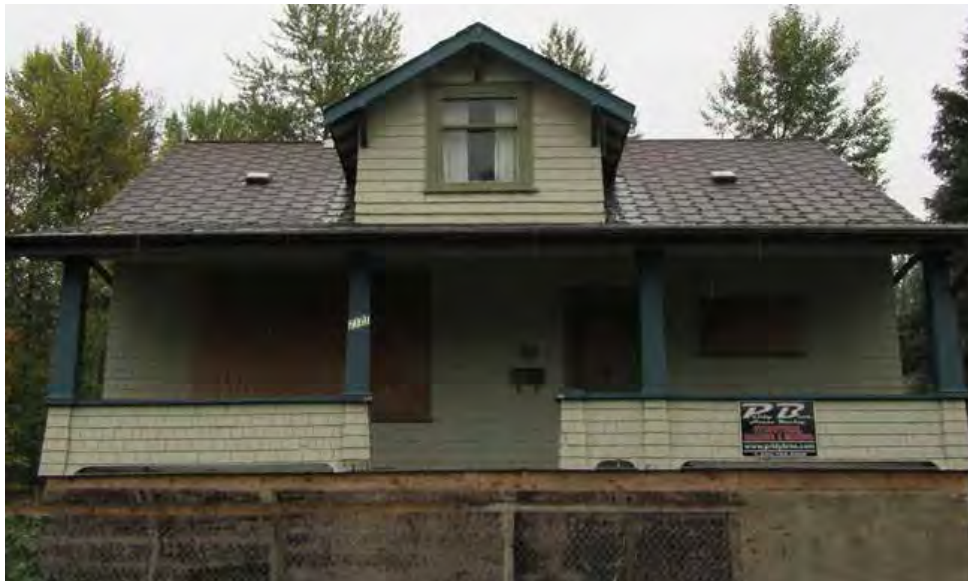
The Moisio Residence features two original verandahs running the full length of the front and rear sides of the house. Both verandahs have very similar configurations consisting of four tapered timber columns with small capitals supporting the verandah roofs, extensions of the main side-gabled roof. The sloping verandah ceilings feature exposed rafter tails and tongue-and-groove soffits. An architectural detail are notched bargeboards. The closed and shingled balustrades have solid wood sills and drainage scuppers.

Front verandah with closed and shingled balustrades

- Preserve the front and rear verandahs as important architectural elements of the house.
- Move both verandahs with the main structure to its permanent location, if possible.
- Restore original verandah elements that are in good condition where feasible, including tapered columns with capitals and rounded base, wooden sills, exposed rafter tails and tongue-and-groove soffits.
- The closed and shingled balustrades with drainage scuppers can preserve their original detailing and height. Building code requirements can be met with alternate compliance method, e.g. installing glass panels or metal railings to meet the required height. The Heritage Consultant can advise on the design.
- Design new wooden front and rear stairs with closed treads and risers. The Heritage Consultant can advise on the design.

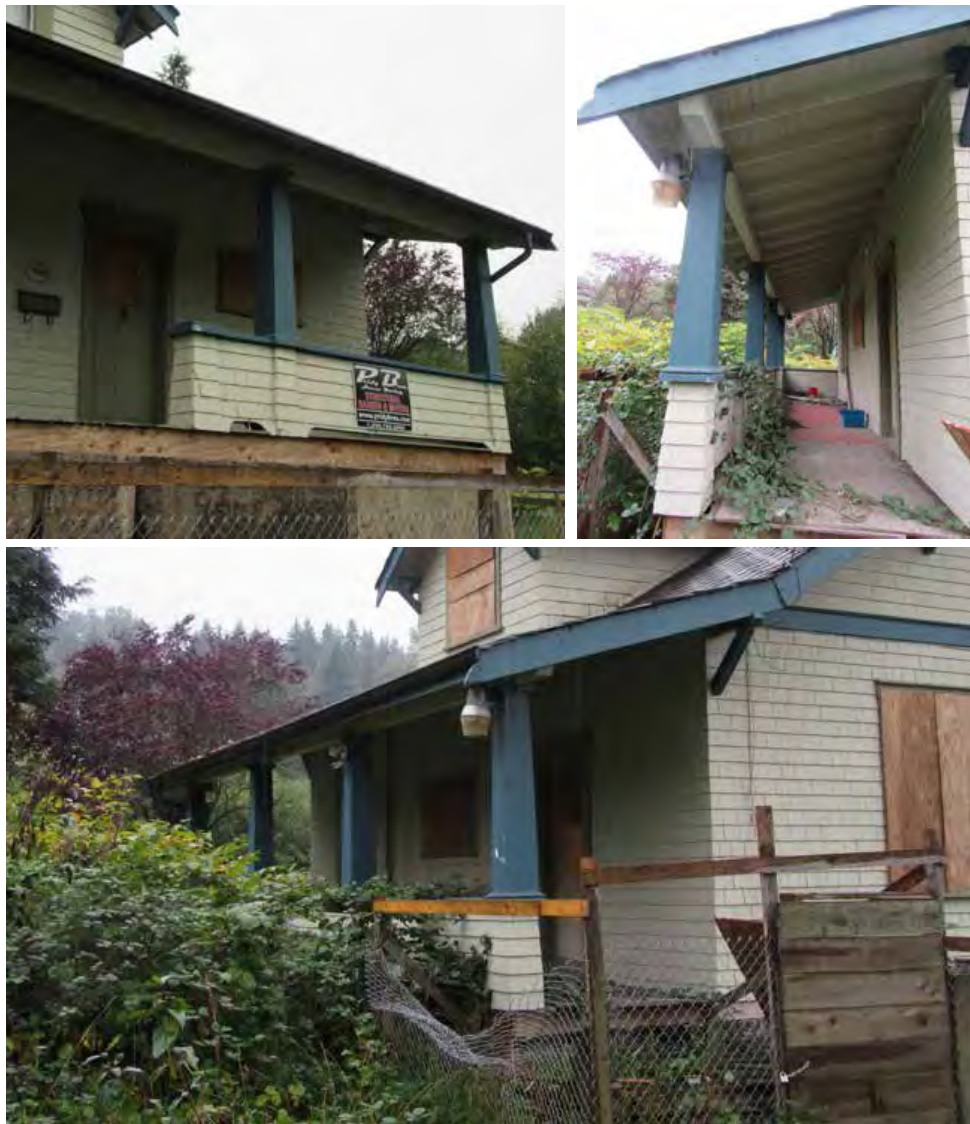
Top Left: Front verandah with tapered columns Top Right: Rear verandah ceiling featuring exposed rafter tails and tongue-and-groove soffits; Bottom: Rear verandah

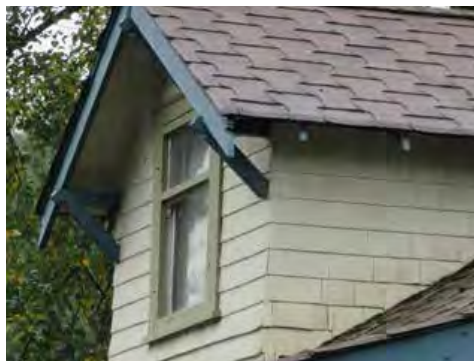
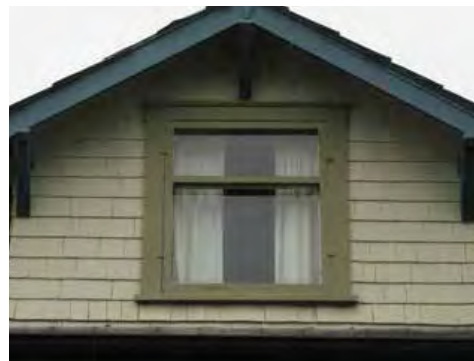
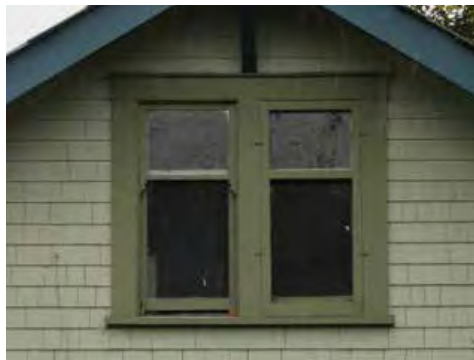
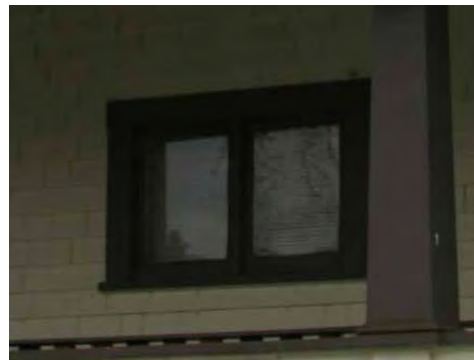
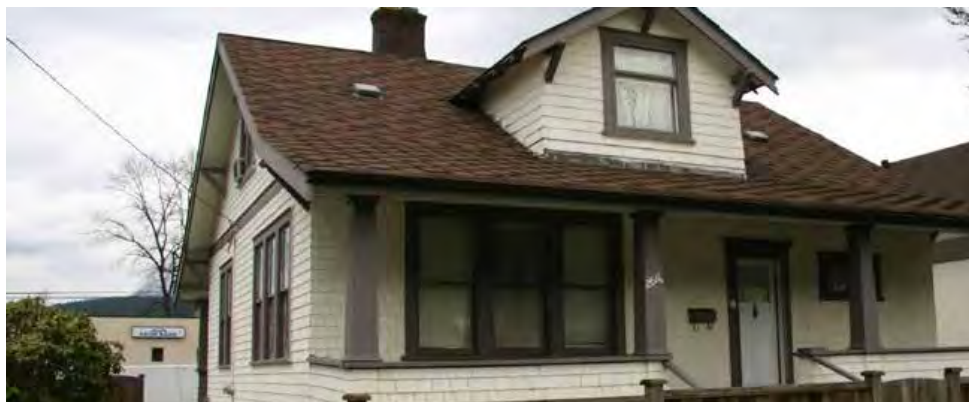
Typical windows of the Moisio Residence

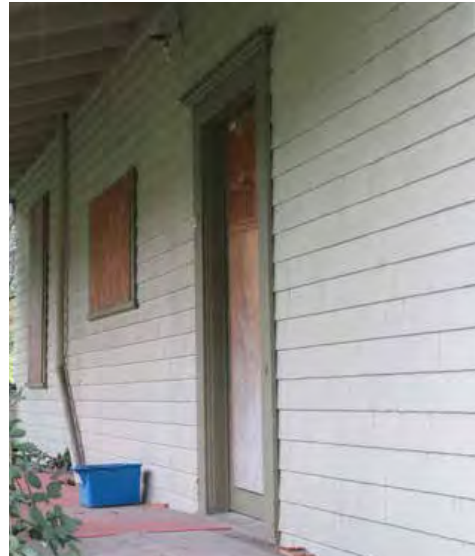
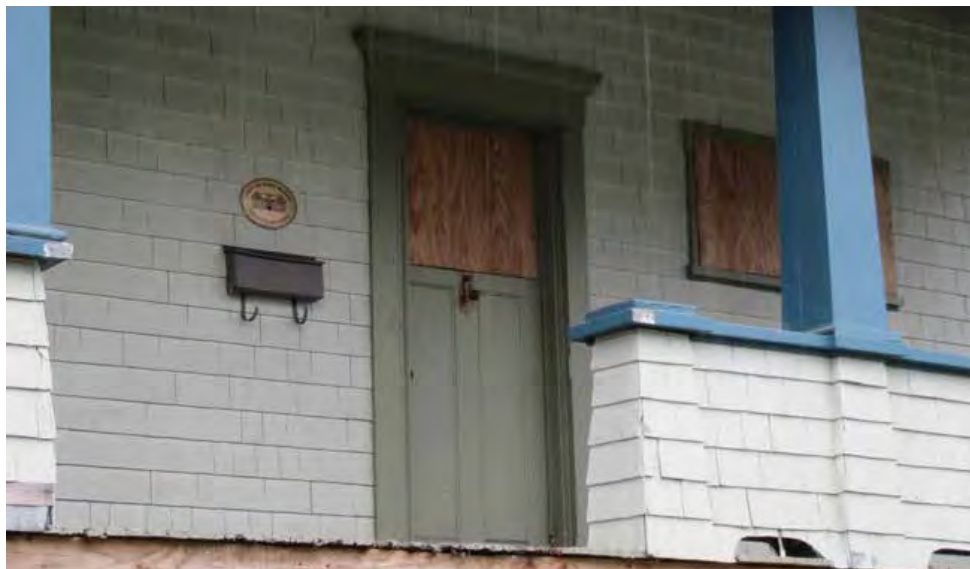
Top: Rear door; Bottom: Front door

- Preserve original front and surrounding trim and mouldings of both door openings, if possible.
- If the front door is being retained, verify that the door fits properly in its frame and joints are tight. Verify that hardware is operational, particularly that hinges are tight and hinge pins not worn. Remove built-up paint at door and jamb. Repair damaged elements to match original. To reduce air infiltration, weather stripping can be installed between door and frame.
- New doors should be sympathetic to the historic character of the house.

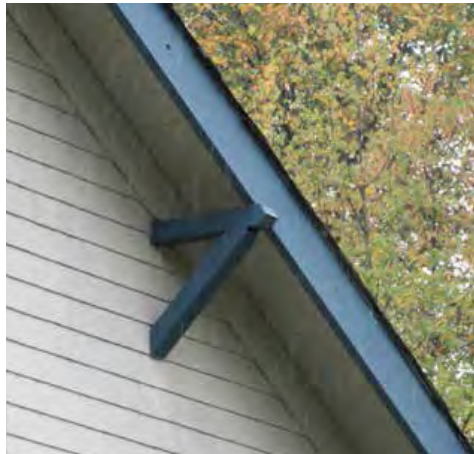
Clockwise from top left: bracket and soffit; tarp covering the chimney roof opening; and overall roof structure

- Preserve the historic roof design including front and rear dormers, if possible.
- The roof can be reshingled with cedar shingles. An alternate material is 'Enviroshingle Silvered Cedar' by Enviroshake or approved equivalent. Asphalt roof shingles may also be acceptable for full reshingling or to replace damaged existing shingles. The recommended colours for asphalt shingles are dark grey or black colour after a review by the Heritage Consultant.
- Design an adequate rainwater disposal system and ensure drainage from the elevations.

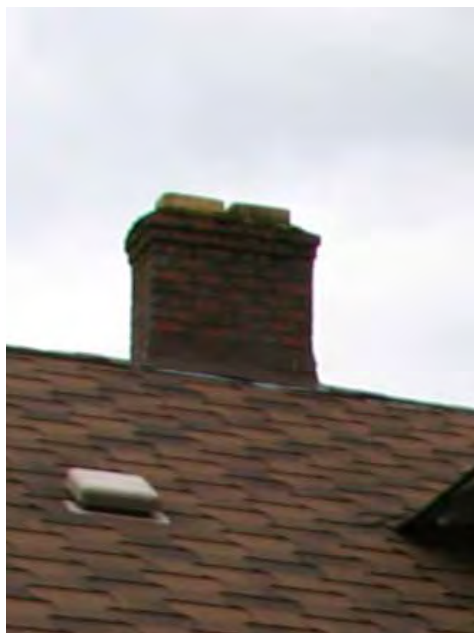
Internal brick chimney with corbelling before removal

- The brick chimney may be reconstructed in its original location and original dimensions as shown in photographs. Use red-common bricks and replicate corbelling detail. Install metal flashings at the base.

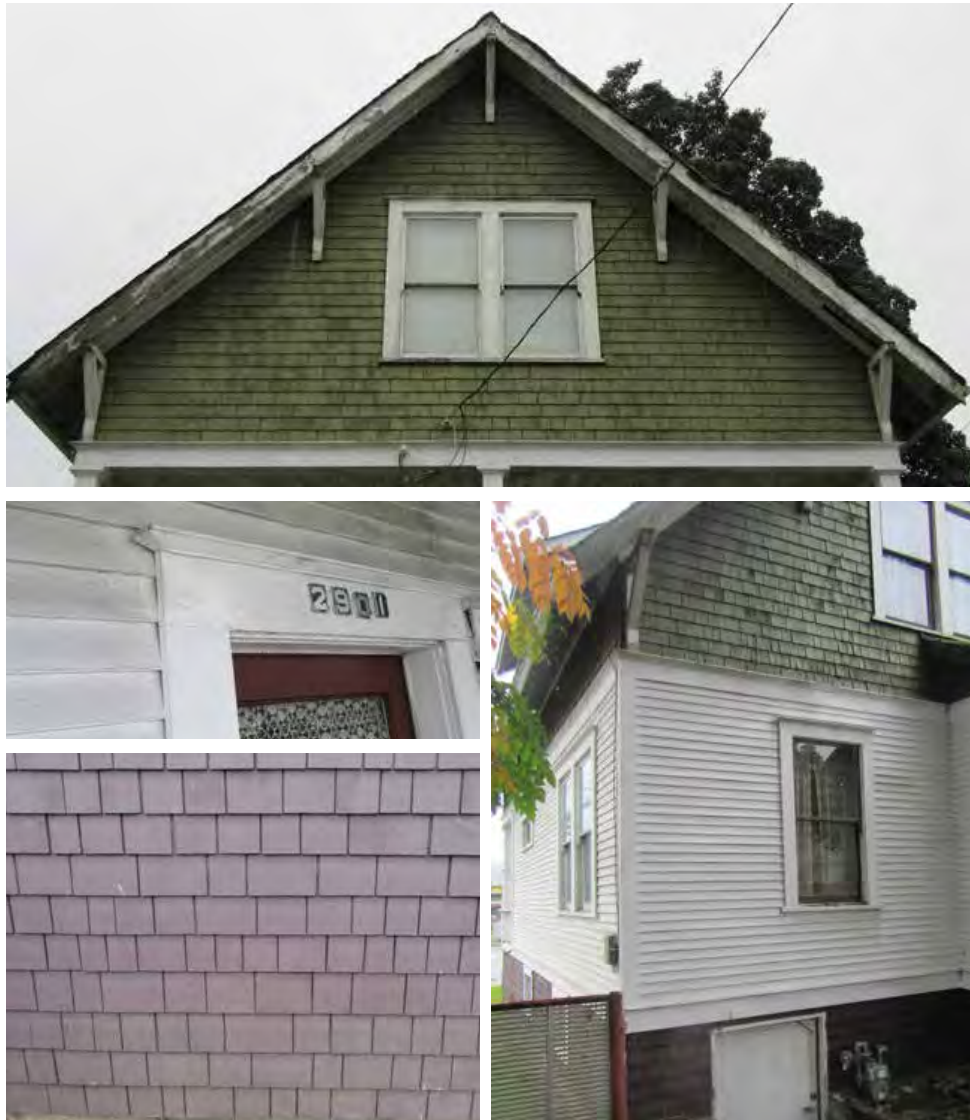
Clockwise from Top: Shingle siding at second floor; Lap siding, belt course, watertable and cornerboard; Shingle siding at basement; Door trim

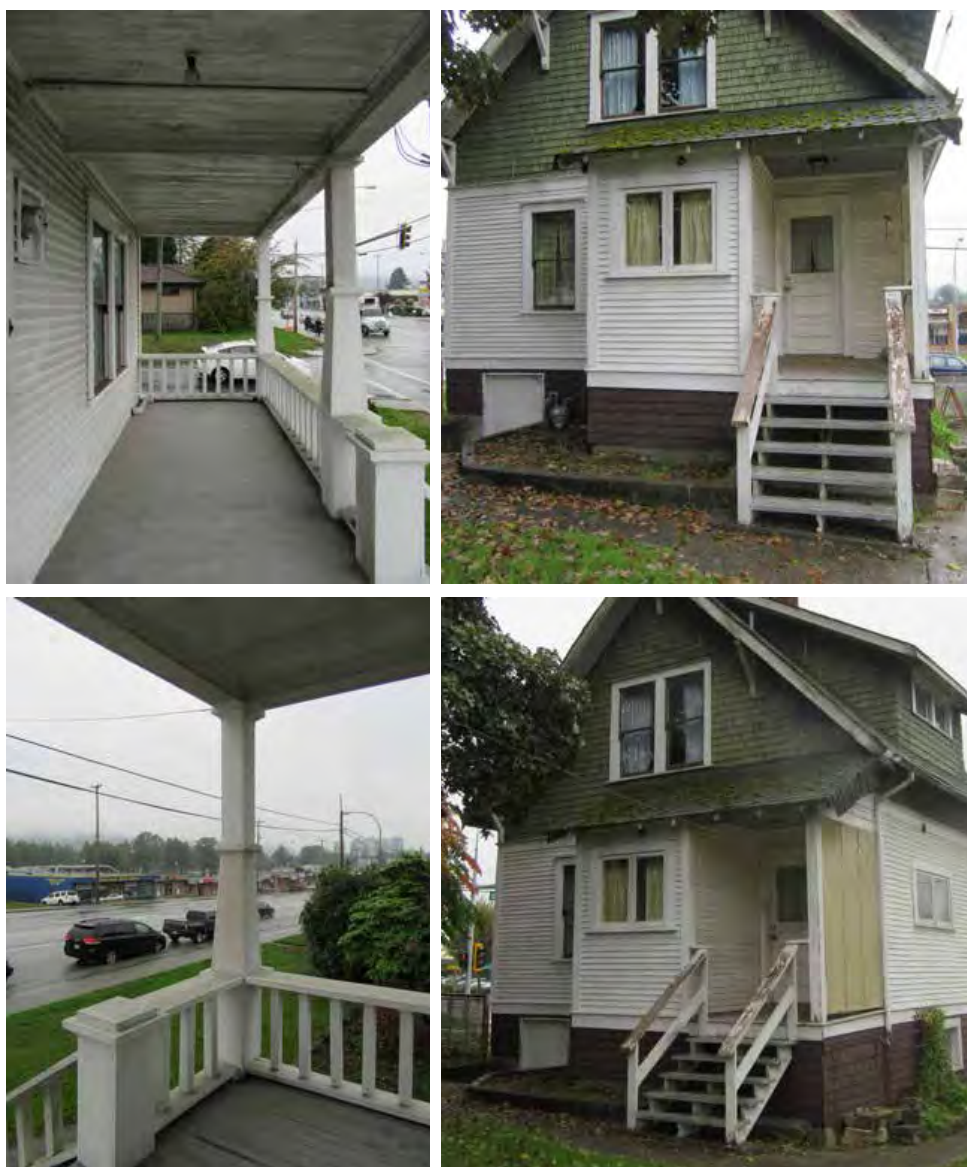
Top Left: Tongue and groove soffit and flooring; Bottom left: Tapered column; Top right and bottom right: Rear porch

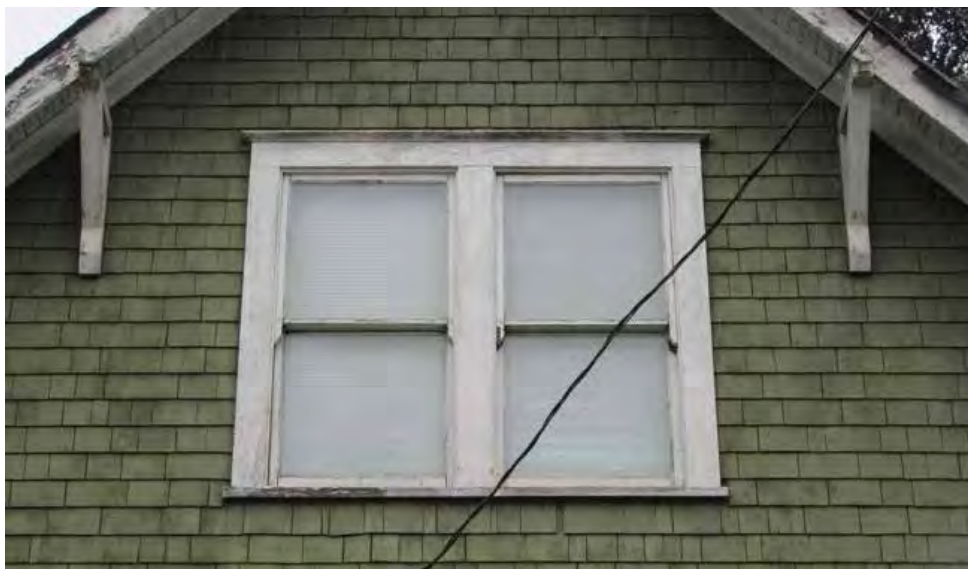
Pair of original one-over-one, double hung wooden sash windows on second storey of front façade

- Prime and paint all wood windows as required in appropriate colours, based on colour schedule devised by the Heritage Consultant.

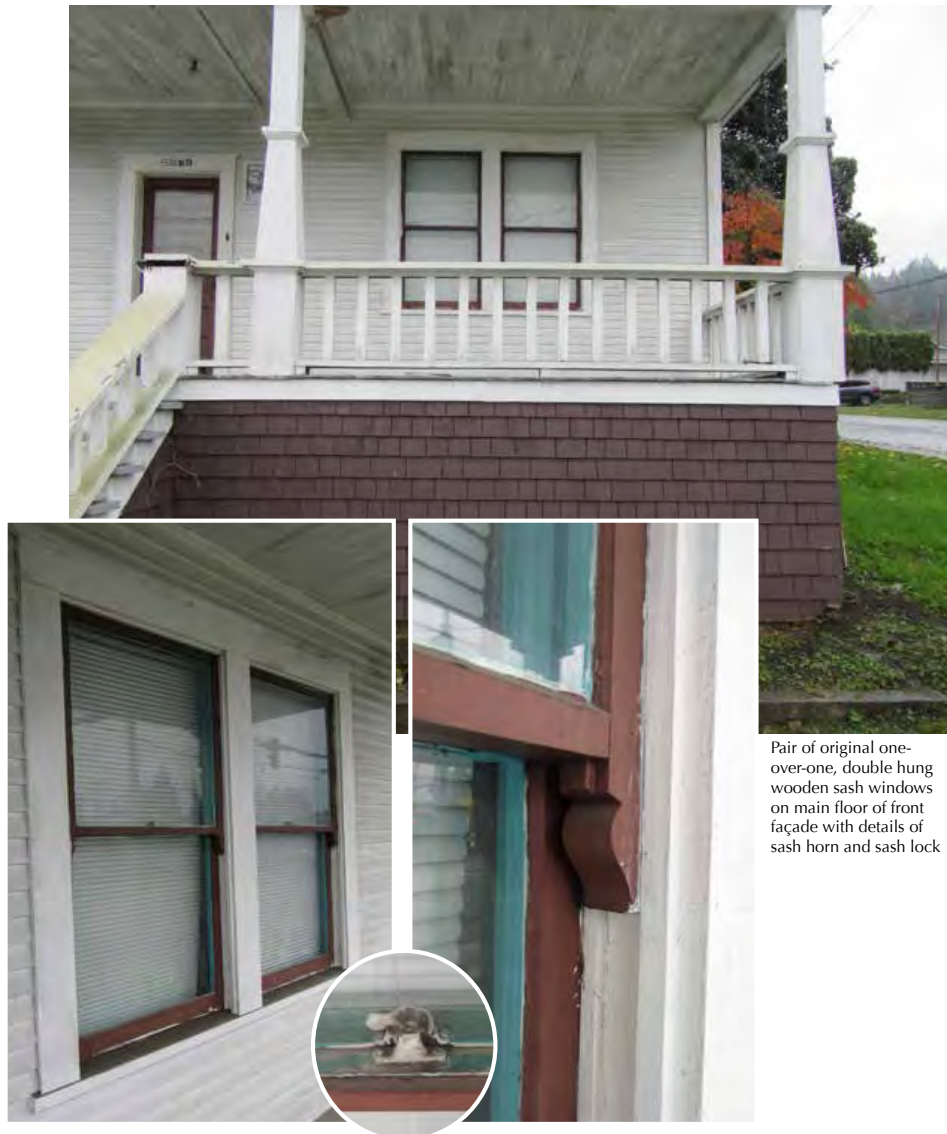
Pair of original one-over-one, double hung wooden sash windows on main floor of front façade with details of sash horn and sash lock

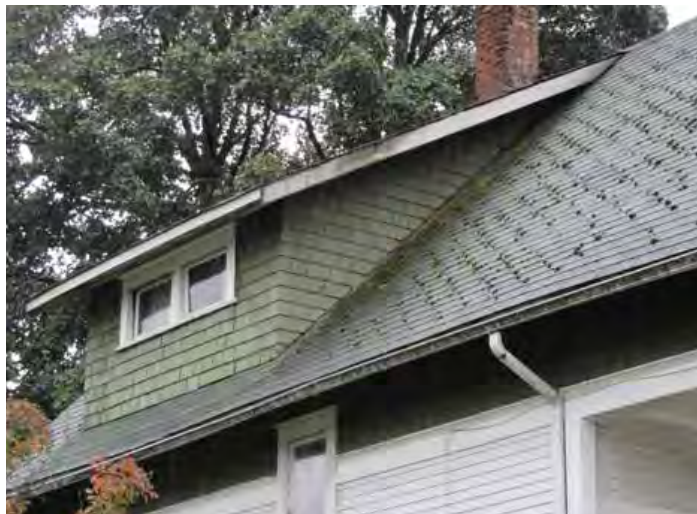
Roof with shed dormer on the east elevation

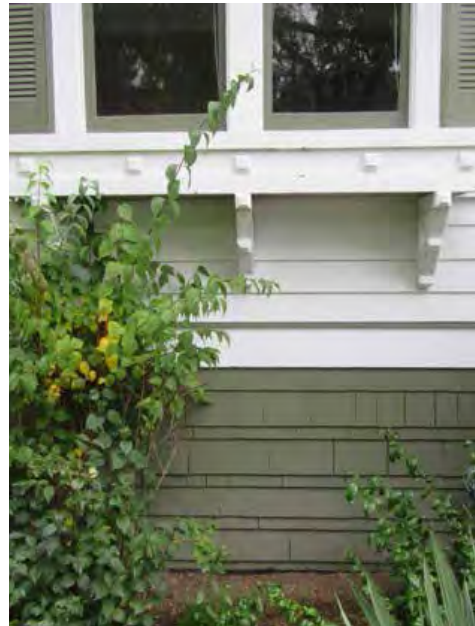
Shingle-clad foundation wall

- It is proposed to relocate the historic house to a subdivided lot at 123 Douglas Street in Moody Centre.
- Install new cedar shingles in double-coursed pattern to match the original appearance.
- New door and window openings at the basement level can be designed. They should be sympathetic to the historic character of the house and made of wood.
- To ensure the prolonged preservation of the new foundations, all landscaping should be separated from the foundations at grade by a course of gravel or decorative stones, which help prevent splash back and assist drainage.

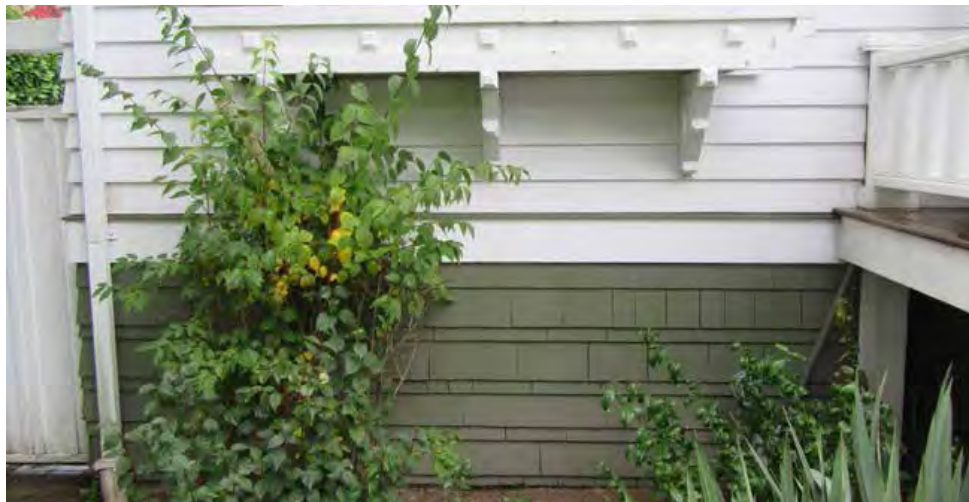
Variety of siding types on the Sutherland Residence

- Retain lap siding and restore in-place. Replace any damaged lap siding to match existing in material, size, profile.
- Combed or textured lumber, vinyl or fibre cement siding are not acceptable replacement materials on the historic house.
- Cleaning procedures of lap siding should be undertaken with non-destructive methods. Areas can be cleaned using a soft, natural bristle brush, without water, to remove dirt and other material. If a more intense cleaning is required, this can be accomplished with warm water, mild detergent (such as Simple Green) and a soft bristle brush. High-pressure power washing, abrasive cleaning or sandblasting should not be allowed under any circumstances on any historic material of the exterior elevations.
- Install new double-coursed cedar shingles at the basement level matching the originals in overall dimensions and installation pattern.

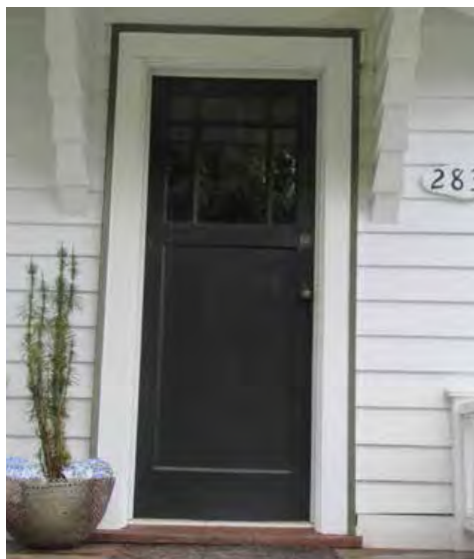
Front door

- Preserve the original door opening, front door including all accessories and surrounding trim. Retain the rear door if possible.
- To improve operation, verify that door fits properly in its frame and joints are tight. Verify that hardware is operational, particularly that hinges are tight and hinge pins not worn. Remove built-up paint at door and jamb. Repair damaged elements to match original. To reduce air infiltration, install weather stripping between door and frame.
- New doors should be sympathetic to the historic character of the house and made of wood.

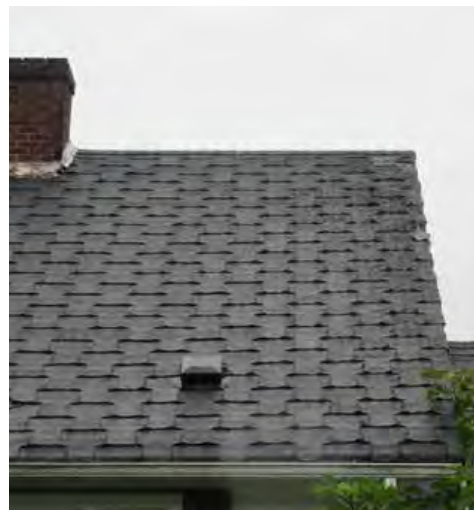
Roof

- Preserve the original roof structure of the Sutherland Residence, including the front hip roof, which should be moved with the main building.
- It seems that the current asphalt shingles are in good repair. If they require replacement, the roof can be re-shingled with cedar shingles. An alternate material is 'Enviroshingle Silvered Cedar' by Enviroshake or approved equivalent. Asphalt shingles may be acceptable in dark grey or black colour.
- Retain the existing gutters and downspouts or design new rainwater disposal system if required.

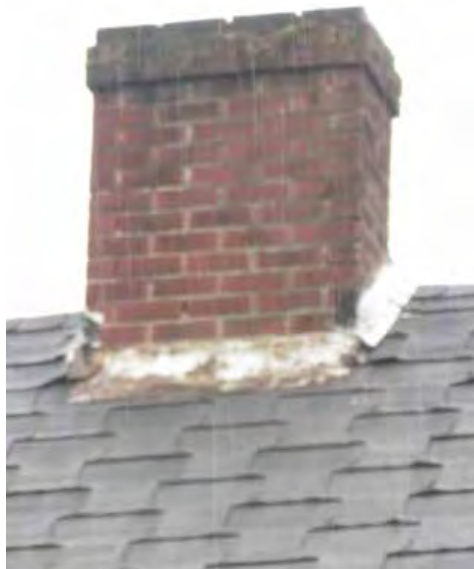
Internal common-red brick chimney

- The existing brick chimney should be retained in place and relocated with the house.
- The brickwork can be gently cleaned of dirt and the brickwork re-pointed as necessary with suitable mortar. The brick chimney will remain unpainted.
- The condition of the existing metal flashings should be reviewed and new flashings installed as necessary.

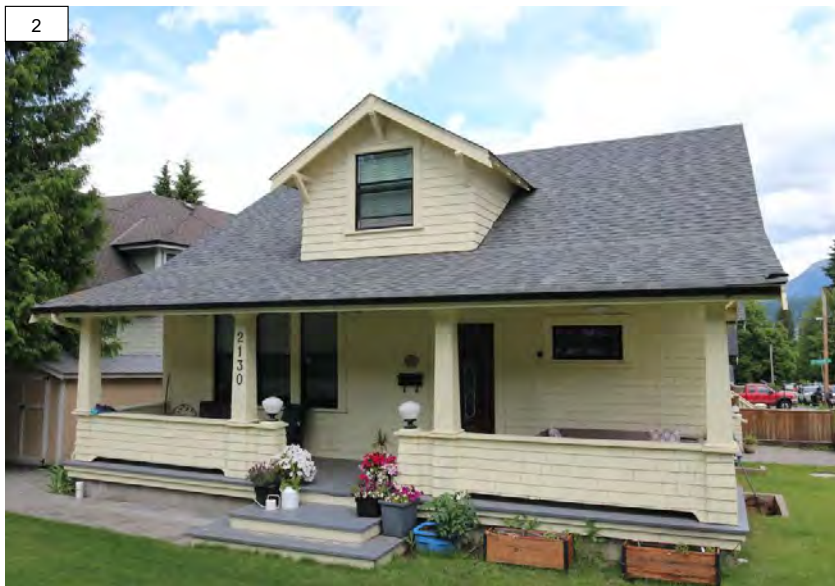
Figure 2: Front elevation of Moisiso Residence, as viewed from St. George Street.

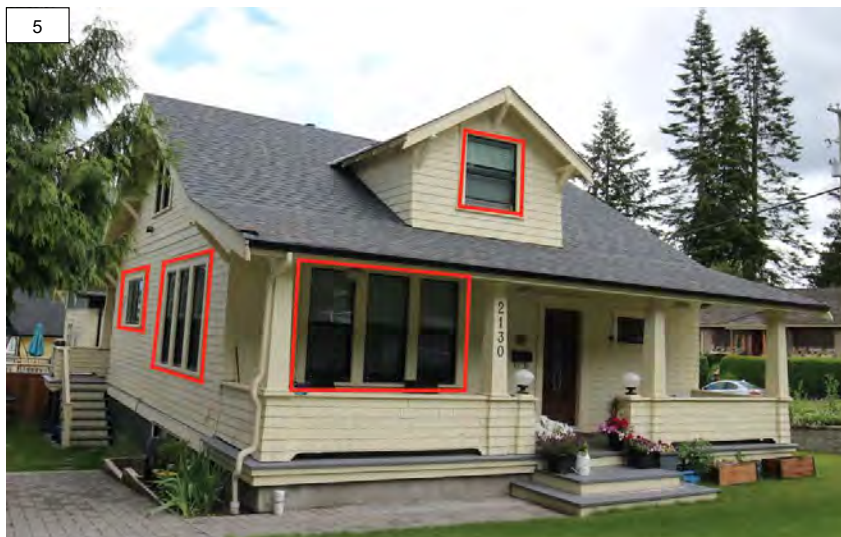
Figure 5: South-west view of Moisio Residence outlining non-wood new and replacement windows.

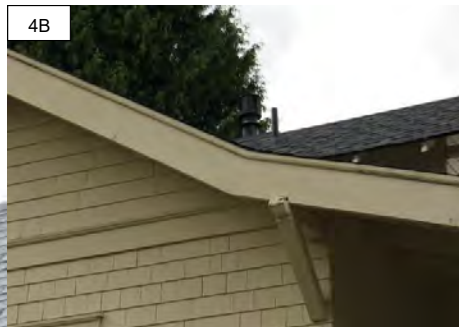
Figure 4B: Observed chimney at time of review.

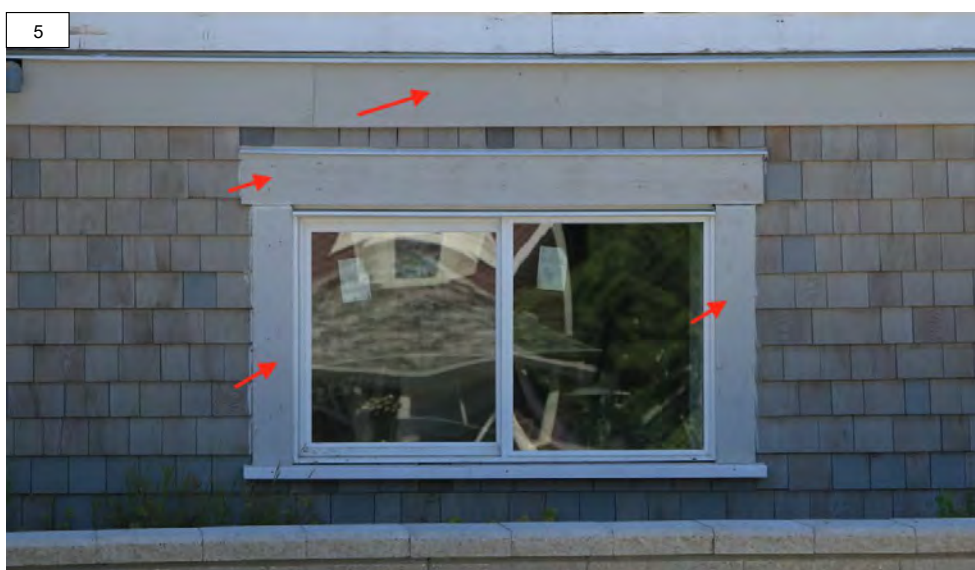
Figure 5: Detail photo showing textured lumber applications at window casing and watertable prior to painting.
