Development Permit No. DP000072

**Development Permit: Hazardous Lands – Soil Liquefaction**

**House of Omeed**  
2340 Clarke Street  
Port Moody, BC V3H 1Y8

Re: **Preliminary Geotechnical Exploration Report**  
Proposed Structure Addition  
2340 Clarke Street, Port Moody, BC

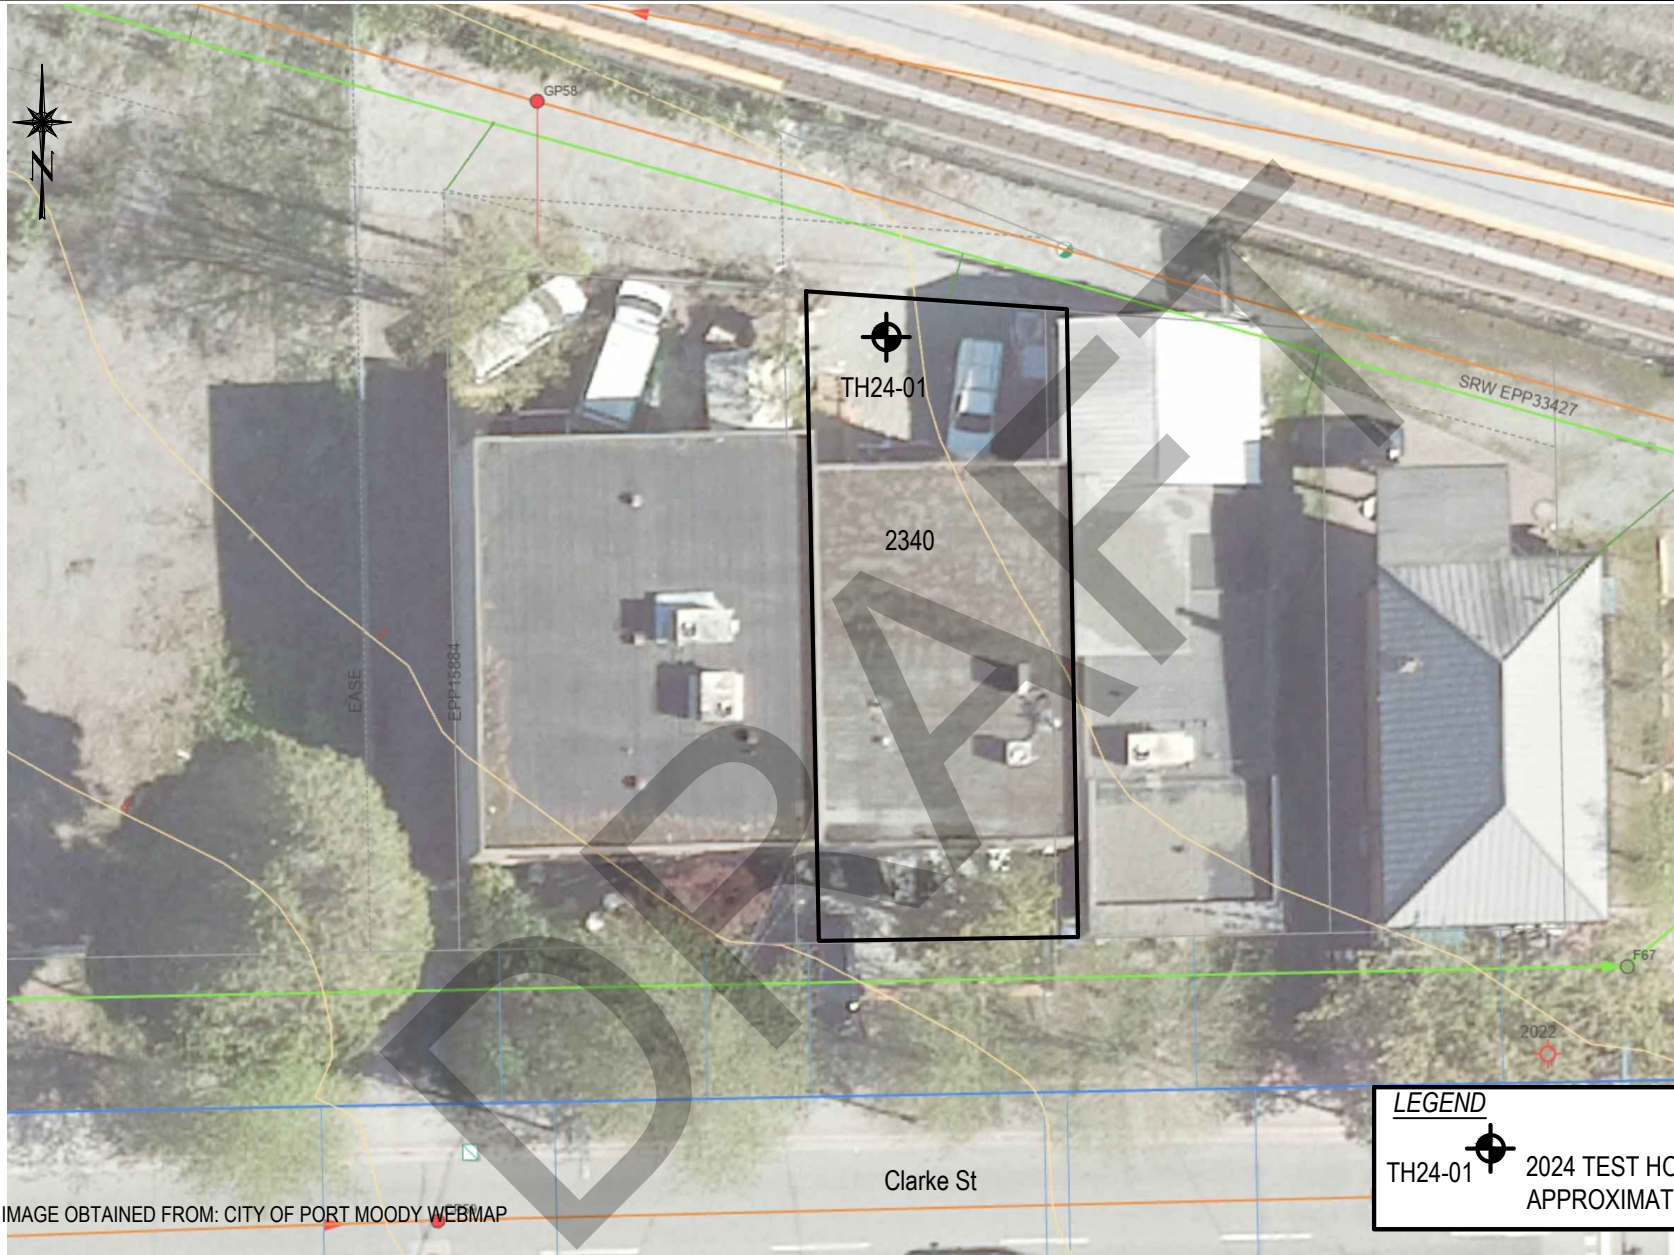
Client				House of Omeed				Title			
Project				Proposed Structure Addition 2340 Clarke St, Port Moody, BC				LOCATION PLAN			
Project no.	Drawn	Design	Checked	Date	Scale	Drawing no.					
24-9856	DD	AC	JO	June 3, 2024	1:300	24-9856-01

The approximate test locations are shown on the enclosed Location Plan (Dwg. no. 24-9856-01).

2024 TEST HOLE APPROXIMATE LOCATION

One test hole (TH24-01) was drilled on June 13, 2024, to a depth of 10.7 m using a truck mounted solid stem auger drill under subcontract to BGL. The soil conditions were logged in the field by BGL. Representative soil samples were returned for moisture content laboratory testing and further visual classification. A Dynamic Cone Penetration Test (DCPT) was advanced adjacent to TH24-01 to a depth of practical refusal at 10.4 m. Local experience indicates that the DCPT results can be approximately correlated with Standard Penetration Test (SPT) N-values and as a screening tool to estimate the relative in situ density of granular soils and strength of cohesive soils.
