# IOCO TOWNSITE

HERITAGE CONSERVATION AREA, PORT MOODY, BC

## HERITAGE CONDITION ASSESSMENT REPORT

JULY 2020

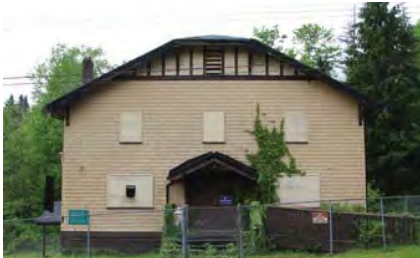
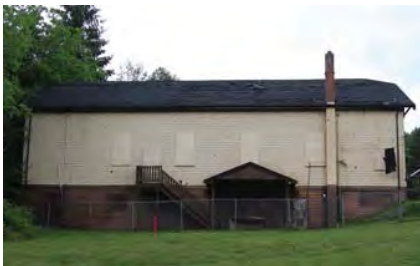
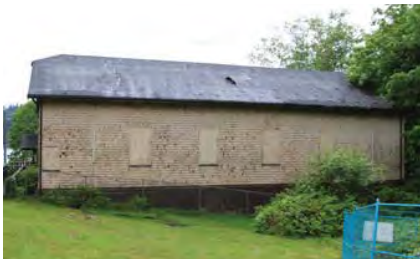
- In general, existing exterior paint finish is in poor condition, as evidenced by alligating, blistering, paint loss altogether.
- Existing condition no longer provides protection of exterior wall cladding and trims as originally intended.

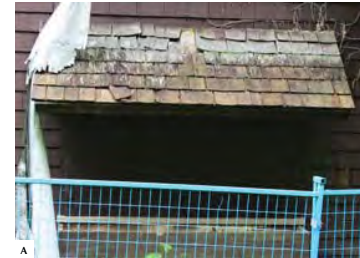
Wood shingles on canopy above window opening at front (west) elevation.

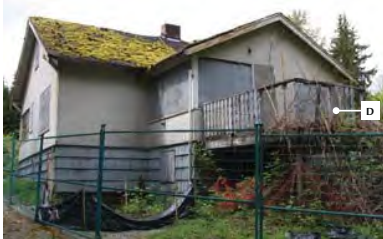
Partial south and east elevations. Note rear extension with later decking.

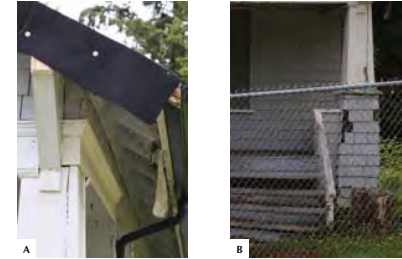
Left: existing woodwork detailing of front entry porch; note exposed soffit beyond.

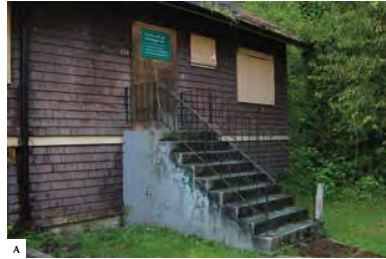
Later front entry stairs, with unsympathetic poured cement steps and metal guard and railing.

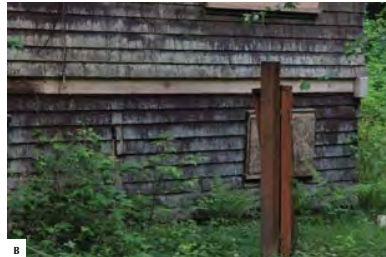
North elevation: heavy biological growth on wall cladding, indicating prolonged water ingress and saturation.

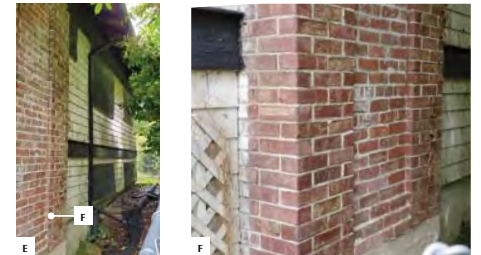
Detail photo showing brickwork detailing at base of exterior chimney.

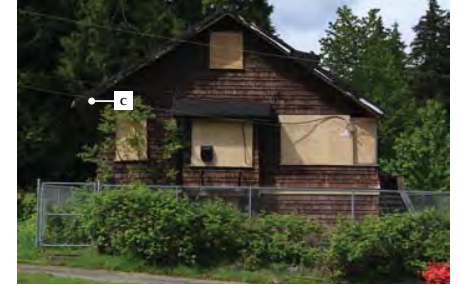
South elevation. Note ribbon coursing of wood shingles.
